# BUNDABERG LEVEE

EPW00390 – Heritage Impact Assessment – Saltwater Creek Rail Bridge  
(30034151-RPT-13.0-001) – Revision 0

May 2024

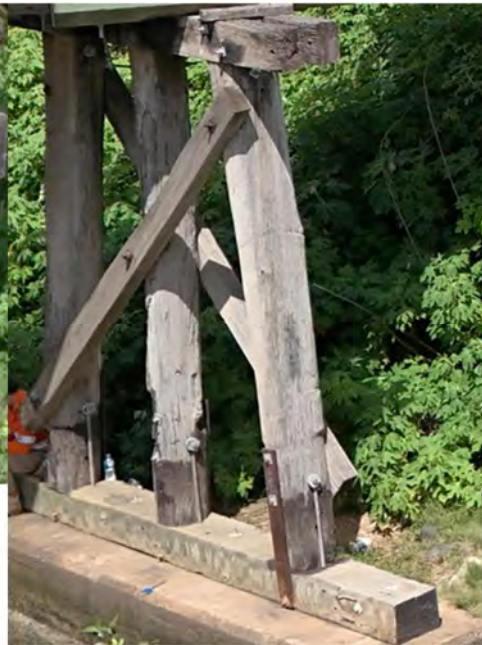
Photo 8 General view of pier 4

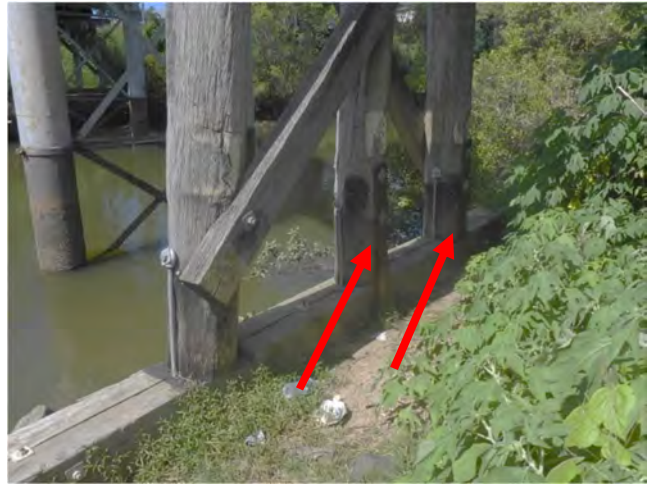
Photo 10 Base plates from the piers to timber footing exhibiting surface corrosion

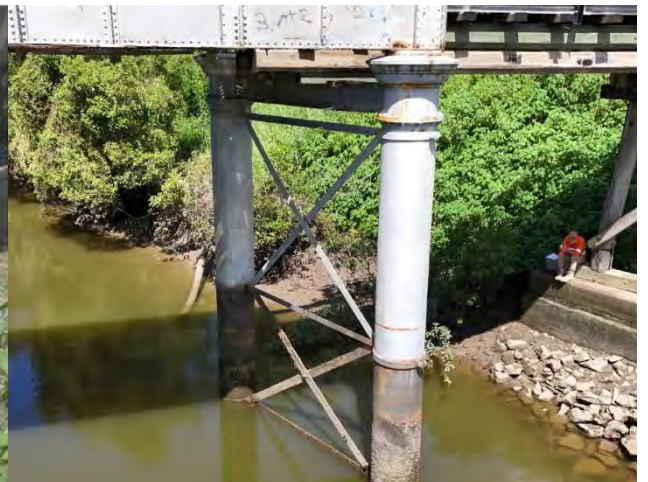
Photo 14 General view of pier 5

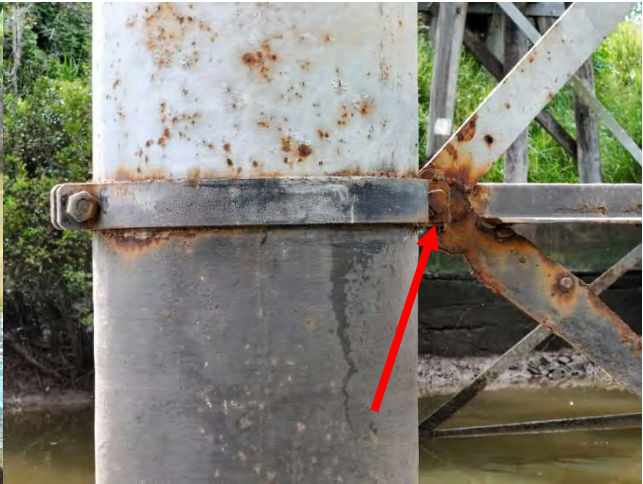
Photo 16 Pier 5 corrosion on bracing element fixings

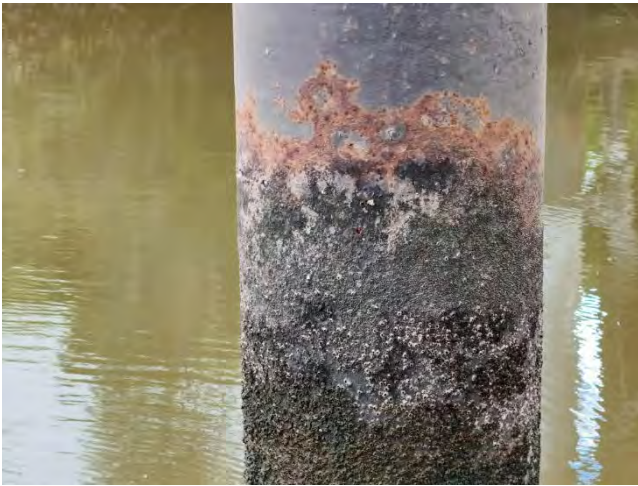
Photo 17 Pier 5 surface corrosion in tidal zone

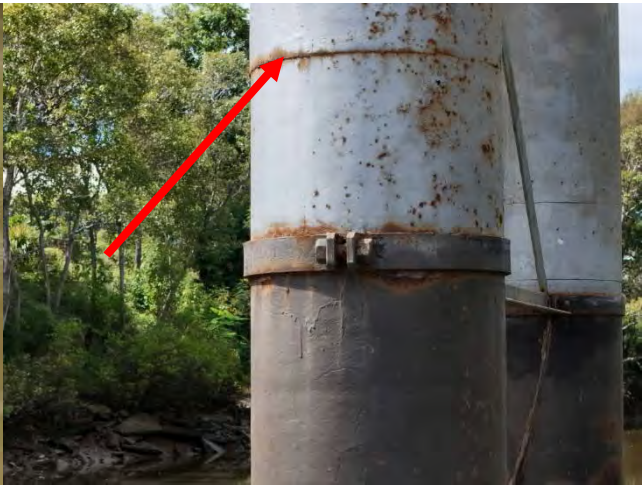
Photo 18 Pier 5 corrosion staining at welds and pitting corrosion in tidal zone

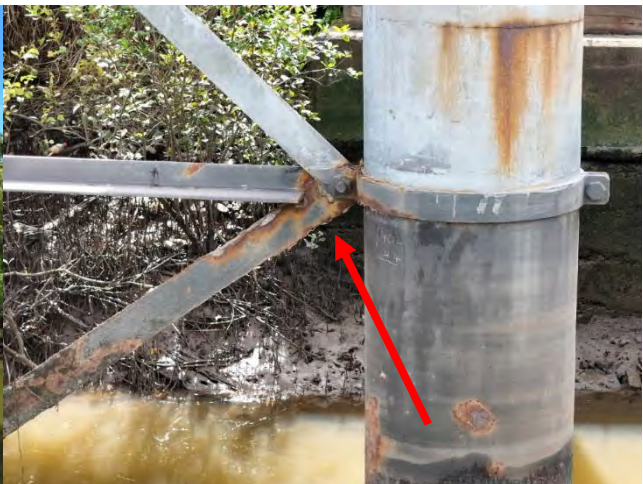
Photo 20 Pier 6 corrosion on bracing elements

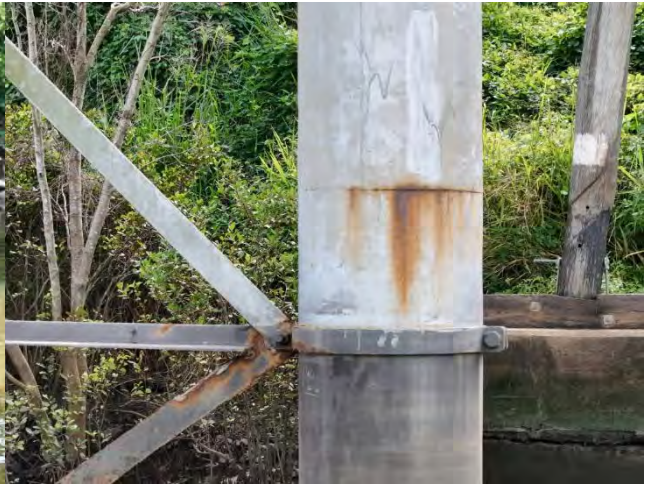
Photo 22 Pier 6 corrosion staining at welds in tidal zone

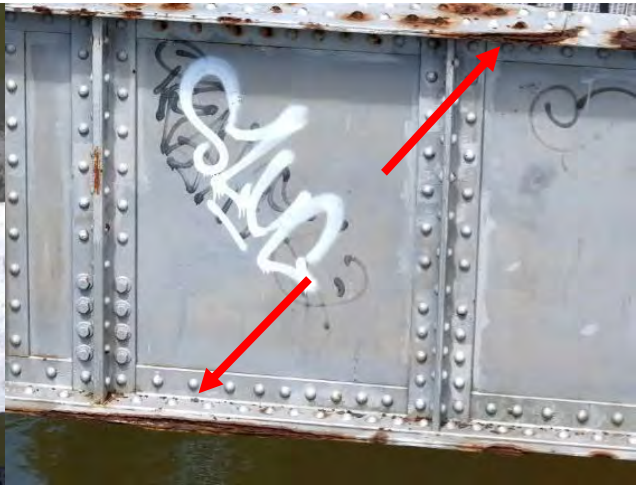
Photo 54 Span 6 main girder left hand side flange corrosion

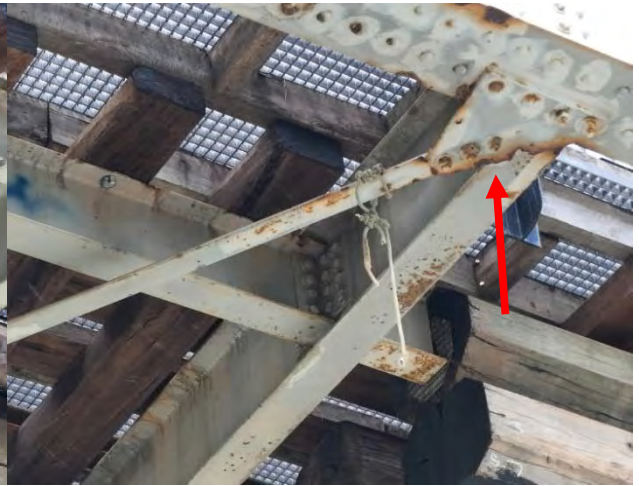
Photo 60 Span 6 cross bracing cleats corrosion at main girder connections

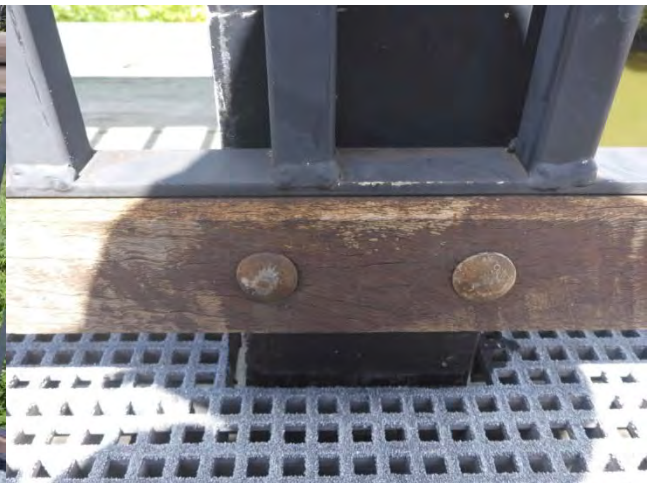
Photo 77 Bridge railing fixings surface corrosion

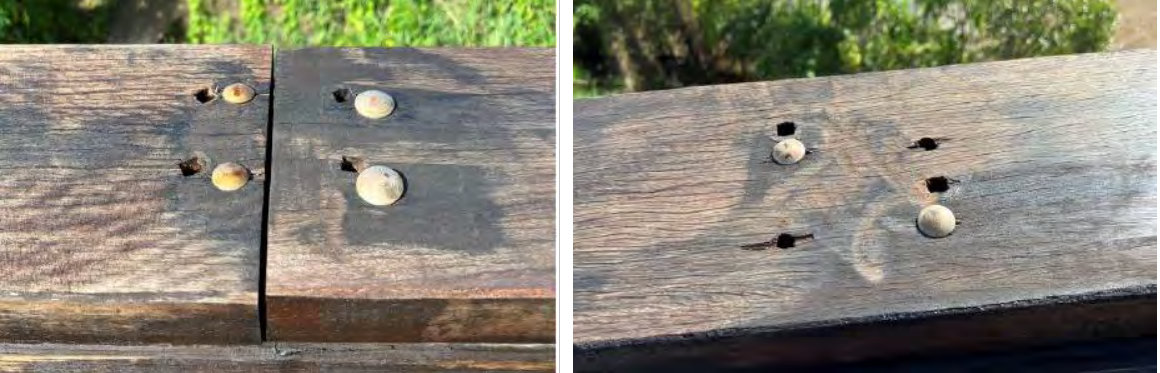
ELEMENT	CONDITION DESCRIPTION AND ILLUSTRATION	
<p><b>Walkway</b></p> <p>Handrail members</p>	<p><u>Incorrect bolt installation</u></p> <p>Several bolts are installed incorrectly and holes from previous installations are not filled, potentially resulting in water penetration and decay.</p>

<p>Bolts installed incorrectly and holes left open (Bligh Tanner 2022).</p> <p>Bolts installed incorrectly and holes left open (Bligh Tanner 2022).</p>
	<p><u>Mismatched replacement timber boards</u></p> <p>Not all replacement boards match the size of the existing and some members are too short.</p>

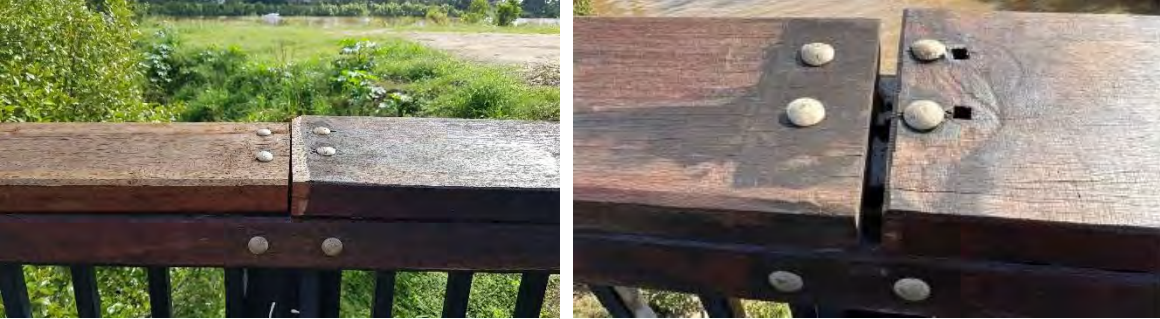
<p>Mismatched size of timber board (Converge 2022).</p> <p>Some members are too short (Bligh Tanner 2022).</p>

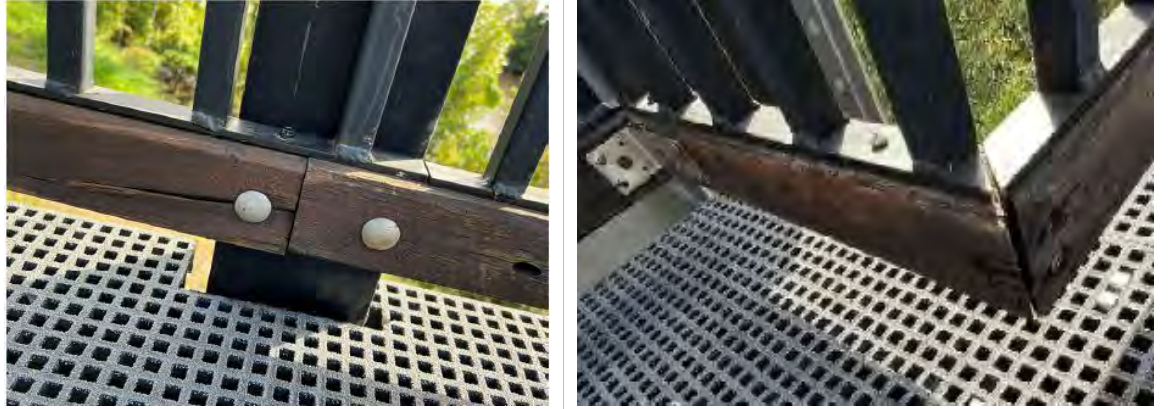
ELEMENT	CONDITION DESCRIPTION AND ILLUSTRATION	
Kick railing	<p><u>Splitting of timber boards</u></p> <p>Major timber splitting was observed at the toe kick railing in some places.</p>

<p>Splitting timber (Bligh Tanner 2022).</p> <p>Splitting timber (Bligh Tanner 2022).</p>
	<p><u>Missing or connector plates/screws</u></p> <p>The connector plates are missing in some places and some plates are missing some screws.</p>

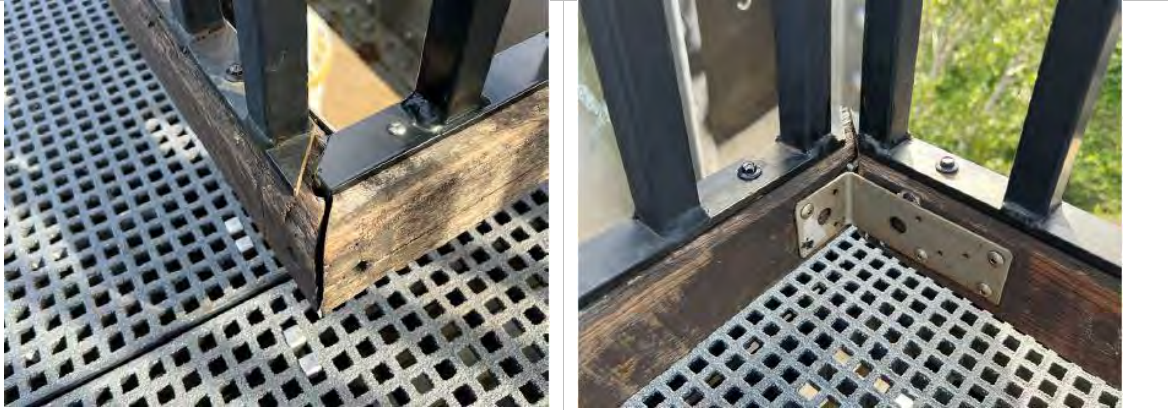
<p>Missing connectore plate (Bligh Tanner 2022).</p> <p>Missing screws (Bligh Tanner 2022).</p>

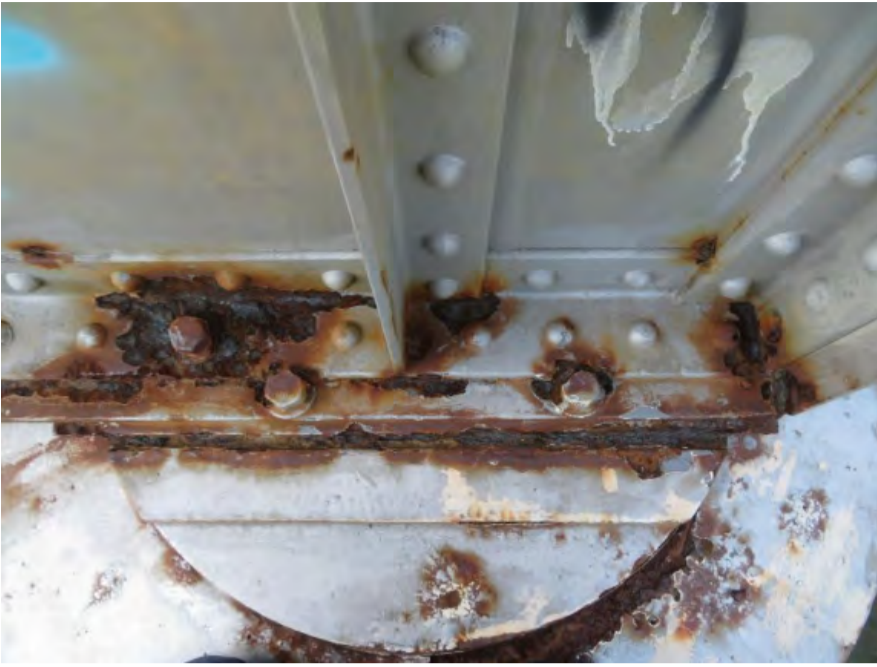
PIER 6, COLUMN 1 - CORRODED BEARING PLATES AND BOLTS	REMOVE EXISTING BOLTS. ABRASIVE BLAST AND THOROUGHLY CLEAN EXISTING SURFACE. INSTALL NEW SAE GRADE 8 BOLTS TO MATCH EXISTING. APPLY PROTECTIVE PAINT COATING AS PER SPECIFICATION.
B

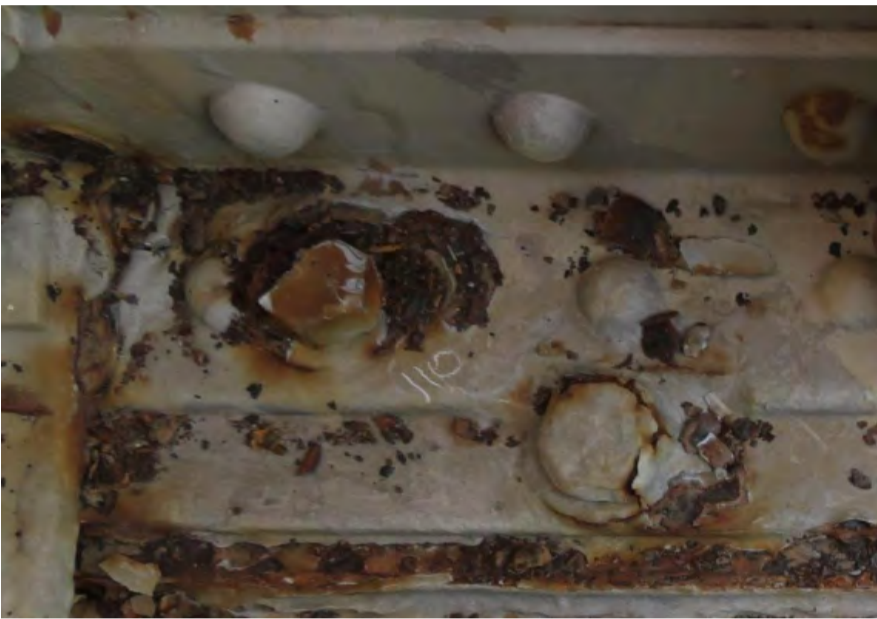
PIER 7, COLUMN 1 - CORRODED BEARING PLATES AND BOLTS	REMOVE EXISTING BOLTS. ABRASIVE BLAST AND THOROUGHLY CLEAN EXISTING SURFACE. INSTALL NEW SAE GRADE 8 BOLTS TO MATCH EXISTING. APPLY PROTECTIVE PAINT COATING AS PER SPECIFICATION.
C

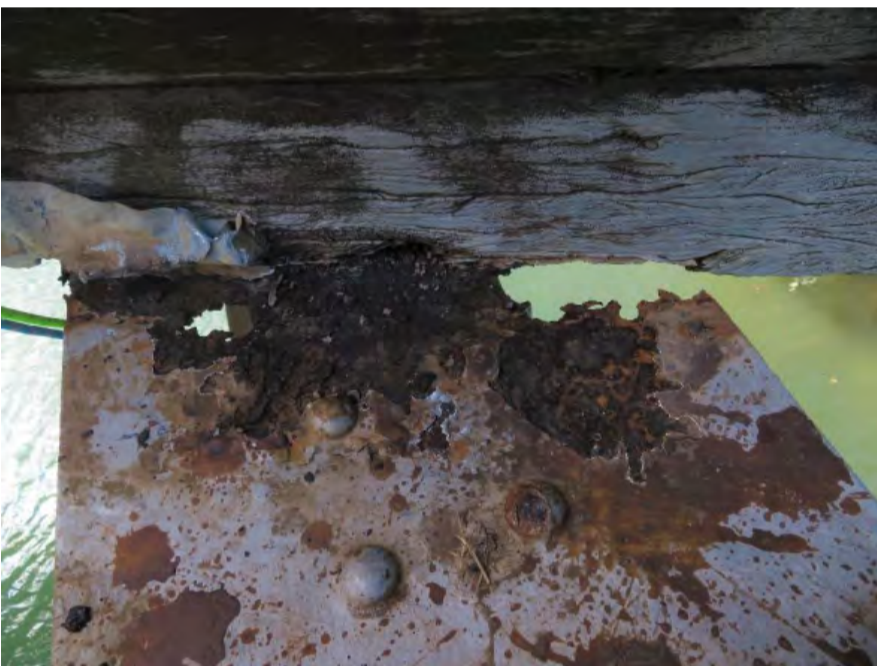
PIER 6 CROSS BEAM - SEVERELY CORRODED TOP PLATE TO EXISTING BEAM	REFER DETAIL AND METHODOLOGY ON DWG S202.
D

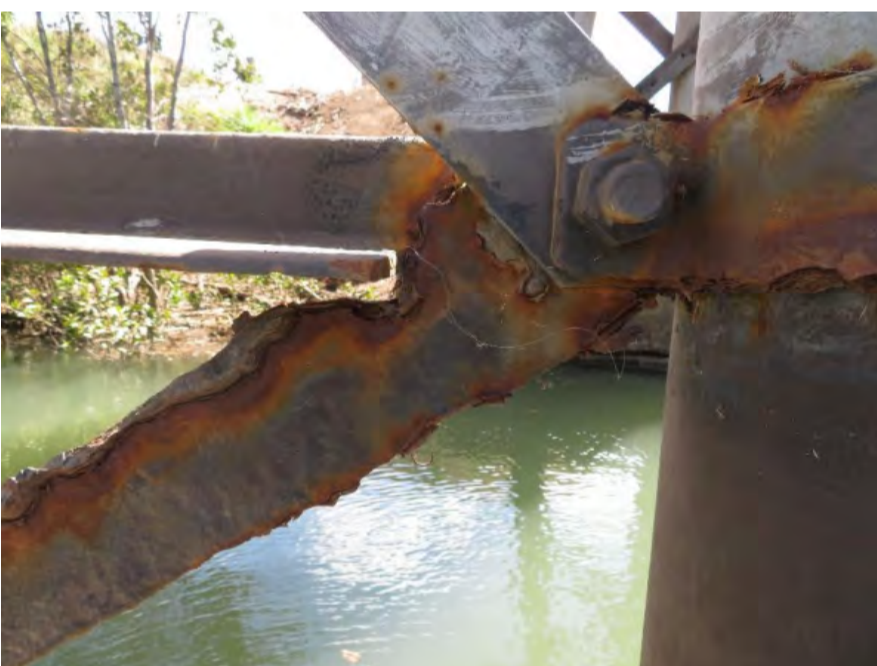
PIER 6 & 7 VERTICAL BRACING, PIER COLLARS AND TEES - SEVERELY CORRODED	REFER DETAIL AND METHODOLOGY ON DWG S202.
E

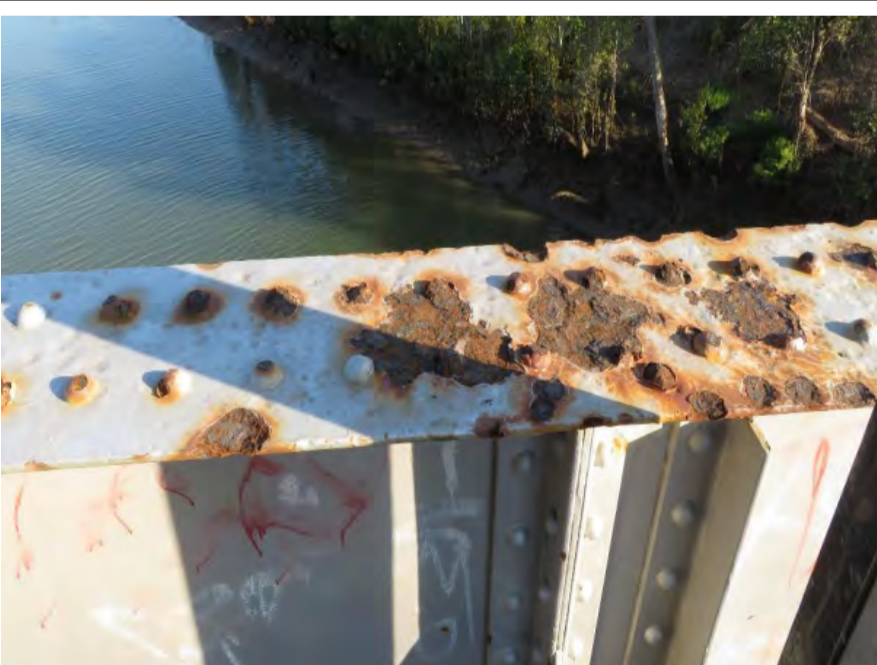
GIRDER 1 - TOP FLANGE RIVETS SEVERELY CORRODED	REMOVE EXISTING SEVERELY CORRODED RIVETS ONE AT A TIME. ABRASIVE BLAST AND THOROUGHLY CLEAN EXISTING GIRDER LOCALLY INSTALL NEW GRADE 8.8/S BOLT TO REPLACE EXISTING RIVET. APPLY PROTECTIVE PAINT COATING IN ACCORDANCE WITH SPECIFICATION. REPEAT FOR ALL SEVERELY CORRODED RIVETS.

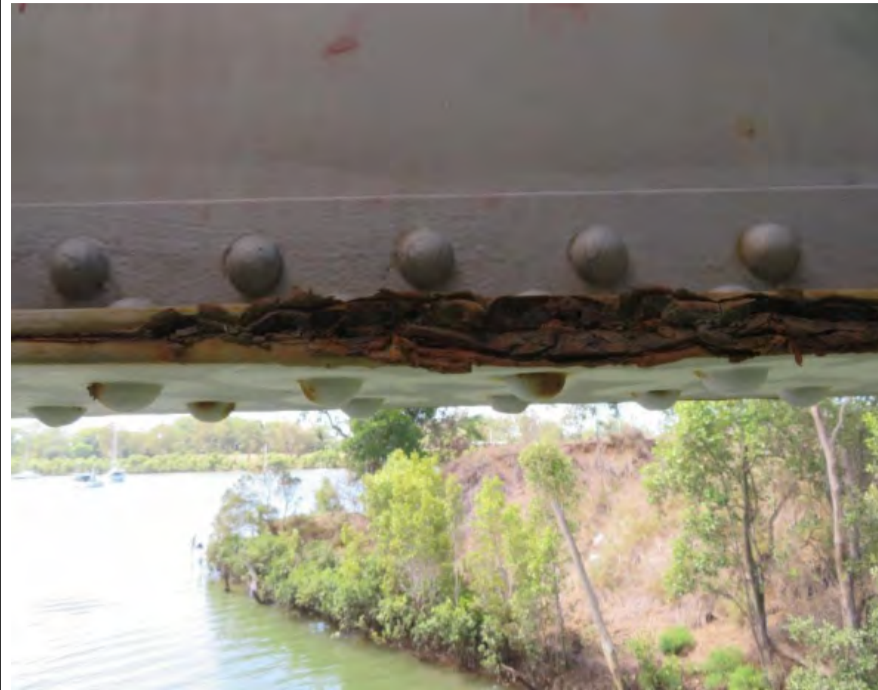
MAIN GIRDERS - CREVICE CORROSION BETWEEN BOTTOM PLATES	ABRASIVE BLAST AND THOROUGHLY CLEAN EXISTING GIRDER. APPLY PROTECTIVE PAINT COATING AS PER SPECIFICATION.
G

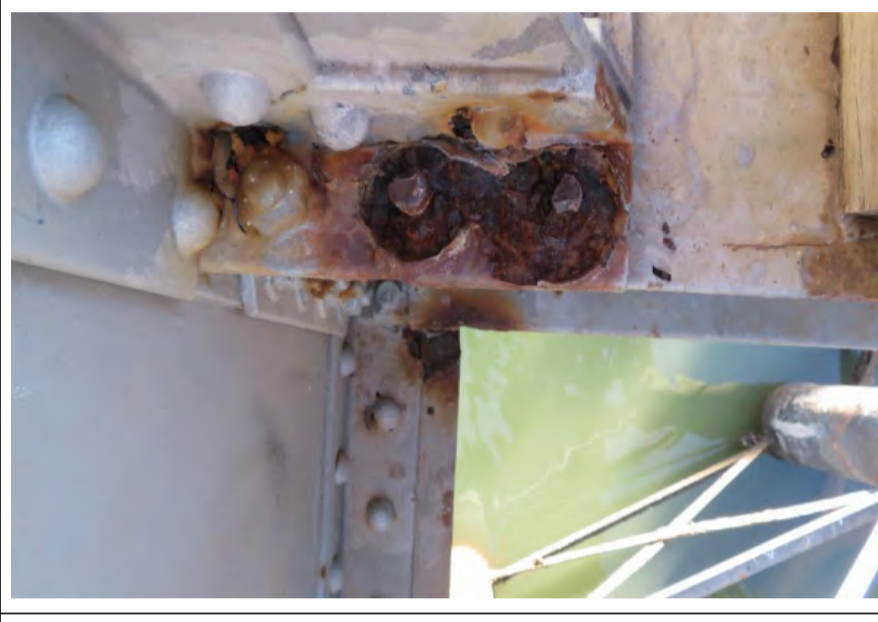
CROSS GIRDER CONNECTION TO MAIN GIRDER - CORRODED RIVETS AND ANGLE	REFER DETAIL AND METHODOLOGY ON DWG S203.
H

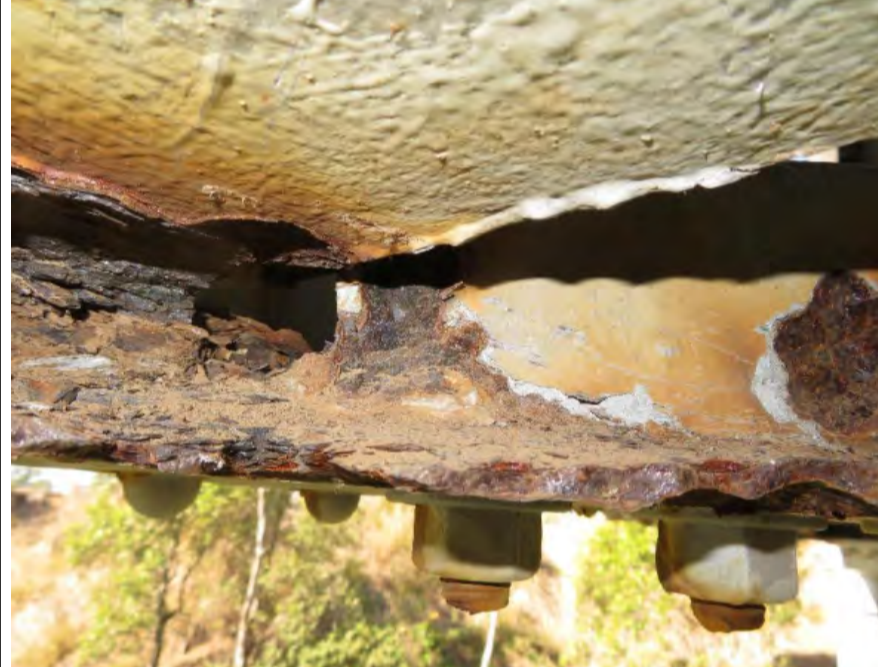
DIAGONAL HORIZONTAL BRACE 1 - SEVERELY CORRODED	REFER DETAIL AND METHODOLOGY ON DWG S203.
J

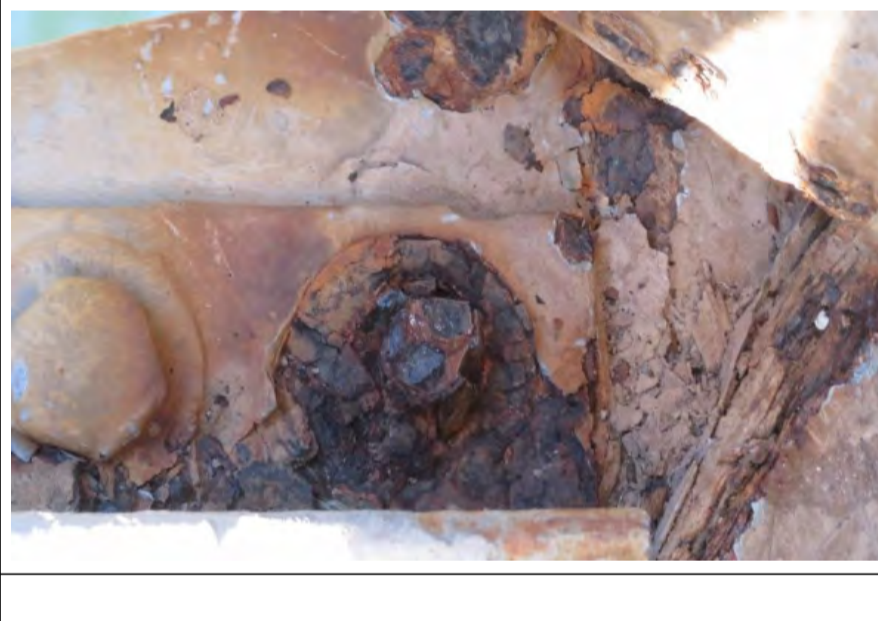
DIAGONAL HORIZONTAL BRACING CLEATS - CREVICE CORROSION AND CORRODED RIVETS	REFER DETAIL AND METHODOLOGY ON DWG S203.
K		GIRDER 1 & GIRDER 2 - CORROSION TO RIVETS.	REPLACE EXISTING CORRODED RIVETS WITH GRADE 8.8/S BOLTS TO MATCH RIVET DIAMETER ONE AT A TIME. ABRASIVE BLAST AND THOROUGHLY CLEAN EXISTING GIRDER AS REQUIRED. APPLY PROTECTIVE PAINT COATING IN ACCORDANCE WITH SPECIFICATION. ALLOW FOR: GIRDER 1 - 55 BOLTS TO TOP PLATE AND 18 BOLTS TO BOTTOM PLATE. GIRDER 2 - 9 BOLTS TO TOP PLATE AND 14 BOLTS TO BOTTOM PLATE
