# BUNDABERG LEVEE

EPW00390 – Heritage Impact Assessment – Saltwater Creek Rail Bridge  
(30034151-RPT-13.0-001) – Revision 0

May 2024

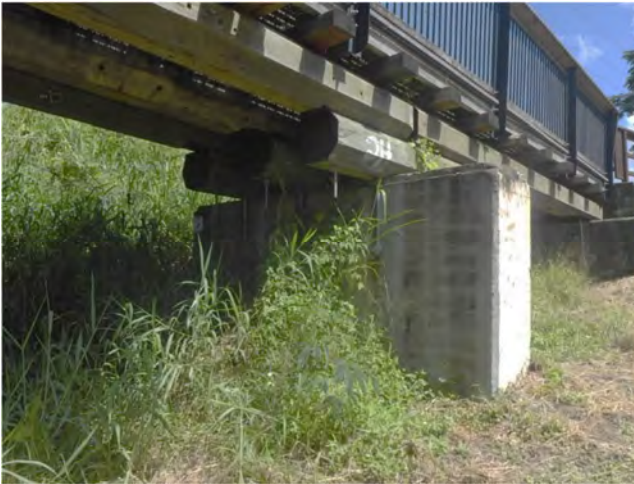
- Pier 1 – Mass concrete (unreinforced)
  - Mass concrete pier was in sound condition (Photo 1, Photo 2). One (1) x isolated defective area was observed, a 300 mm x 200 mm delaminated area on the left hand side top corner of the mass concrete pier (Photo 3).

Photo 1 General view of pier 1 (1)

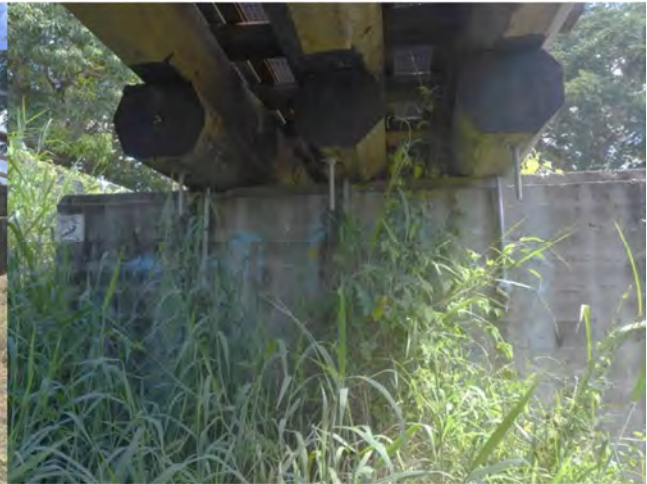
Photo 2 General view of pier 1 (2)

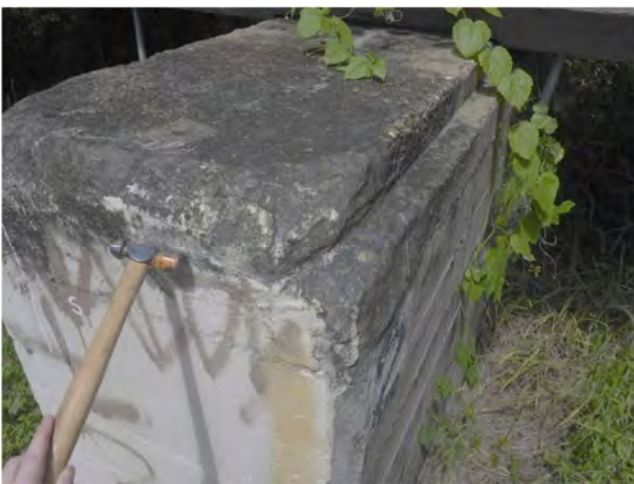
Photo 3 Pier 1 side 1 concrete delamination, 300 mm x 200 mm

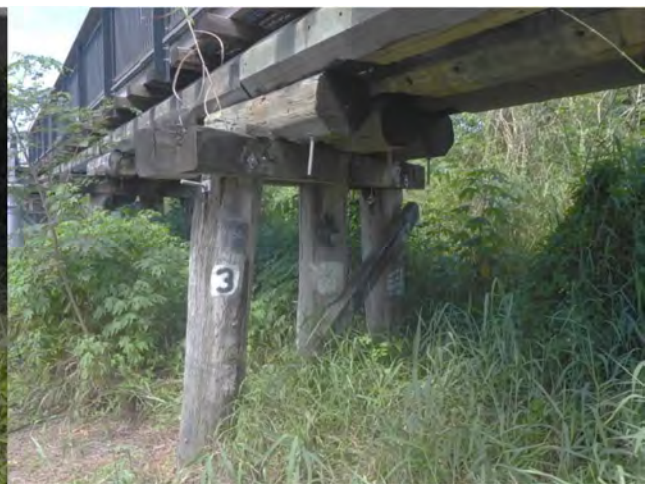
- Pier 2 – Timber
  - Timber piles were in fair condition (Photo 4). Vertical splitting was observed in all piles (Photo 5).
- Pier 3 – Timber
  - Timber piles were in sound condition. Vertical splitting below the headstock was observed on one (1) pier (Photo 7).

Photo 4 General view of pier 2

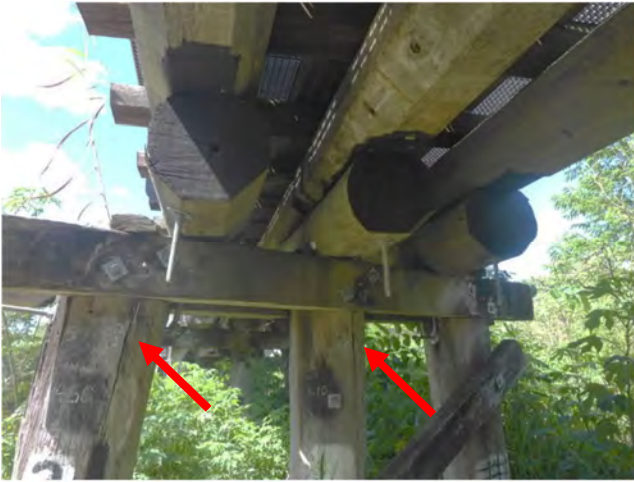
Photo 5 Pier 2 vertical splitting

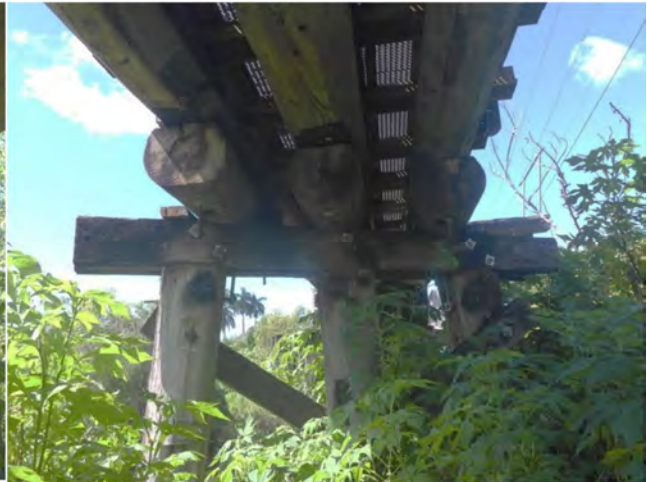
Photo 6 General view of pier 3

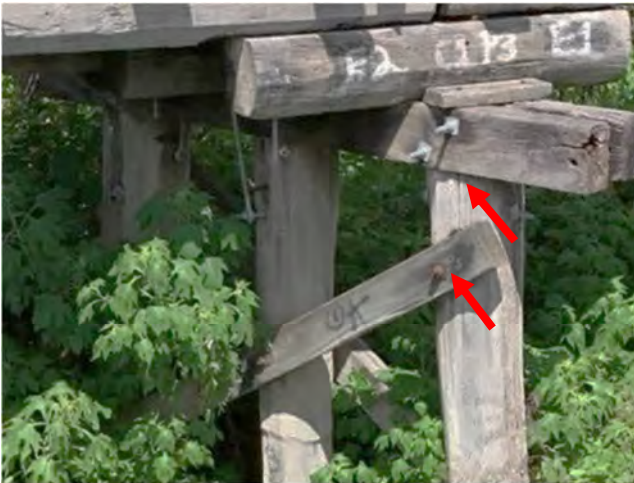
- Several fixings exhibited surface corrosion, including cross bracing bolts on both pier faces (Photo 7).
- Pier 4 – Timber with Mass Concrete (Unreinforced) Footing

Photo 7 Pier 3 cross bracing bolts surface corrosion, vertical splitting below headstock

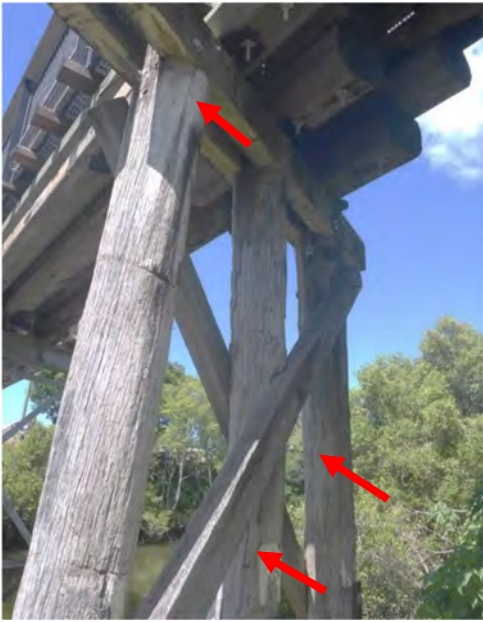
- Timber piles were in fair condition (Photo 8). Vertical splitting was observed in all piles (Photo 9, Photo 11).
  - Several fixings exhibited surface corrosion, including cross bracing bolts on both pier faces (Photo 11) and three (3) base plates from the piers to timber footing (Photo 10).

Photo 9 Pier 4 vertical splitting

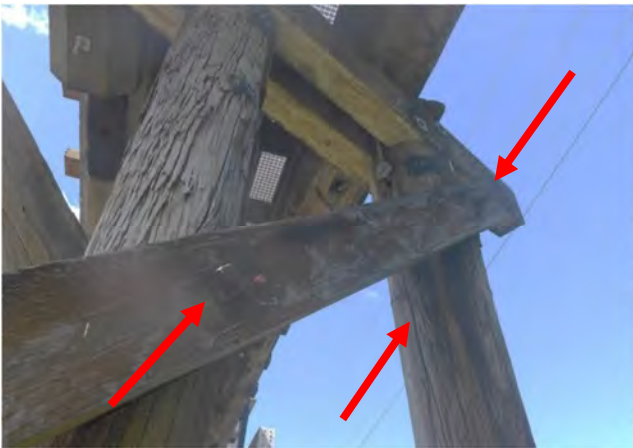
Photo 11 Pier 4 cross bracing bolts surface corrosion, vertical splitting in piers

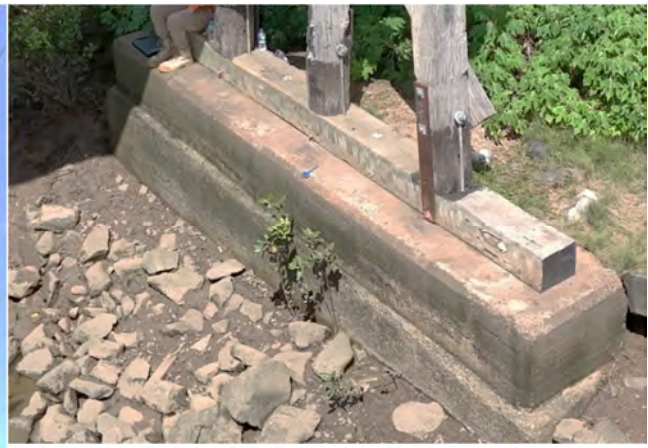
- Mass concrete footing was in sound condition (Photo 12). One (1) x isolated defective area was observed, an approximately 300 mm x 300 mm concrete spall on the left hand side corner of the concrete footing (Photo 13).

Photo 12 General view of pier 4 mass concrete footing

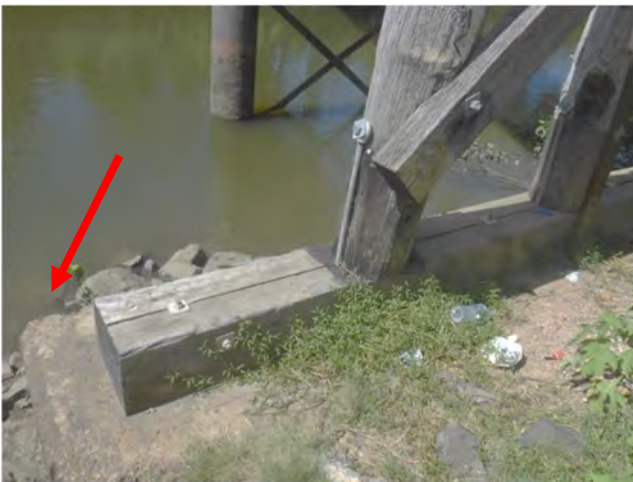
Photo 13 Pier 4 footing corner spall, 300 mm x 300 mm

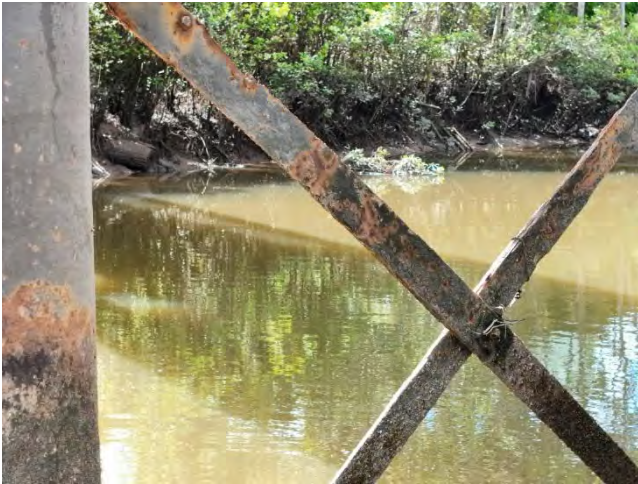
- Pier 5 – Cast Iron
  - Corrosion resulting in section loss was typically observed on the bracing elements and fixings near the tidal zone (Photo 15, Photo 16).

Photo 15 Pier 5 corrosion on bracing elements

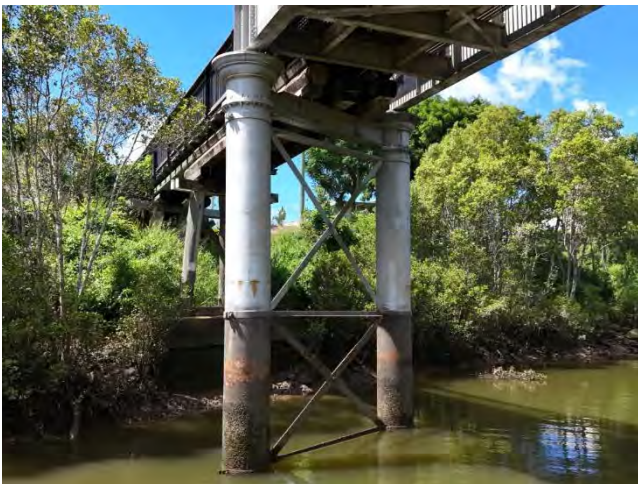
Photo 19 General view of pier 6

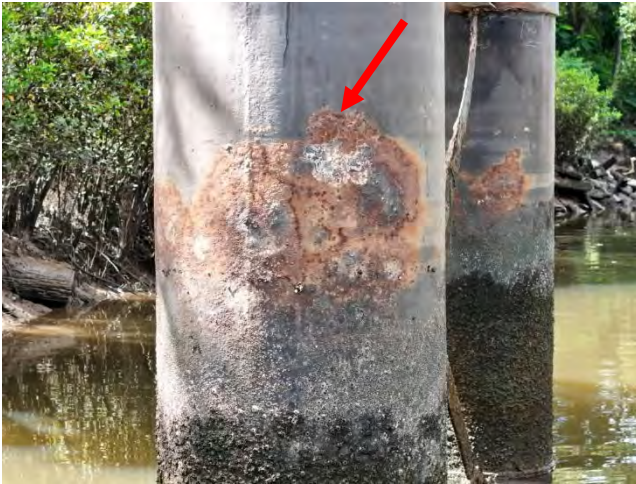
- Surface corrosion was typically observed on the pier surfaces in the tidal zone (Photo 21).
  - Pitting corrosion was occasionally observed on the pier surfaces in the tidal zone (Photo 21).

Photo 21 Pier 6 surface corrosion and pitting corrosion in tidal zone

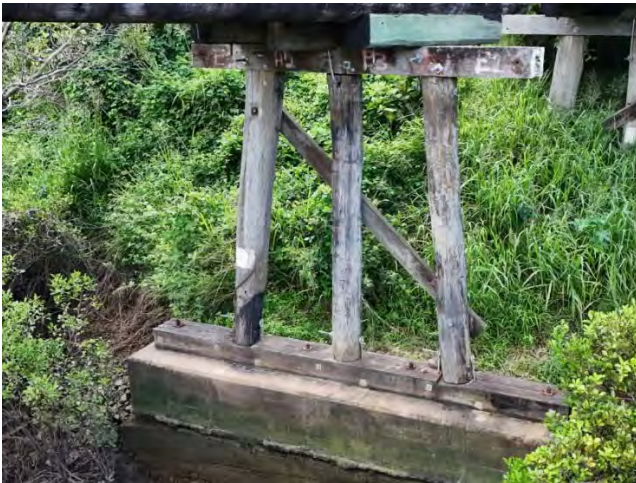
- Some timber piles were in poor condition (Photo 23). Vertical splitting below the headstock was observed all piers (Photo 24).
- Several of the timber footing bolts exhibited surface corrosion (Photo 25).
- One (1) tie rod on the abutment 1 face was bent (Photo 26).
- Mass concrete footing was in sound condition. Poor concrete compaction was typically observed (Photo 27).
- Pier 8 – Timber
  - Some timber piles were in poor condition (Photo 28). Both outer piers had significant vertical splitting near the headstock (Photo 29)
  - Several fixings exhibited surface corrosion, including cross bracing bolts on both pier faces (Photo 29).
- Pier 9 – Timber
  - Timber piles were in sound condition.

Photo 23 General view of pier 7

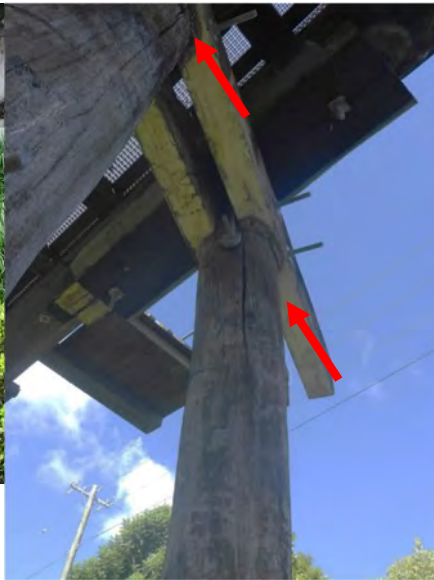
Photo 24 Pier 7 vertical splitting below headstock

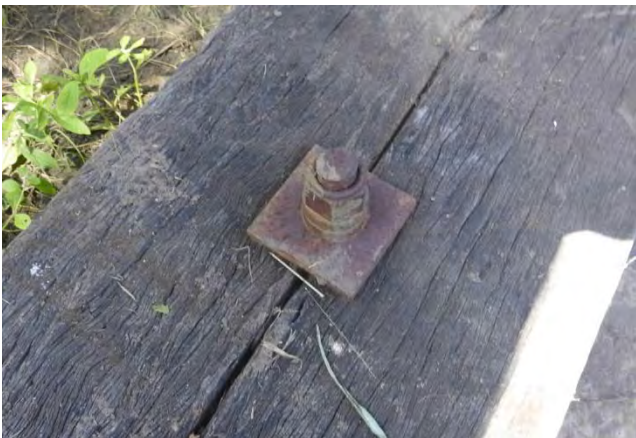
Photo 25 Pier 7 timber footing bolts exhibiting surface corrosion

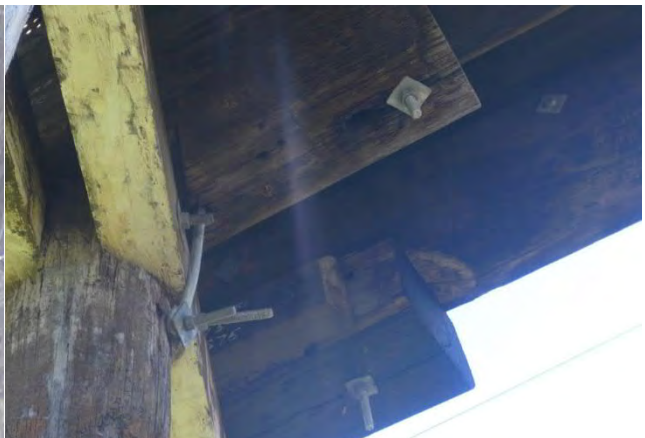
Photo 26 Pier 7 tie rod on abutment 1 face bent

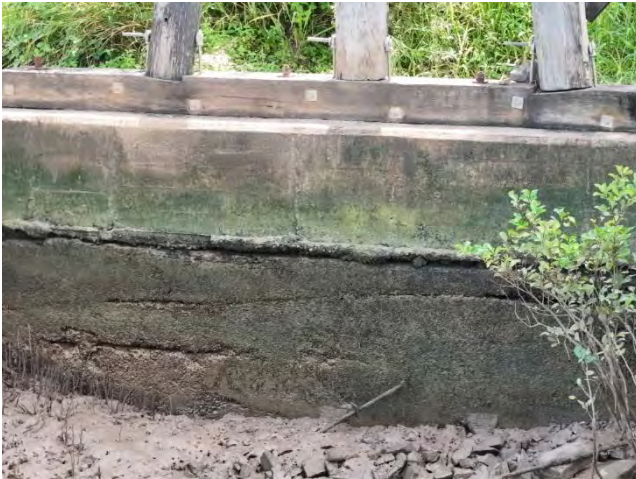
Photo 27 General view of pier 7 mass concrete footing, poor compaction typical

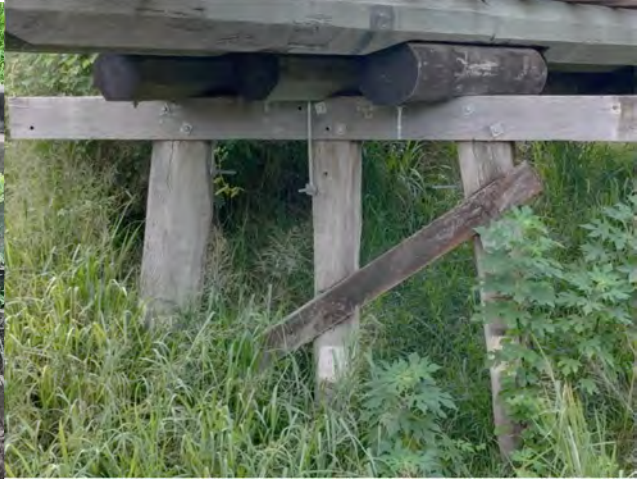
Photo 28 General view of pier 8

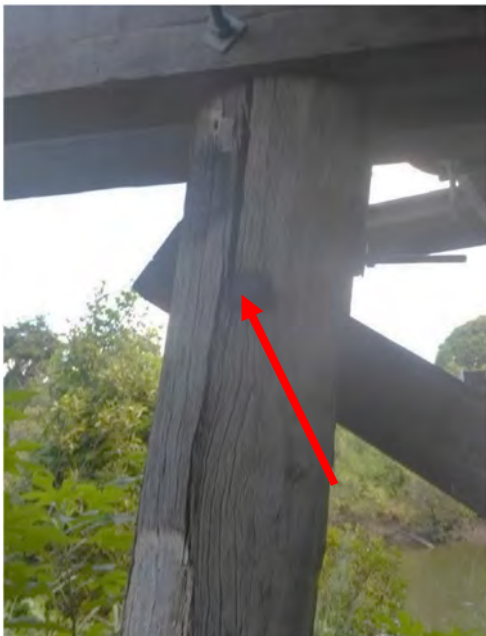
Photo 29 Pier 8 timber splitting, cross bracing bolts exhibiting surface corrosion

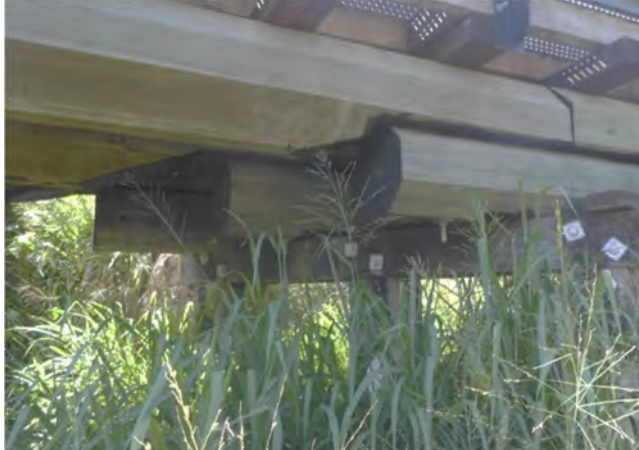
Photo 30 General view of pier 9

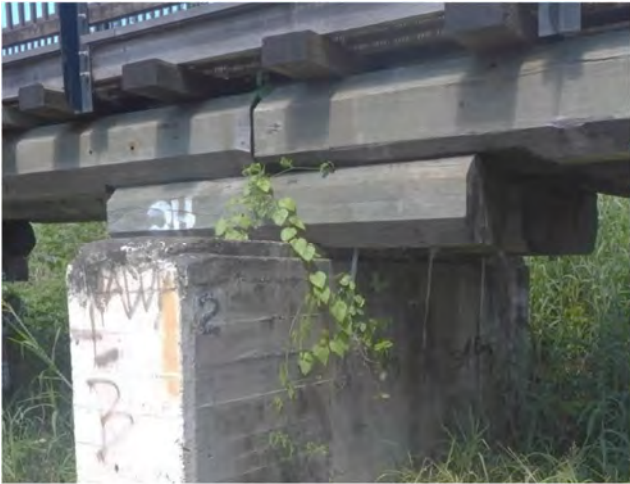
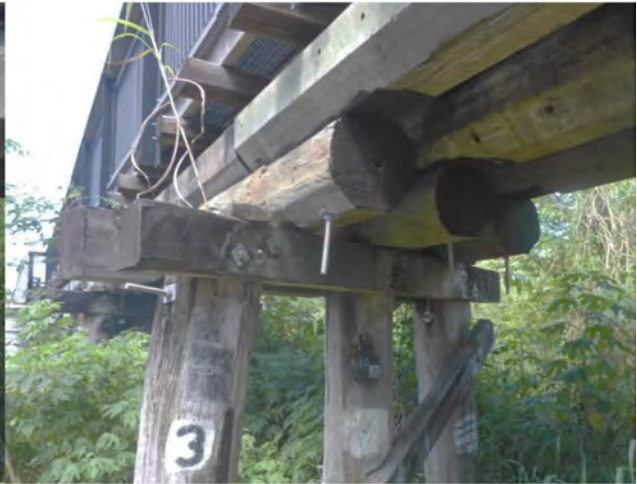
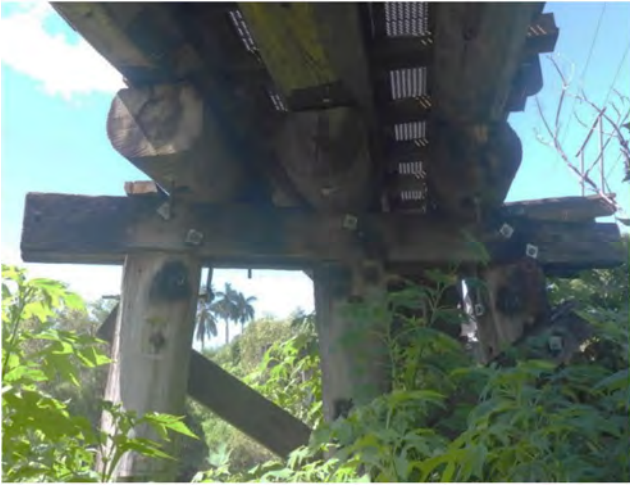
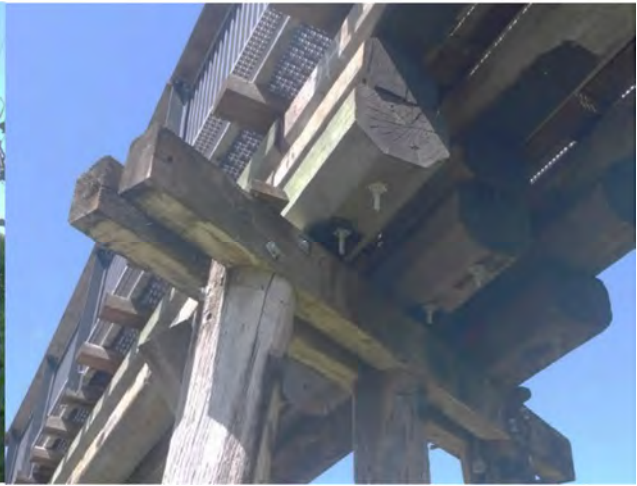
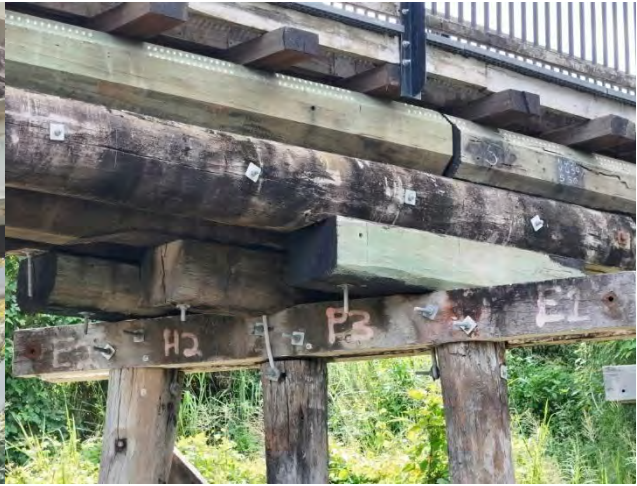
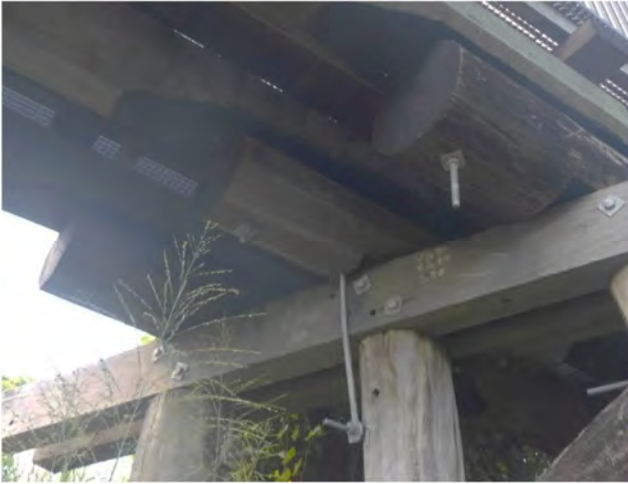
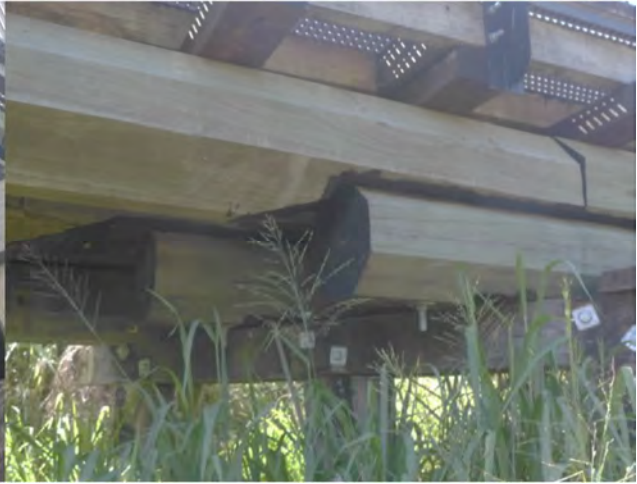
- Pier corbels/headstocks/cross beams were in generally sound condition (Photo 31 to Photo 40). Isolated defects were observed:
  - Pier 5 cross beam had two (2) areas of severe section loss of approximately 200 mm x 100 mm on the top flange, abutment 1 face (Photo 36). Surface corrosion was typically observed on the top and bottom flanges. Isolated areas of surface corrosion were typically observed on the web.
  - Pier 6 cross beam typically had isolated areas of surface corrosion on the web and flanges (Photo 37).

Photo 31 General view pier 1 corbels

Photo 32 General view pier 2 corbels/headstock

Photo 33 General view pier 3 corbels/headstock

Photo 34 General view pier 4 corbels/headstock

Photo 38 General view pier 7 corbels/headstock

Photo 39 General view pier 8 corbels/headstock

Photo 40 General view pier 9 corbels/headstock

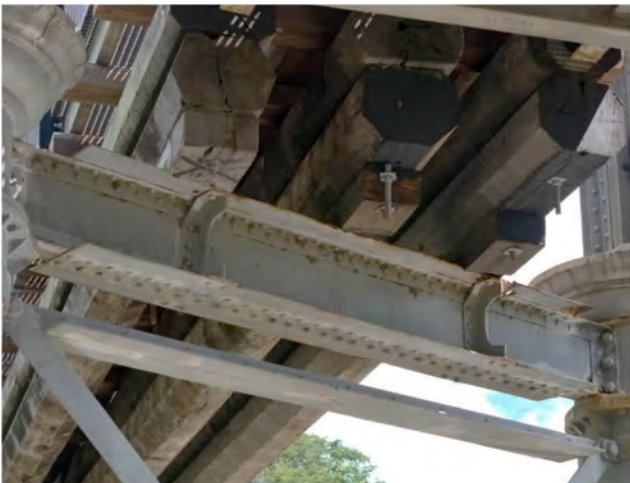
Photo 35 General view pier 5 cross beam

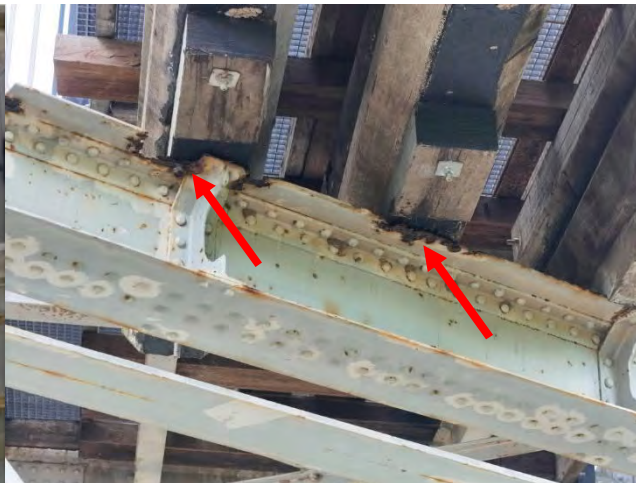
Photo 36 Pier 5 cross beam top flange section loss

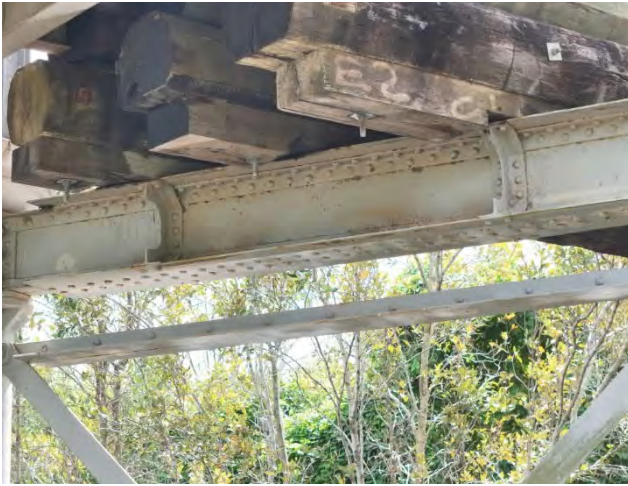
Photo 37 General view pier 6 cross beam, isolated areas of surface corrosion

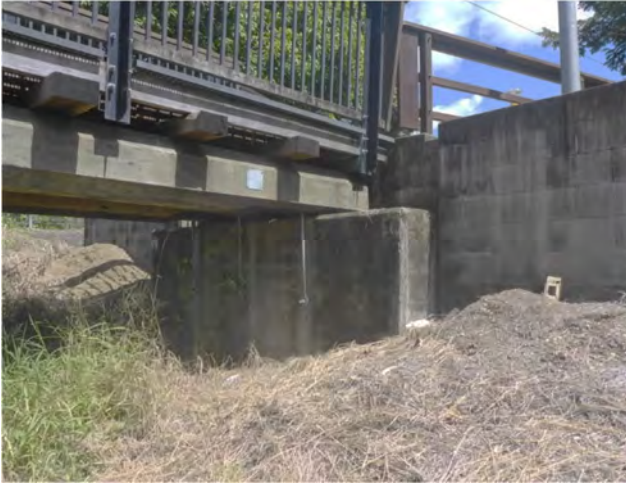
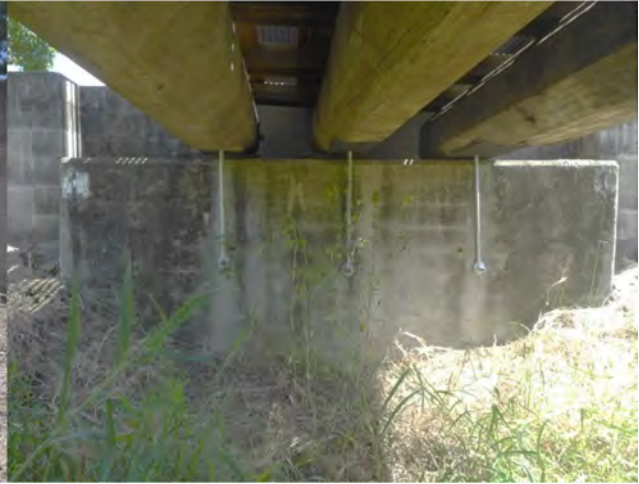
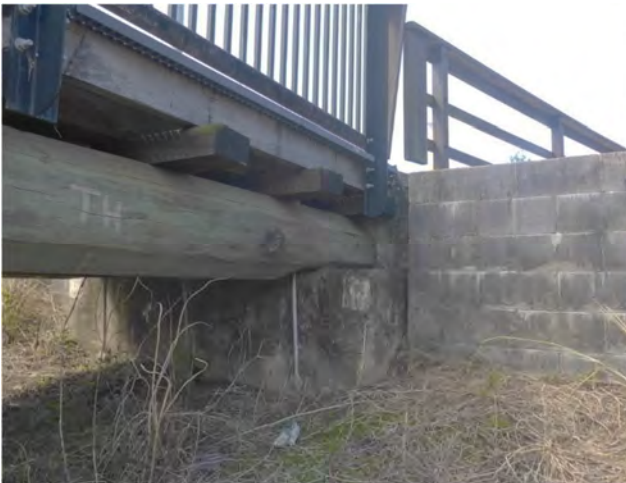
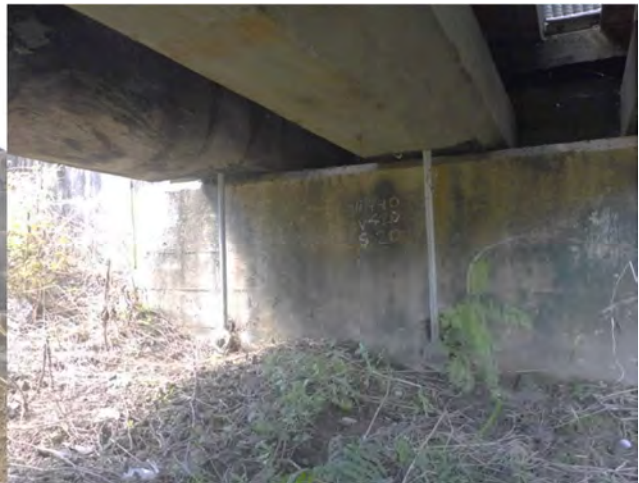
- Abutment 1 and 2 walls were in generally sound condition (Photo 41 to Photo 44).

Photo 41 General view abutment 1 wall (1)

Photo 42 General view abutment 1 wall (2)

Photo 43 General view abutment 2 wall (1)

Photo 44 General view abutment 2 wall (2)

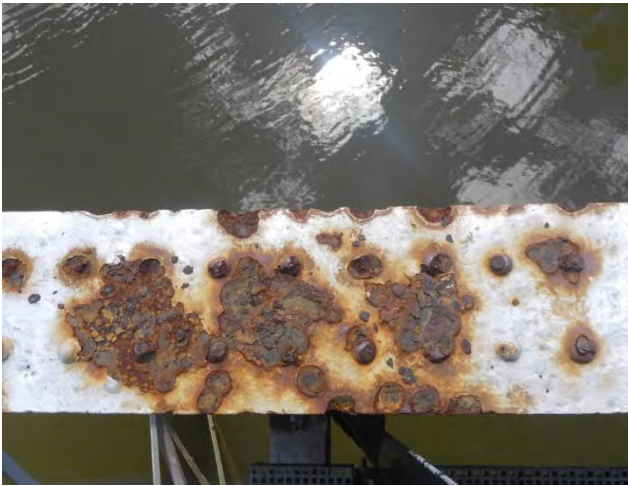
- Girders in all spans were in generally sound condition (Photo 45 to Photo 64). Isolated defects were observed:
  - Span 6 main girder top flanges had significant pitting corrosion concentrated on the left hand side, near the beginning of the span (Photo 53). Rivets were also heavily corroded in the immediate area.
  - Span 6 main girders top and bottom flanges had isolated areas of significant corrosion on the left hand side (Photo 54). Isolated areas were also observed on the right hand side.
  - Span 6 main girder had an isolated area of corrosion on the web, left hand side above the bearing plate for pier 5 (Photo 55).
  - Span 6 main girders bottom flange rivets typically exhibited surface corrosion (Photo 56).

Photo 53 Span 6 main girder pitting corrosion

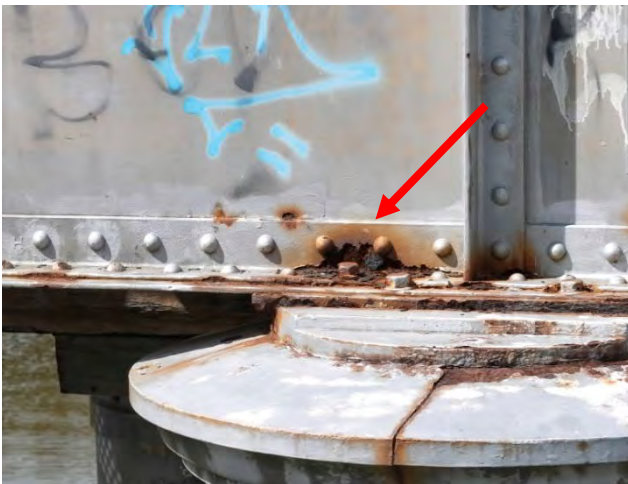
Photo 55 Span 6 main girder left hand side web corrosion

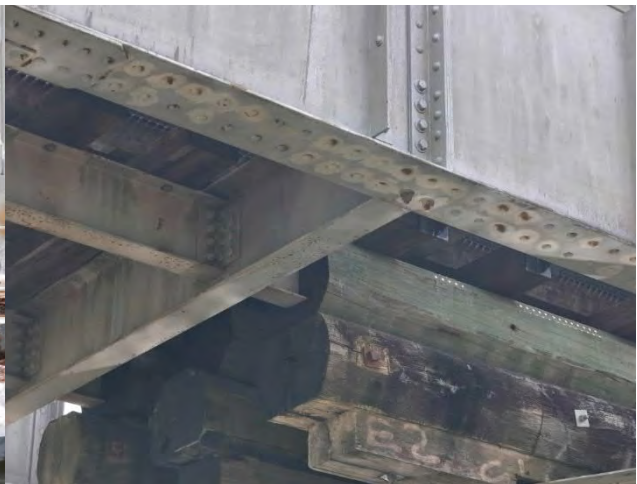
Photo 56 Span 6 main girder bottom flange rivets surface corrosion

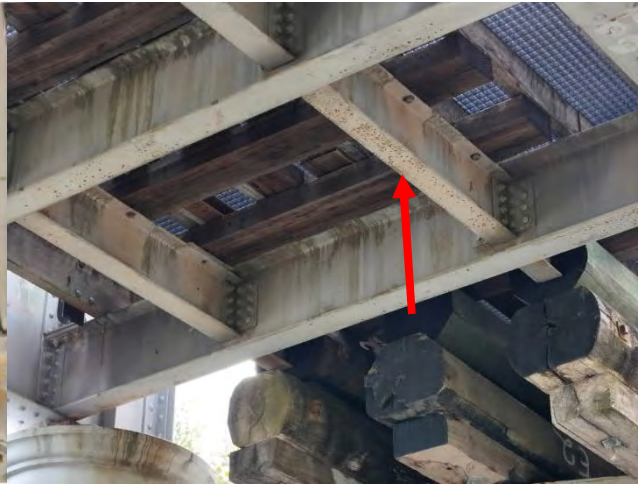
- Span 6 cross girders typically had corrosion spots or surface corrosion (Photo 57). There were isolated areas of more significant corrosion (Photo 57).
- Span 6 strut beams typically had corrosion spots and surface corrosion (Photo 58).
- Span 6 cross bracing typically exhibited surface corrosion (Photo 59). Cross bracing cleats exhibited more significant corrosion at main girder connections (Photo 60).

Photo 58 Span 6 strut beams surface corrosion

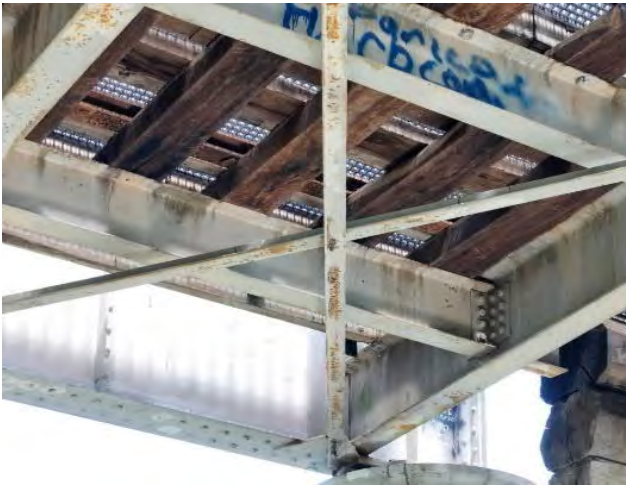
Photo 59 Span 6 cross bracing surface corrosion

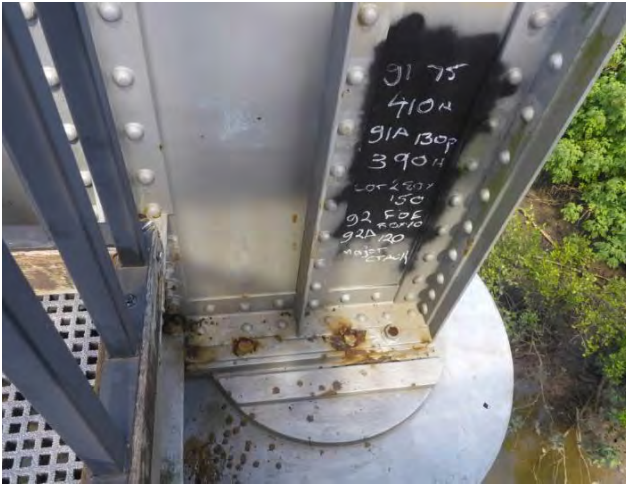
- Bearing plates at piers 5 and 6 were in generally sound condition. Isolated defects were observed:
  - Main girder to bearing plate bolts exhibited corrosion on both sides of the bridge (Photo 65).
  - Surface corrosion and crevice corrosion was observed on the bearing plate at pier 5, left hand side (Photo 66).
  - Bearing plates typically had corrosion staining and corrosion spots (Photo 67, Photo 68).

Photo 65 Main girder to bearing plate bolts corrosion

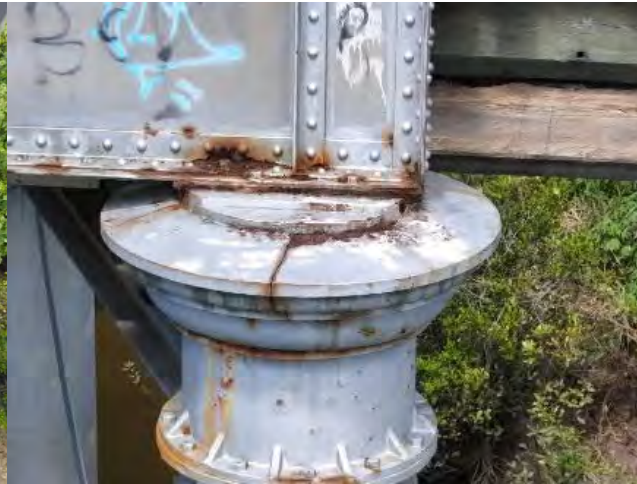
Photo 66 Bearing plate surface and crevice corrosion

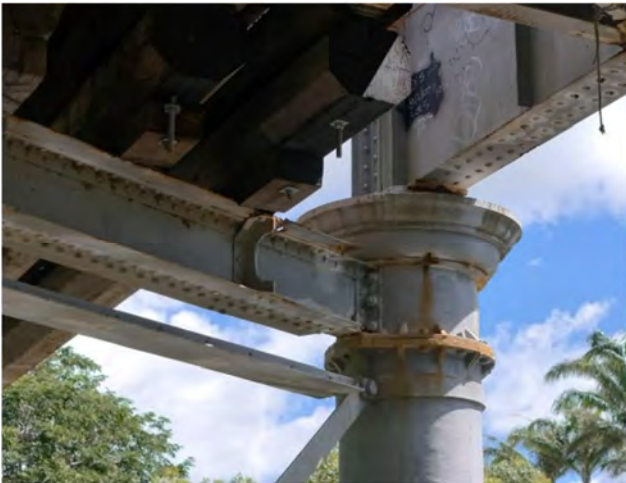
Photo 67 Bearing plate corrosion staining

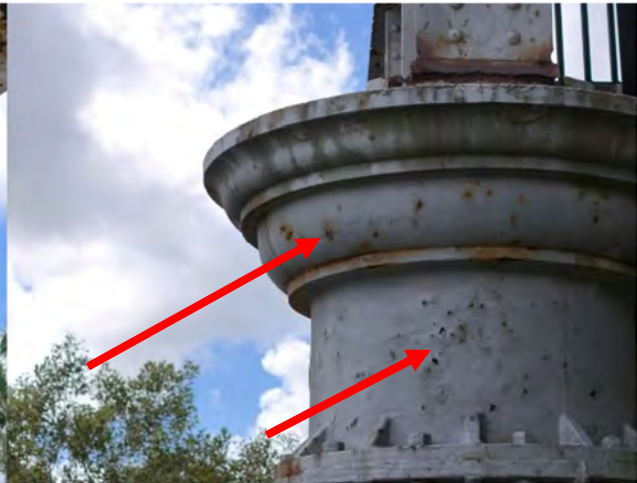
Photo 68 Bearing plate corrosion spots

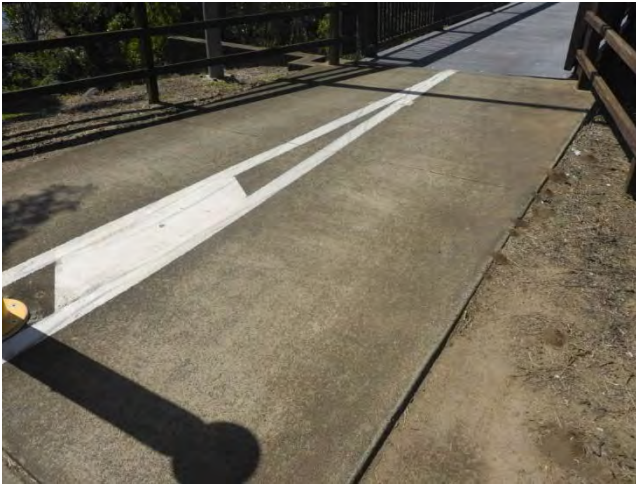
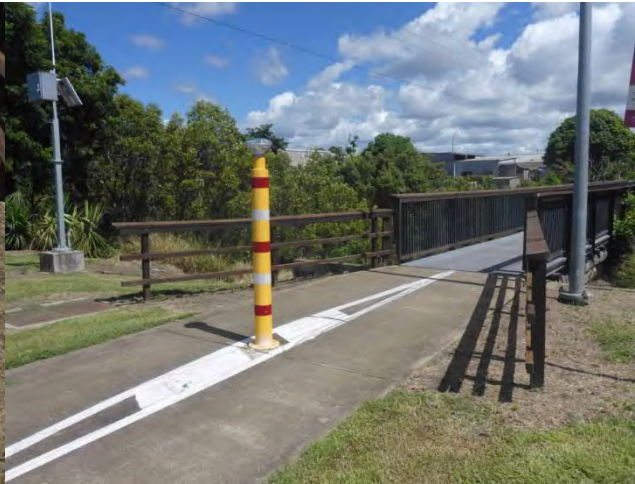
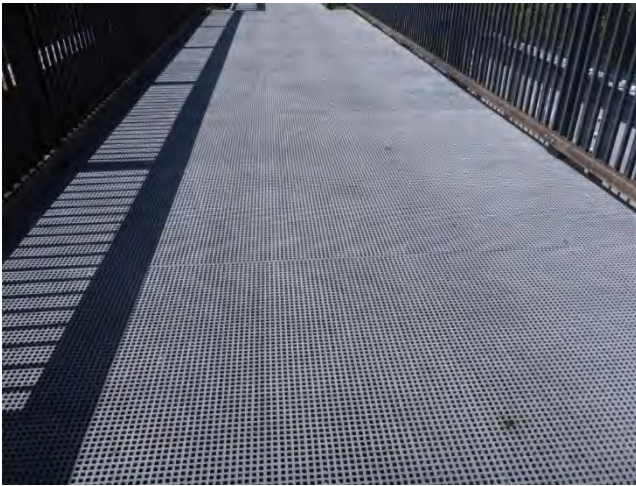
- The bridge and approach footway segments were in generally sound condition (Photo 69, Photo 71). Minor defects observed included:
  - Cracks up to 0.3 mm were observed in the approach 2 footway slab (Photo 72).
  - Minor unevenness in the approach slab to FRP footway at approach 2 (Photo 73).

Photo 69 Approach 1 footway sound

Photo 70 Approach 2 footway sound

Photo 71 FRP footway sound

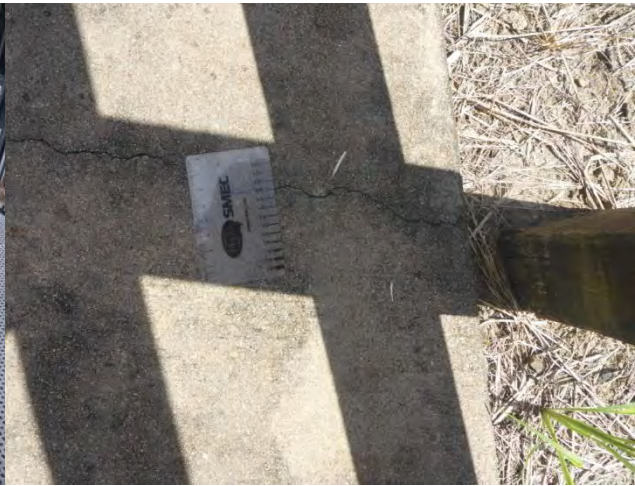
Photo 72 Cracks up to 0.3 mm in approach 2 footway slab

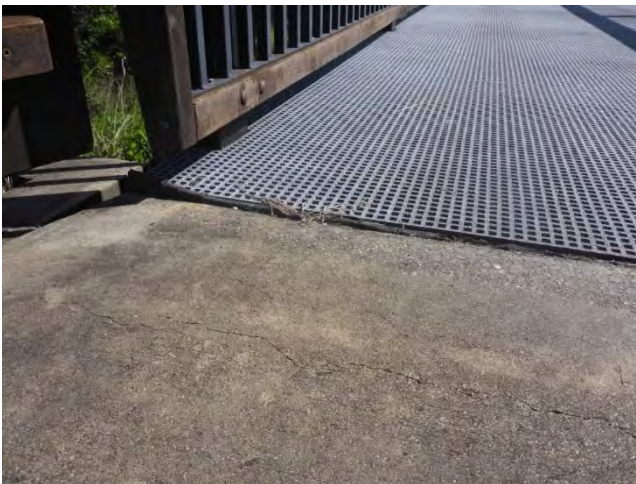
Photo 73 Approach 2 minor unevenness

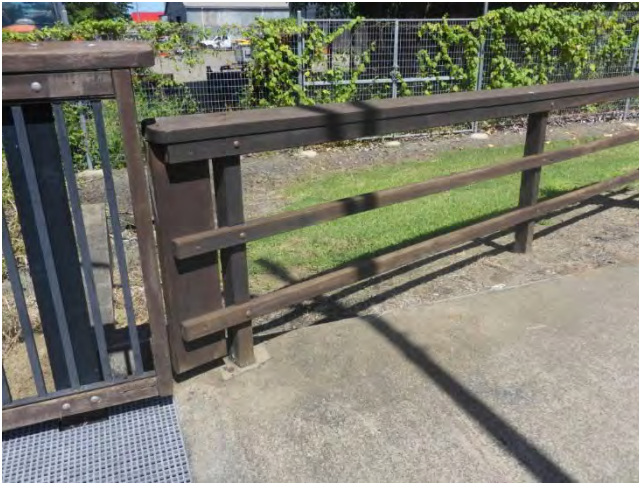
Photo 74 Approach 1 railings sound

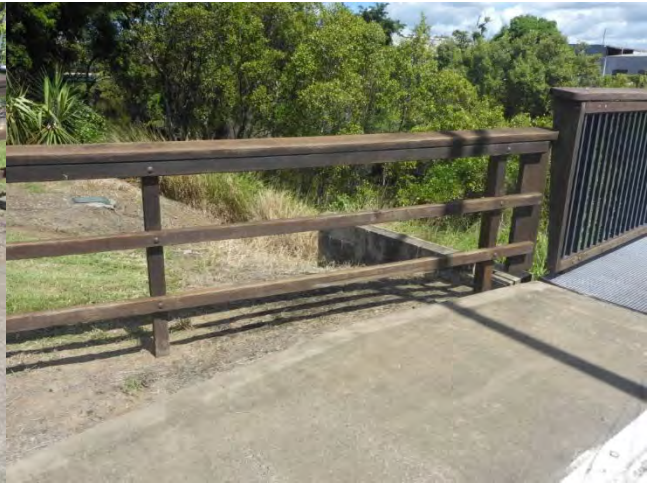
Photo 75 Approach 2 railings sound

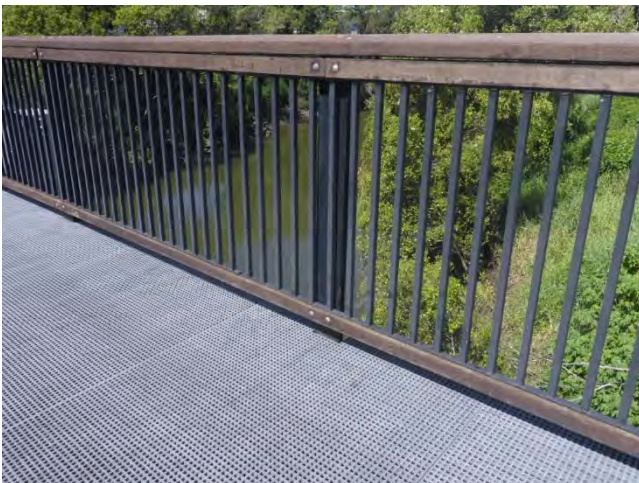
Photo 76 Bridge railing sound

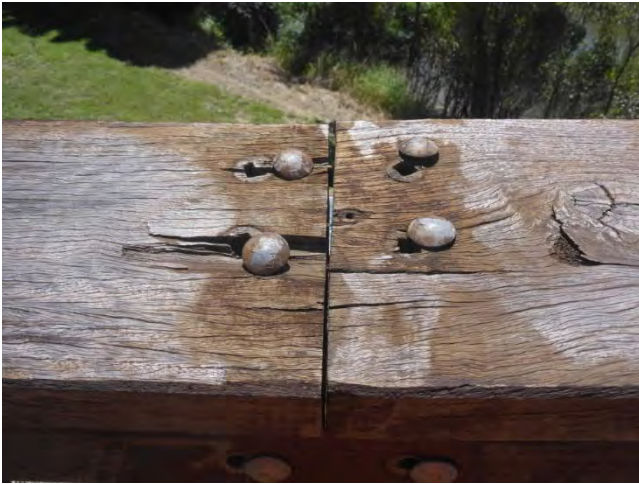
- Bridge pedestrian railings were in generally sound condition (Photo 74 to Photo 76). Observations included:
  - Railing fixings typically had surface corrosion (Photo 77). Top railing fixings were typically installed incorrectly (Photo 78).
  - Isolated timber splitting was observed at toe boards near the centre of the bridge (Photo 79).
  - Several connector plates were not installed on the toe boards near the centre of the bridge (Photo 80).
  - Left hand side railing near approach 2 had excessive vegetation (Photo 81).

Photo 78 Top railing fixings installed incorrectly

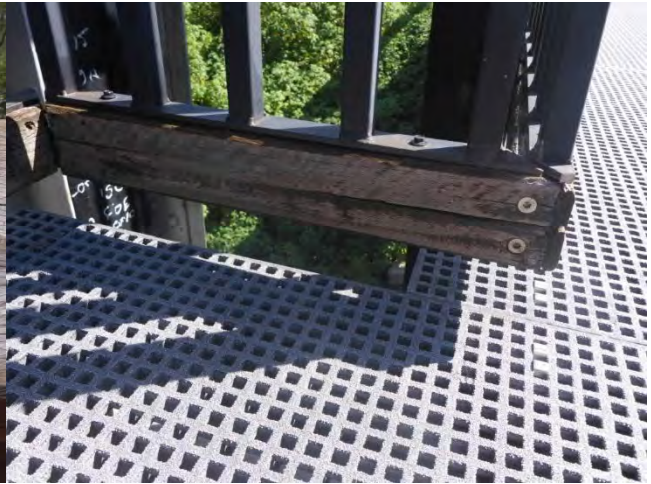
Photo 79 Timber splitting at toe boards

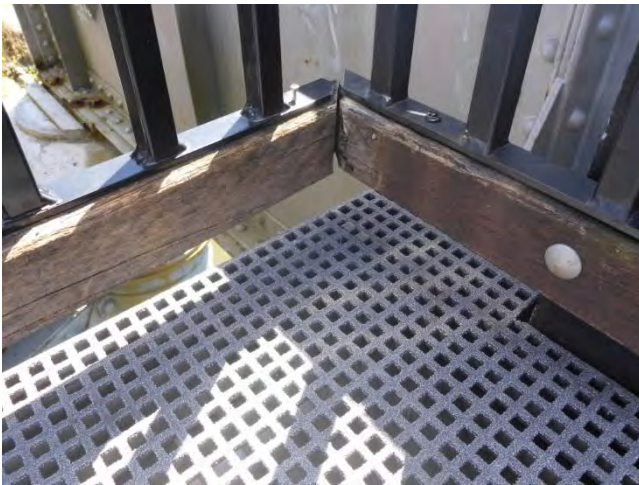
Photo 80 Connector plates not installed toe boards

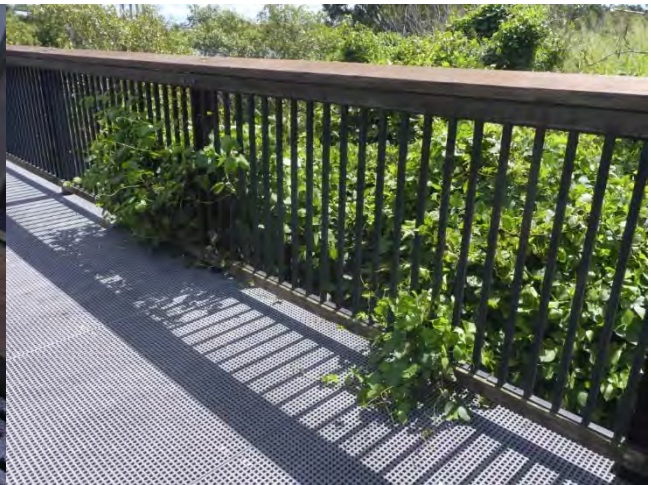
Photo 81 Excessive vegetation on left hand side railing near approach 2

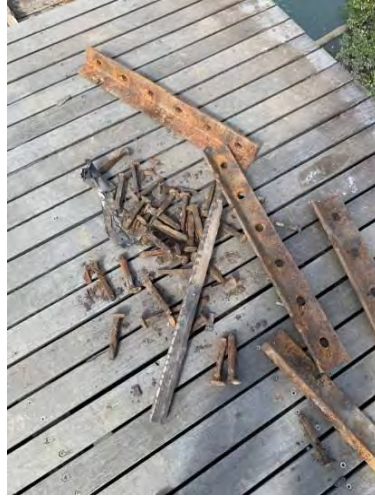
Figure 50: Heavily corroded bolts and steel connections (Bligh Tanner 2022).

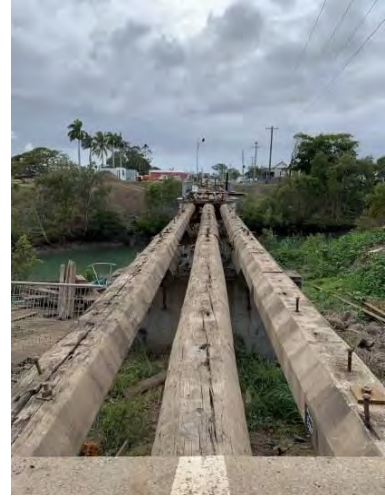
Figure 51: View from Span 1 to 5, almost all girders badly deteriorated (Bligh Tanner 2022).

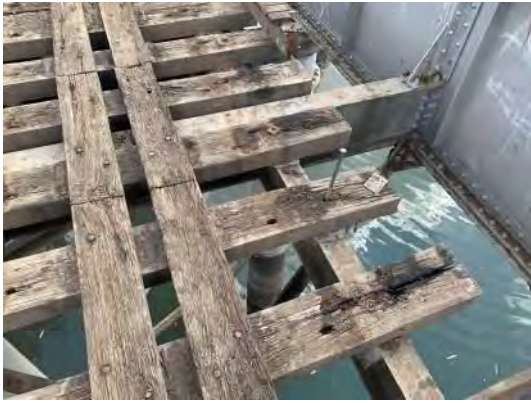
Figure 52: Badly deteriorated timber sleepers (Bligh Tanner 2022).

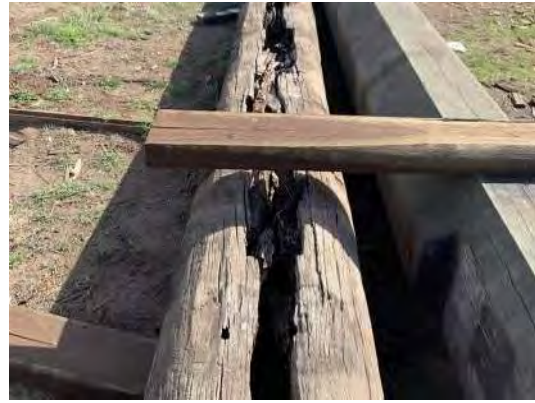
Figure 53: Badly deteriorated girder (Bligh Tanner 2022).

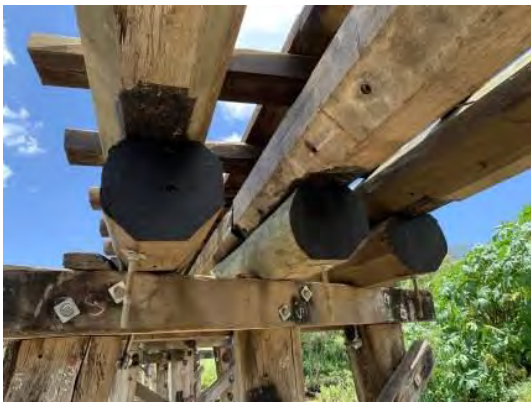
Figure 54: Replacement girder, corbel, and headstock (Bligh Tanner 2022).

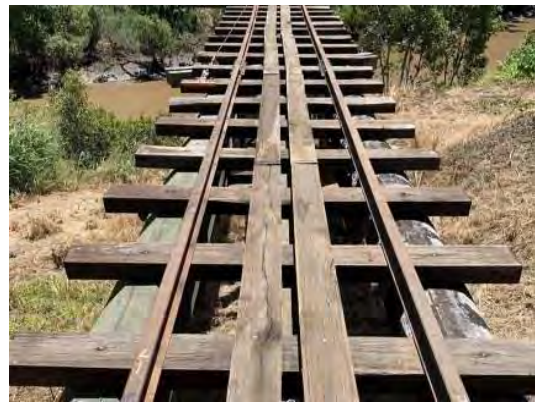
Figure 55: Replacement timber sleepers (Bligh Tanner 2022).

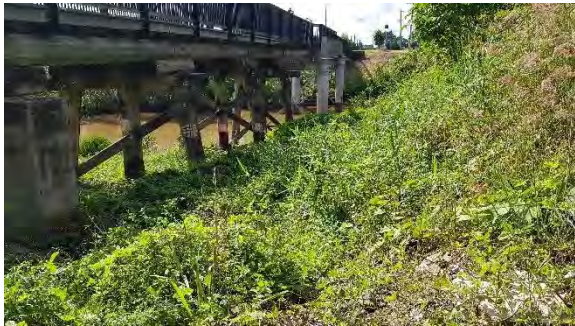
The banks of Saltwater Creek consist of grassed sloping terrain with what appears to be rock reinforcement towards the water's edge. Generally, the banks are overgrown with grass, self-seeded shrubs, mangroves, castor oil plants (*Ricinus communis*) and small trees, and show signs of erosion in places, particularly on the west side exacerbated by a stormwater drain on the south side discharging water causing dirt to wash down the banks and accumulating around the bridge structure.

Figure 70: Overgrown area on the SW side with erosion noticed caused by water from a drain up top (Converge 2022).

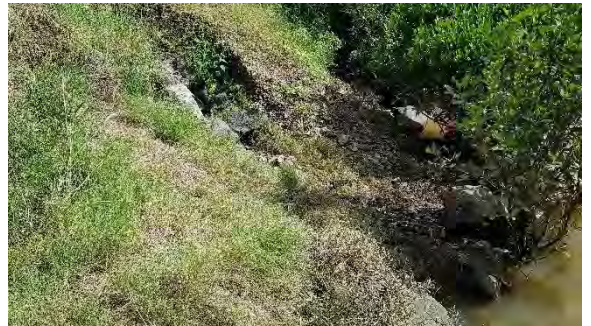
Figure 71: Erosion on the NW river bank (Converge 2022).

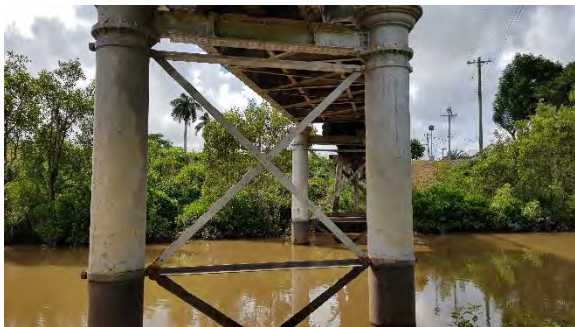
Figure 72: View to east embankment (Converge 2022).

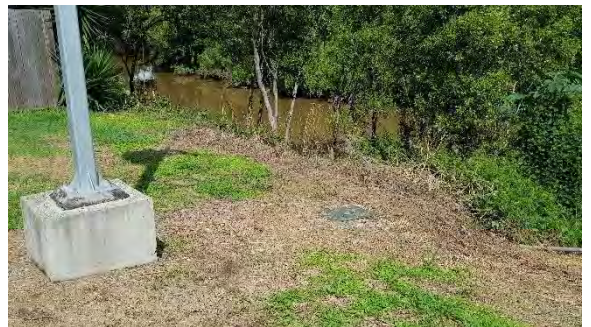
Figure 73: Slashed area around monitoring station on SE embankment (Converge 2022).

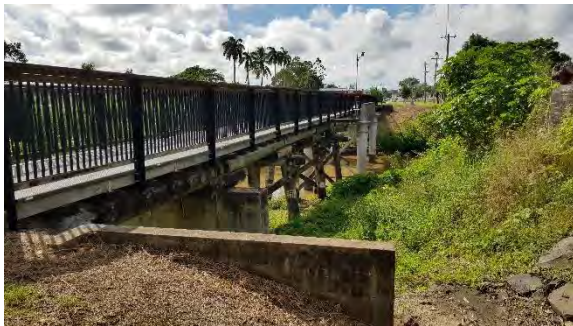
Figure 76: View east along south side of bridge; note overgrown embankment and short retaining wall (Converge 2022).

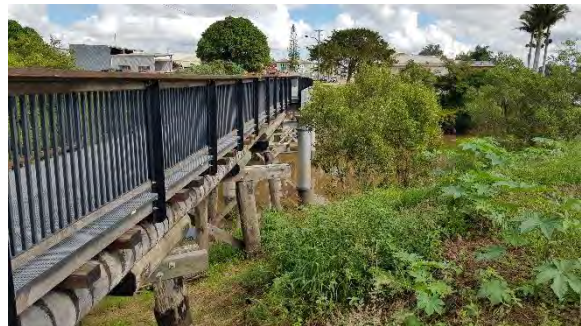
Figure 77: View west along north side of bridge, note the overgrown embankment (Converge 2022).

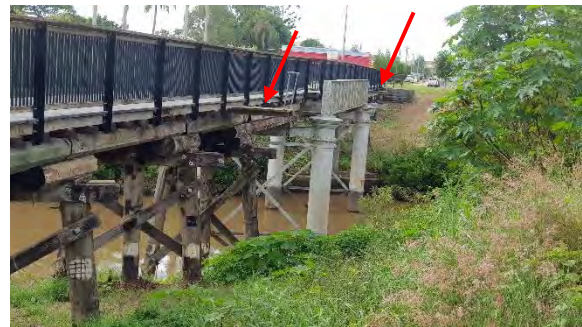
There are two timber platforms situated on the upstream side, one at Span#5 (Figure 80) and the second at Span#9 (Figure 80 and Figure 105).<sup>12</sup>

Figure 80: Southside of bridge, arrows mark platforms at Span#5 and 9 (Converge 2022).

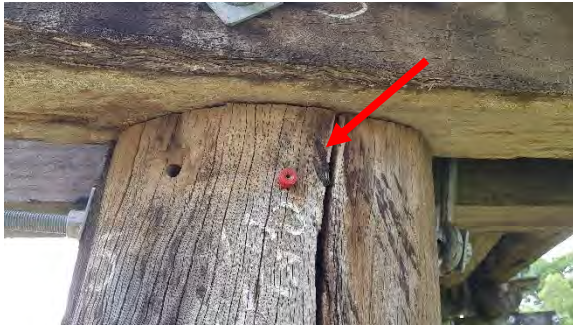
During Stage 1 works a large number of timber members have been replaced with like-for-like material and it appears that pest/fungal treatment has been undertaken. Some timber piers have been fitted with weed matting at the base.

Figure 111: Cap visible on timber pier indicating pest/fungal treatment (Converge 2022).
