# BUNDABERG LEVEE

EPW00390 – Heritage Impact Assessment – Saltwater Creek Rail Bridge  
(30034151-RPT-13.0-001) – Revision 0

May 2024

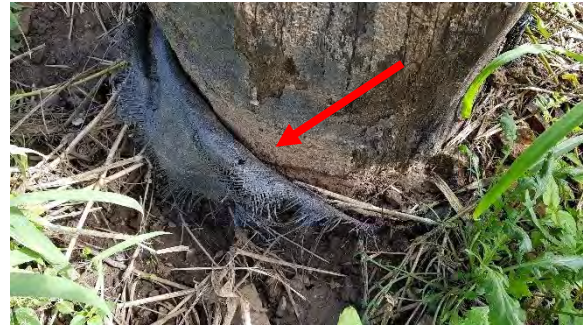
Figure 112: Example of weed matting found on some timber piers. Note the soil built-up in between the fabric and the timber (Converge 2022).
