Geotechnical Factual Report

Bundaberg East Levee

Reference No. 30034151-RPT-3.7-001

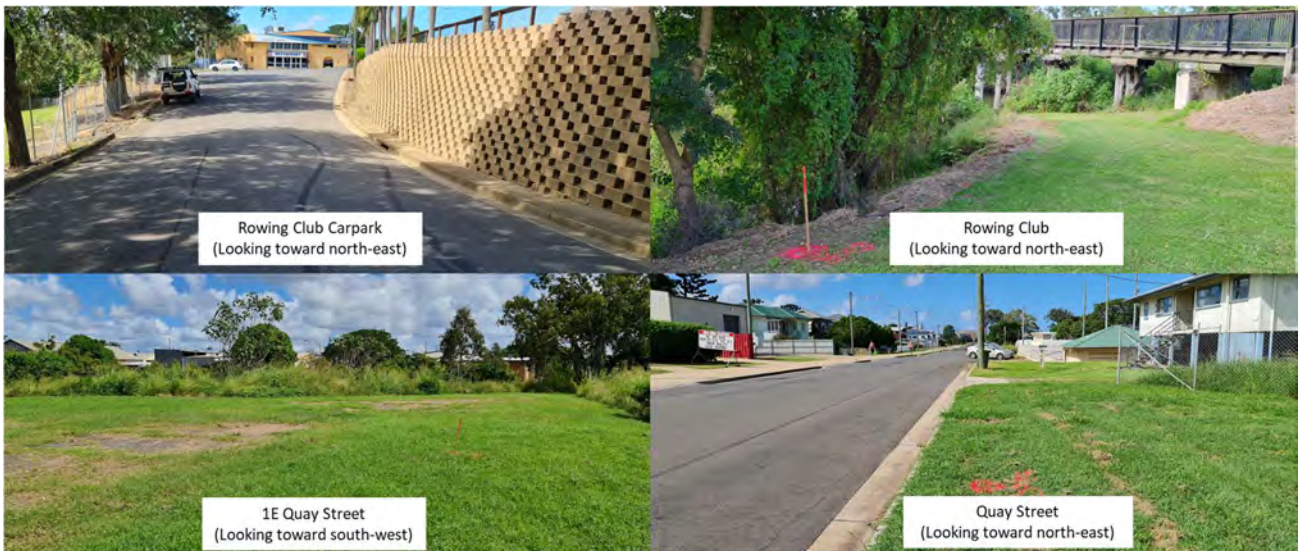
Figure 2-2: City Levee Alignment Site

The City Levee alignment is located in the south-western section of the project site, bounded by Quay Street to the south, pedestrian footpath and crossing over the Saltwater Creek and Scotland Street to the south, Peterson Street to the east, and the Burnett River to the north. Large flood gate and pump station structures will be constructed at the Saltwater Creek crossing and connected to the levee at both sides of the structures i.e. Rowing Club and 1E Quay Street. The City Levee length approximates around 1000m.

The Bundaberg Rowing Club and carpark are situated in the low-lying area near the Saltwater Creek and bounded by the existing block wall (approximately 3m high) and concrete footpath connecting to the 1E Quay Street through the existing pedestrian bridge. The 1E Quay Street area is located in a relatively elevated area and covered by grass. Significant slope instability due to toe scouring of the southern riverbank during a flood event were reported by Bundaberg Regional Council (BRC) in this area. The area from Quay Street to Peterson Street is used for commercial and residential purposes and located generally flat ground with some elevation. Overhead power lines are present along the Quay Street in close proximity to the proposed levee alignment.

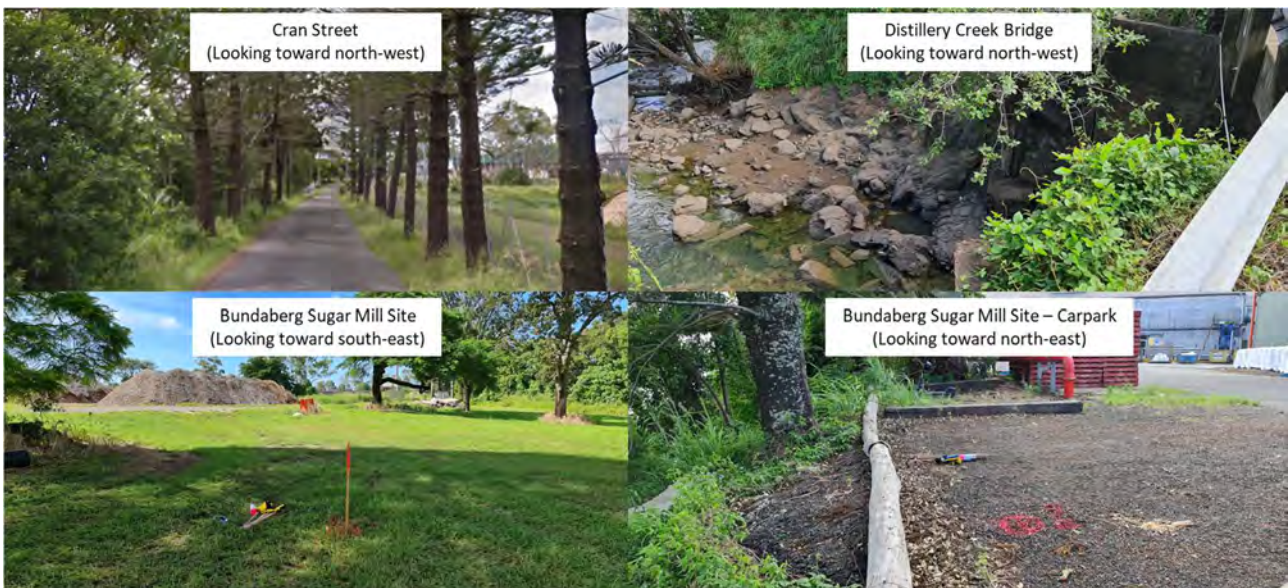
Figure 2-3: Distillery Levee Alignment Site

The Distillery Levee alignment is located in the north-eastern section of the site, bounded by Crane Street to the south, crossing over the unnamed creek near the distillery (Distillery Creek) and the Bundaberg Sugar Mill site to the east and the Burnett River to the north. The flood gate will be constructed parallel to the existing bridge at the Distillery Creek crossing and connected to the levee at both side of the structures i.e. northern end of Cran Street and south-west of Bundaberg Sugar Mill site. The Distillery Levee length is approximately 570 m.

Cran Street is connected to the Distillery Creek bridge entering into the Bundaberg Sugar Mill (BSM) site. Various sized boulders and rock blocks were observed in the creek bed with an evidence of scour at the bridge approach embankments. The proposed alignment within the BSM site is generally located in a grassed area until it starts running parallel to the southern bank of the Burnett River.

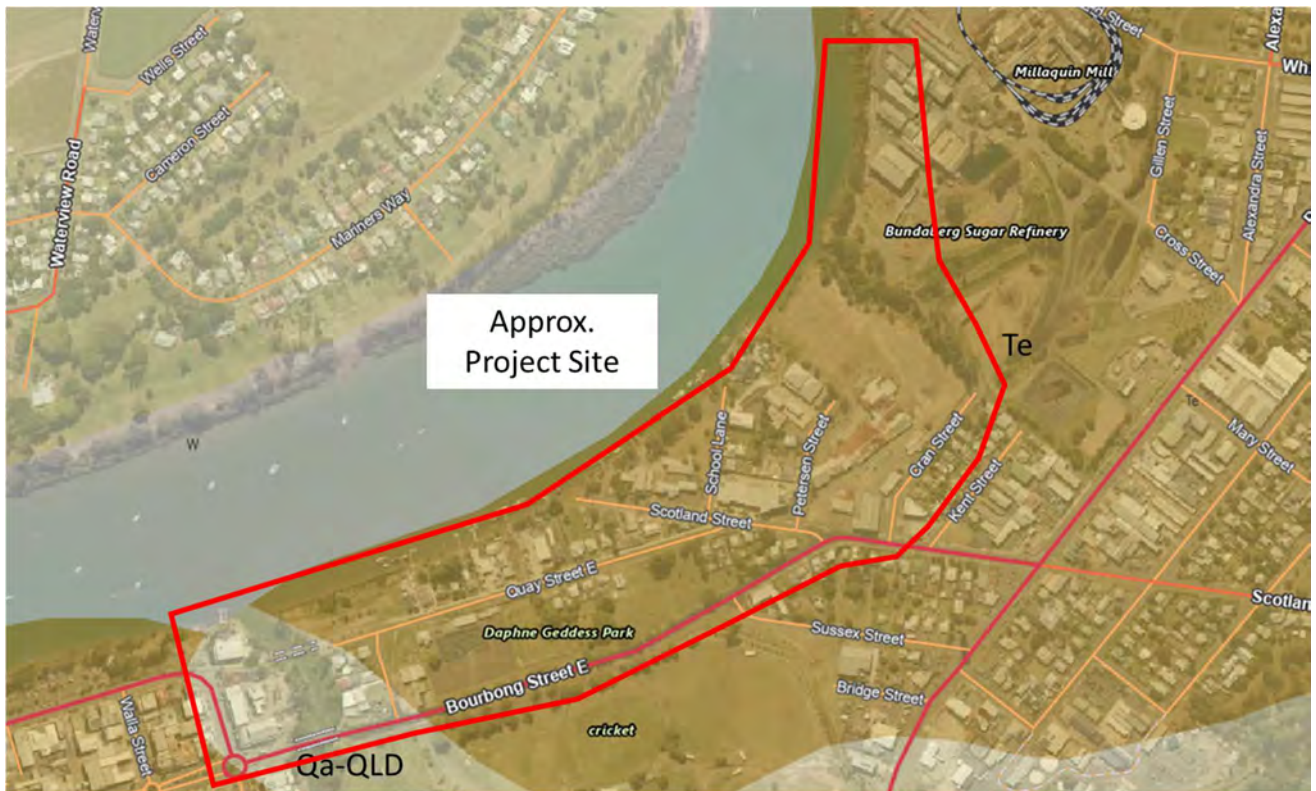
Figure 3–1: Published Geology of the Project Site

The Elliot Formation is a significant geological unit in the Bundaberg region and generally experienced periods of deep weathering during Cenozoic Era, resulting in distinct features including reddish-brown colour, mottling, iron-oxide rich patches and a unique duricrust appearance, and zones of increased permeability. The formation typically comprises of a few meters of moderate plasticity clays above a weakly cemented sandstone cap overlying a 20 m to 30 m thick gravelly and clayey sand layer. The top of bedrock is typically encountered at a depth of around 60 m below existing ground surface in the vicinity of Saltwater Creek (based on an advice from a local drilling contractor).

The published surface geology of the project site is shown in Figure 3–1, and the published descriptions of the corresponding geological formations are provided in Table 3–1.

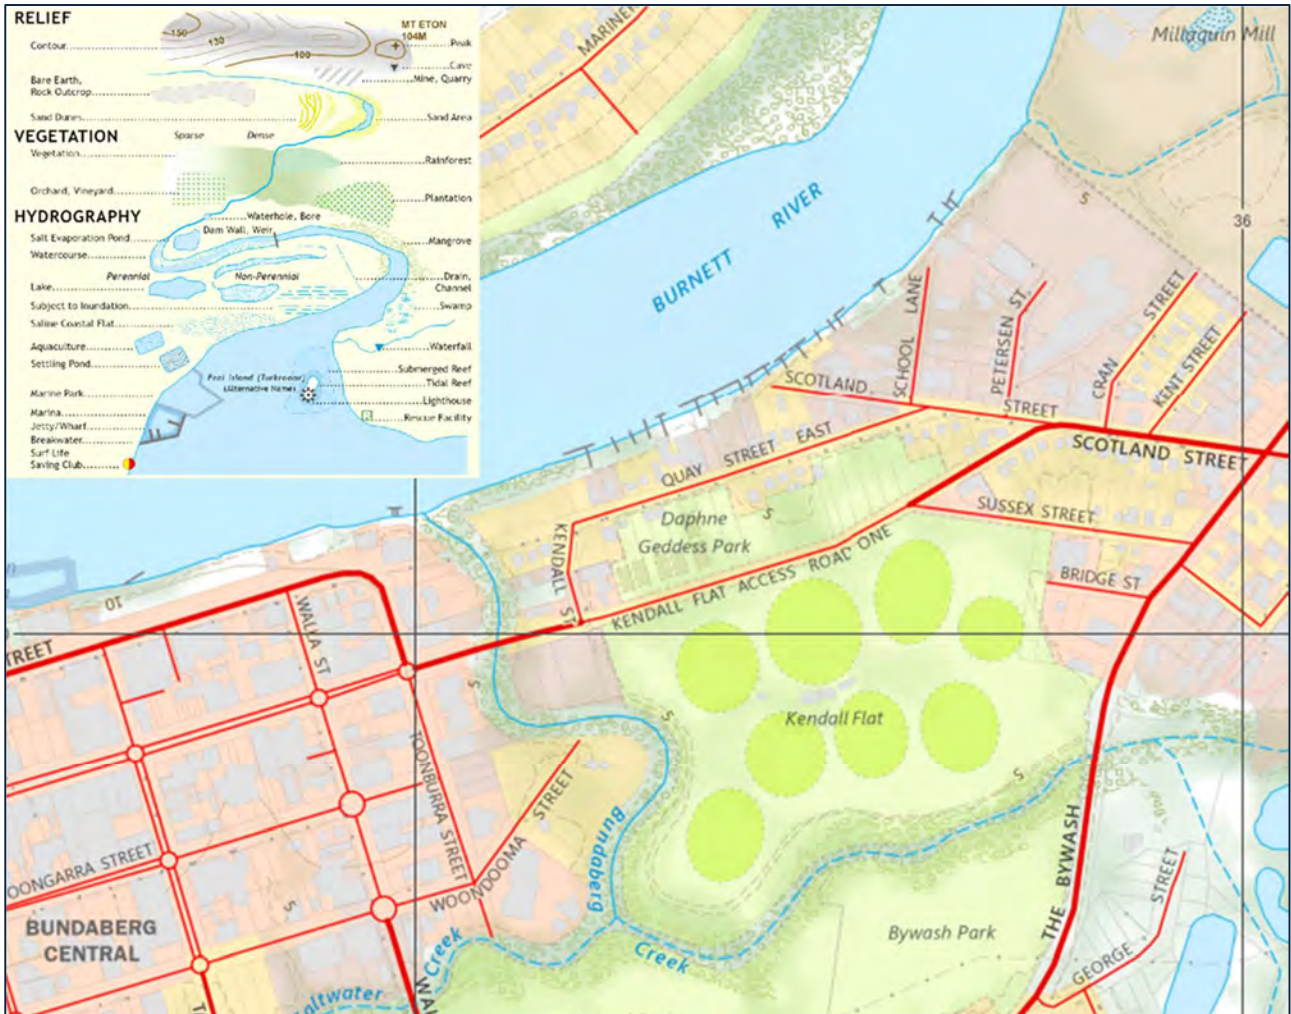
Figure 3–2: Published Topography of the Project Site

Dense vegetation comprising mangroves and marine plants is generally present in low-lying areas located along the Burnett River and the Saltwater Creek. A historical road bridge crossing the Saltwater Creek at Daphne Geddes park is situated between Quay Street and Bourbong Street near Kendall Flat sport ground. Settling ponds are located in the north-eastern side of Cran Street and within the Bundaberg Sugar Ltd site.

The published topography map for the Bundaberg East area is provided in Figure 3–2.

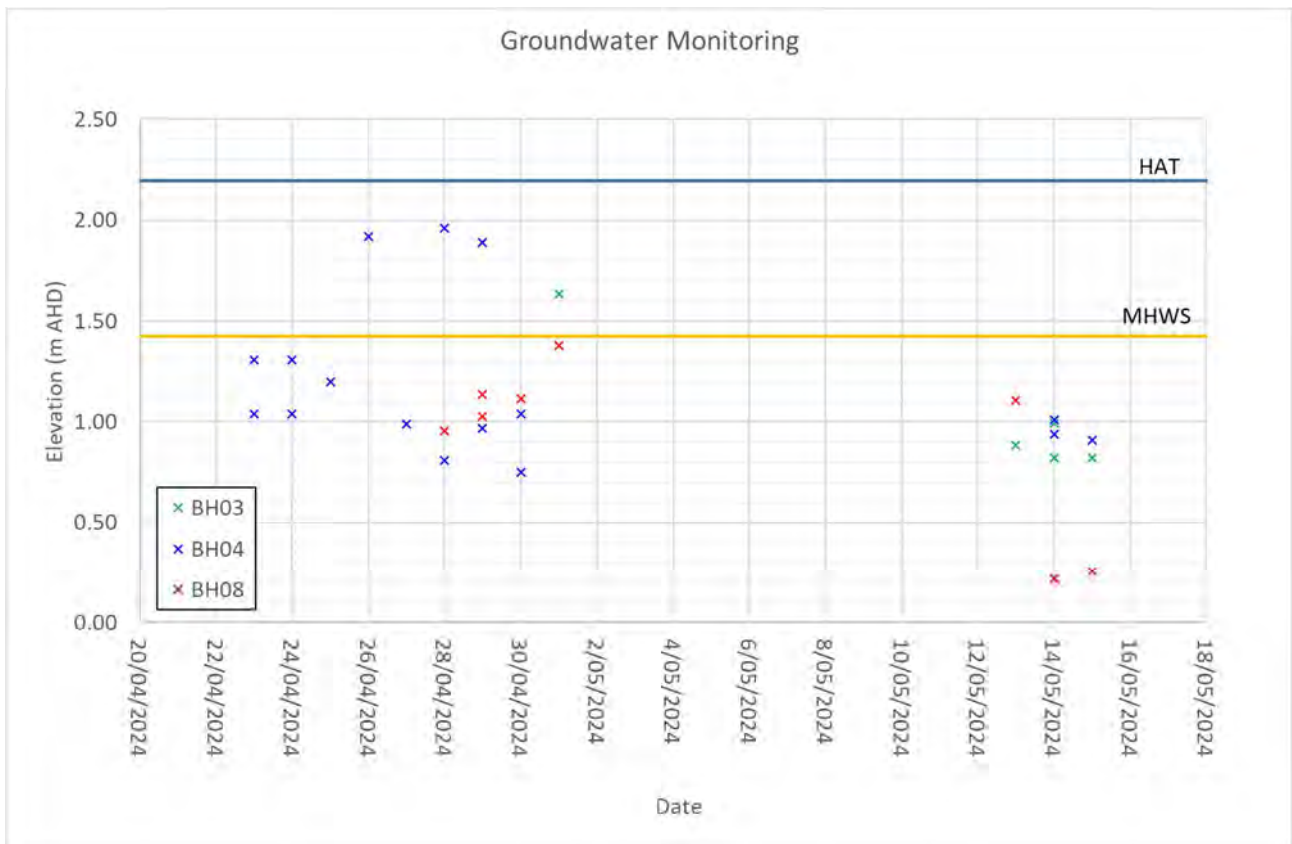
Figure 5-1: Groundwater Level Variation

Standing water levels were measured with a frequency of twice a day in the standpipe piezometers installed in BH03, BH04 and BH08 during the investigation period. The observed groundwater levels are summarised in Figure 5-1.

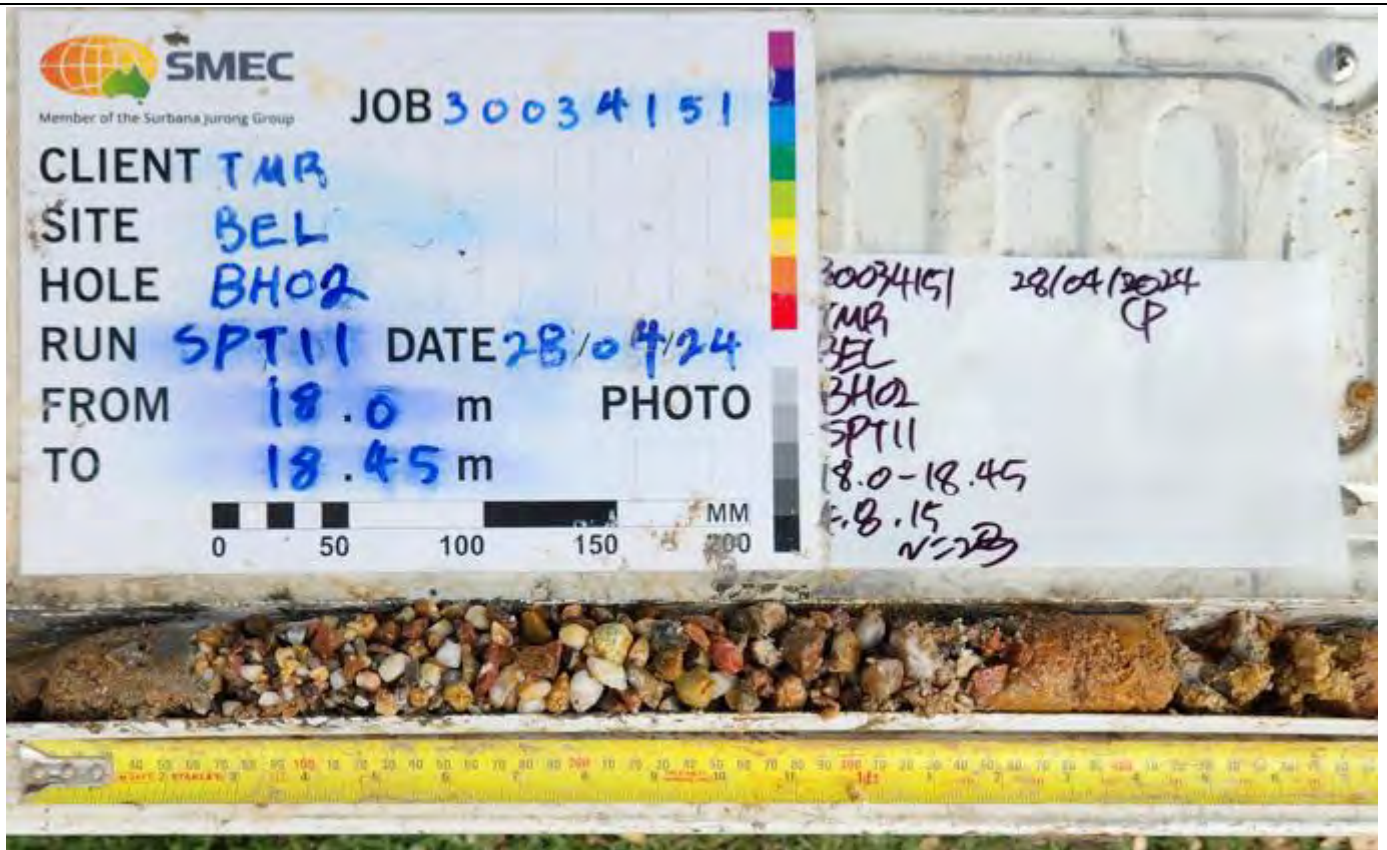
Photo 28: BH02 SPT11

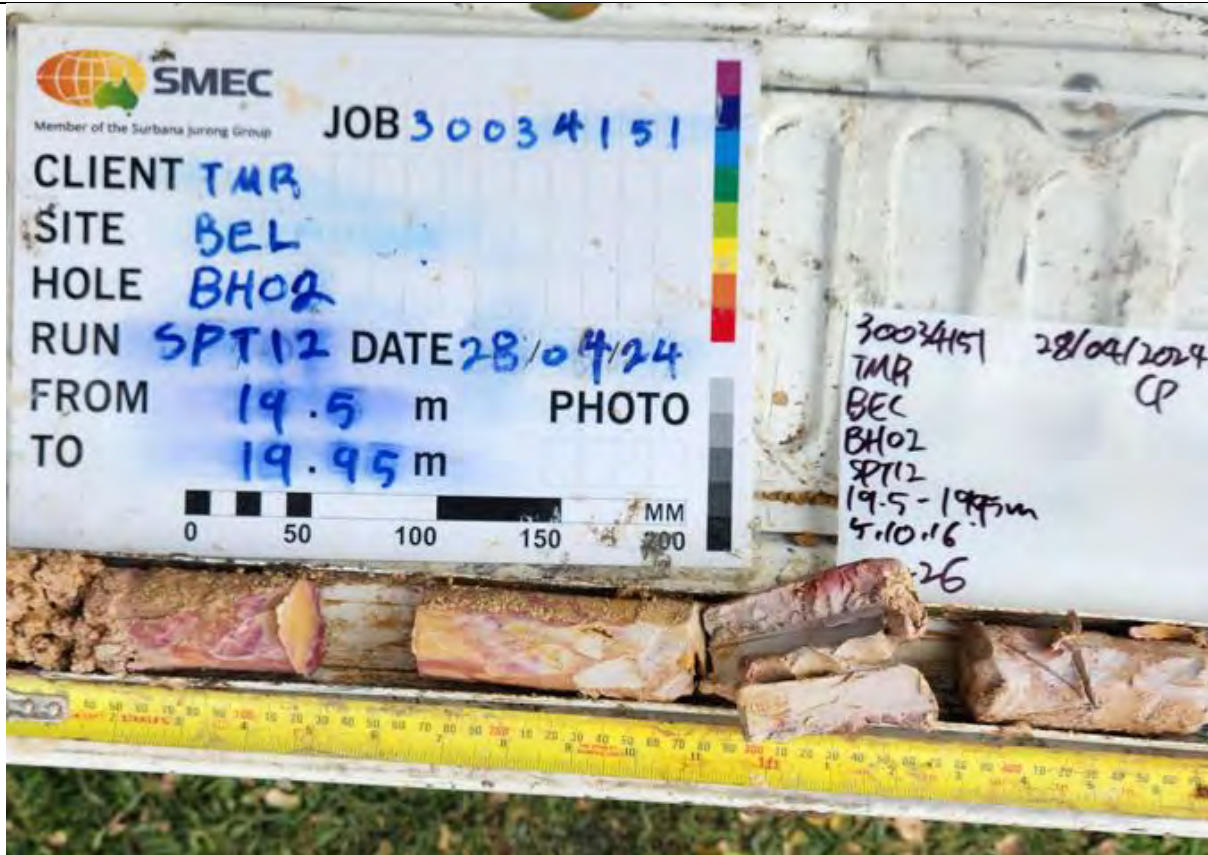
Photo 29: BH02 SPT12

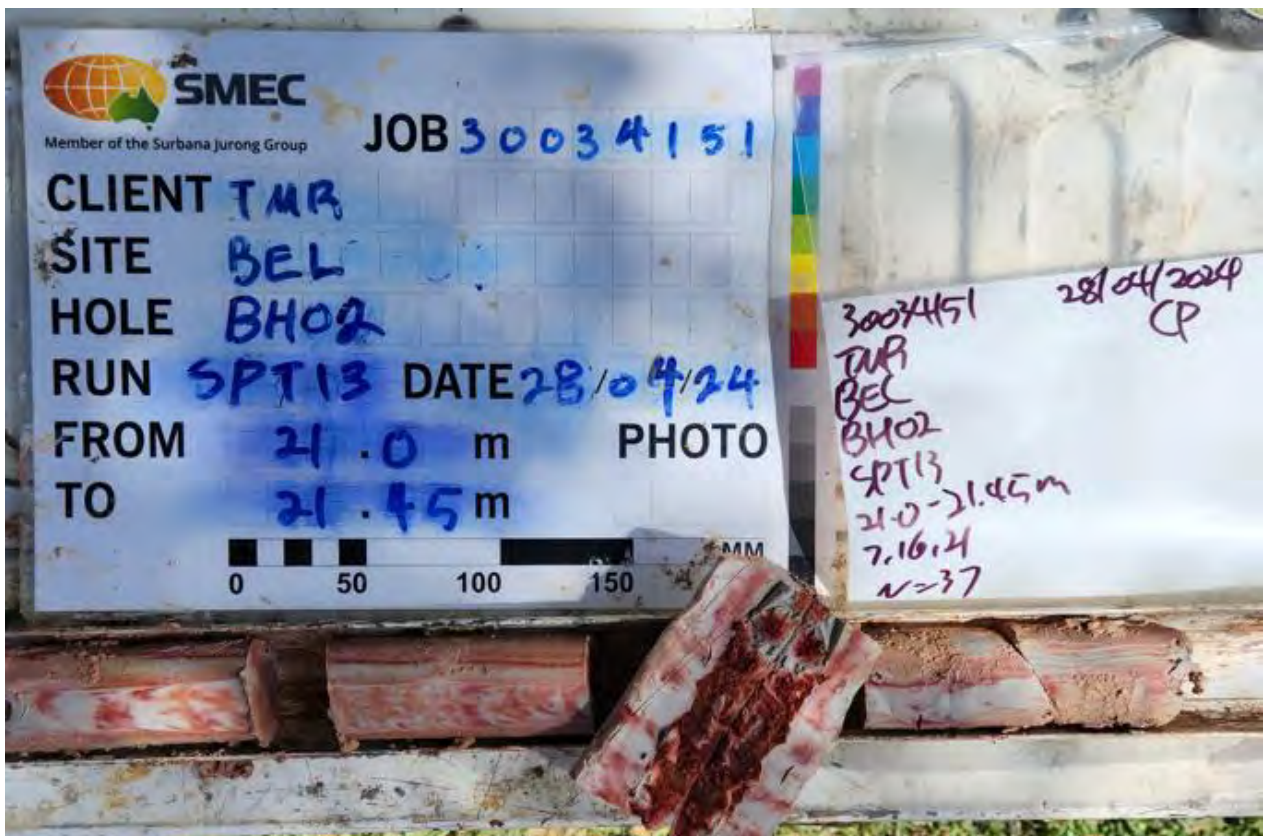
Photo 30: BH02 SPT13

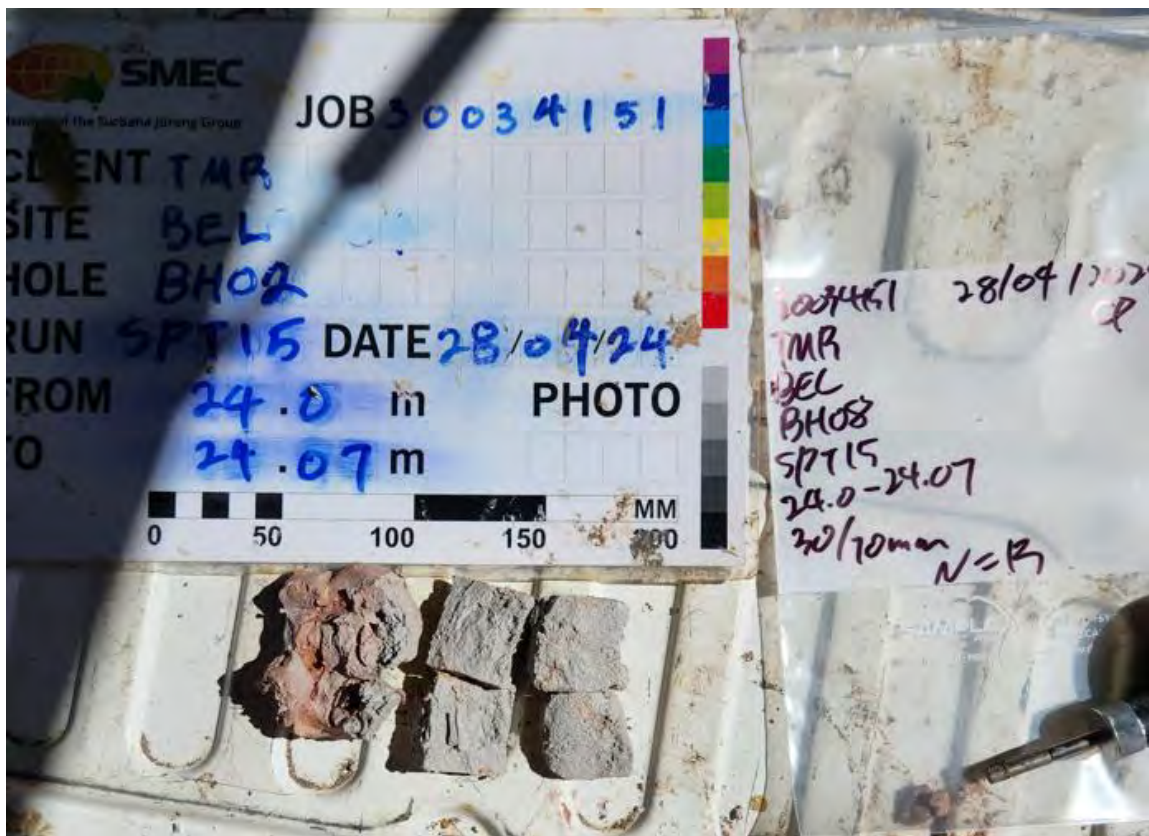
Photo 32: BH02 SPT15

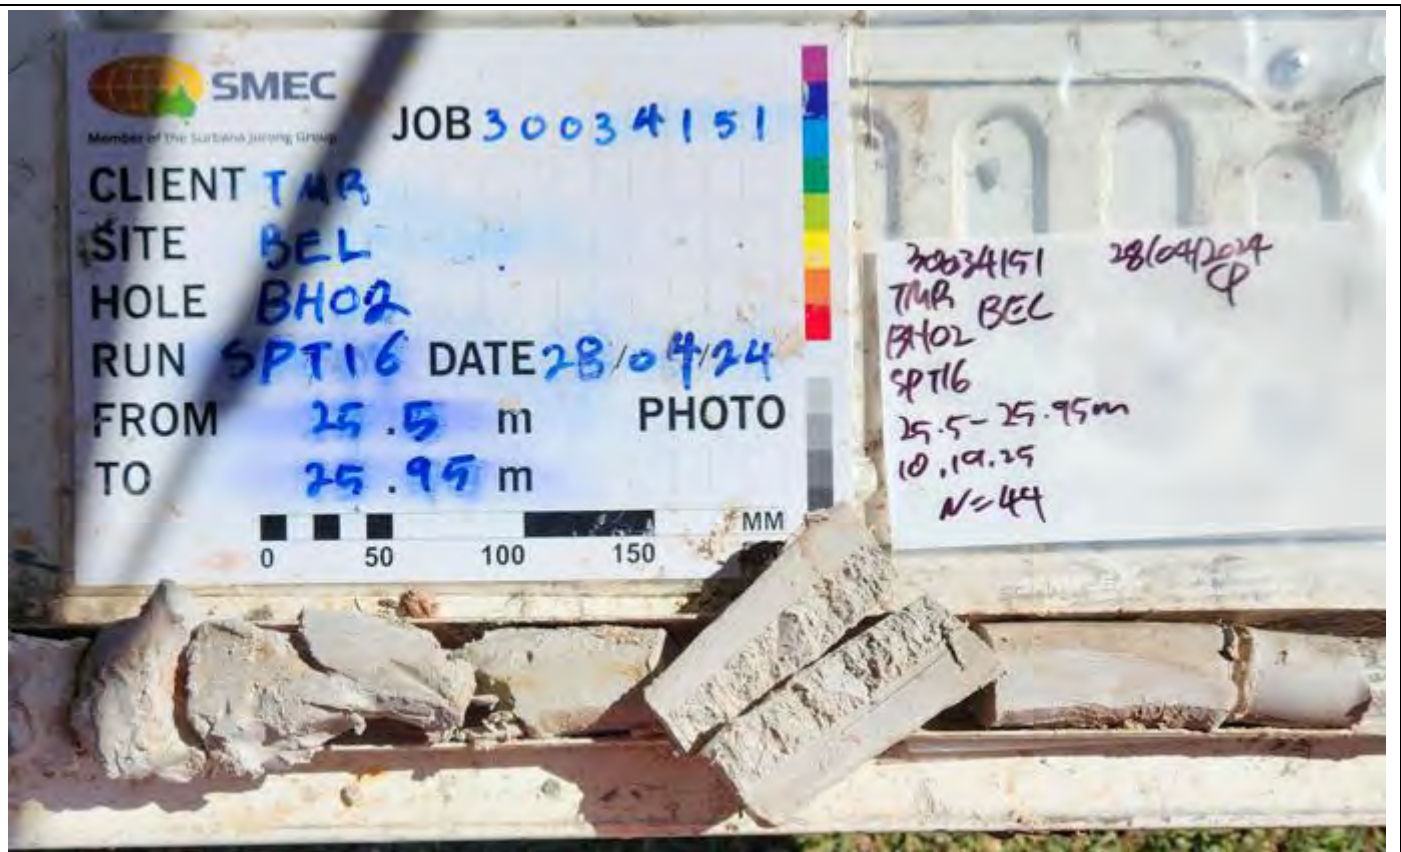
Photo 33: BH02 SPT16

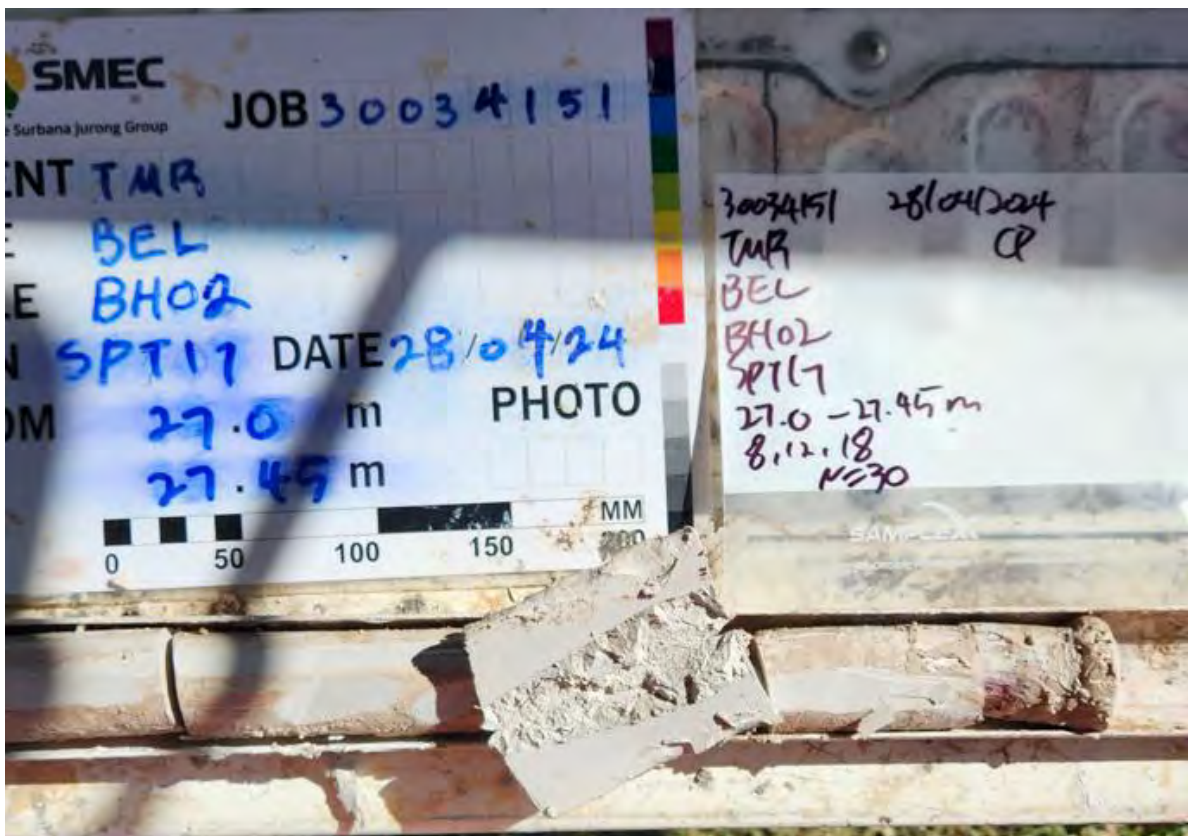
Photo 34: BH02 SPT17

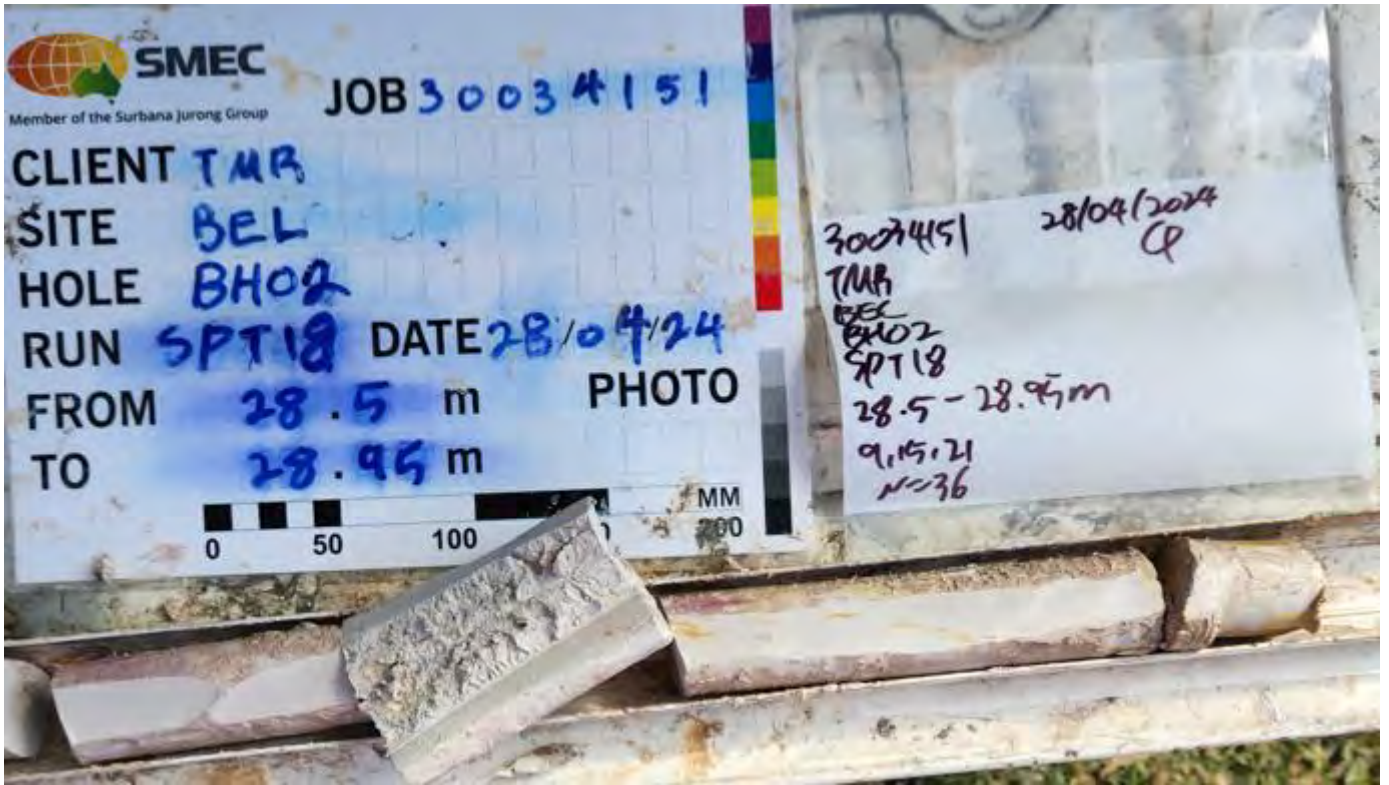
Photo 35: BH02 SPT18

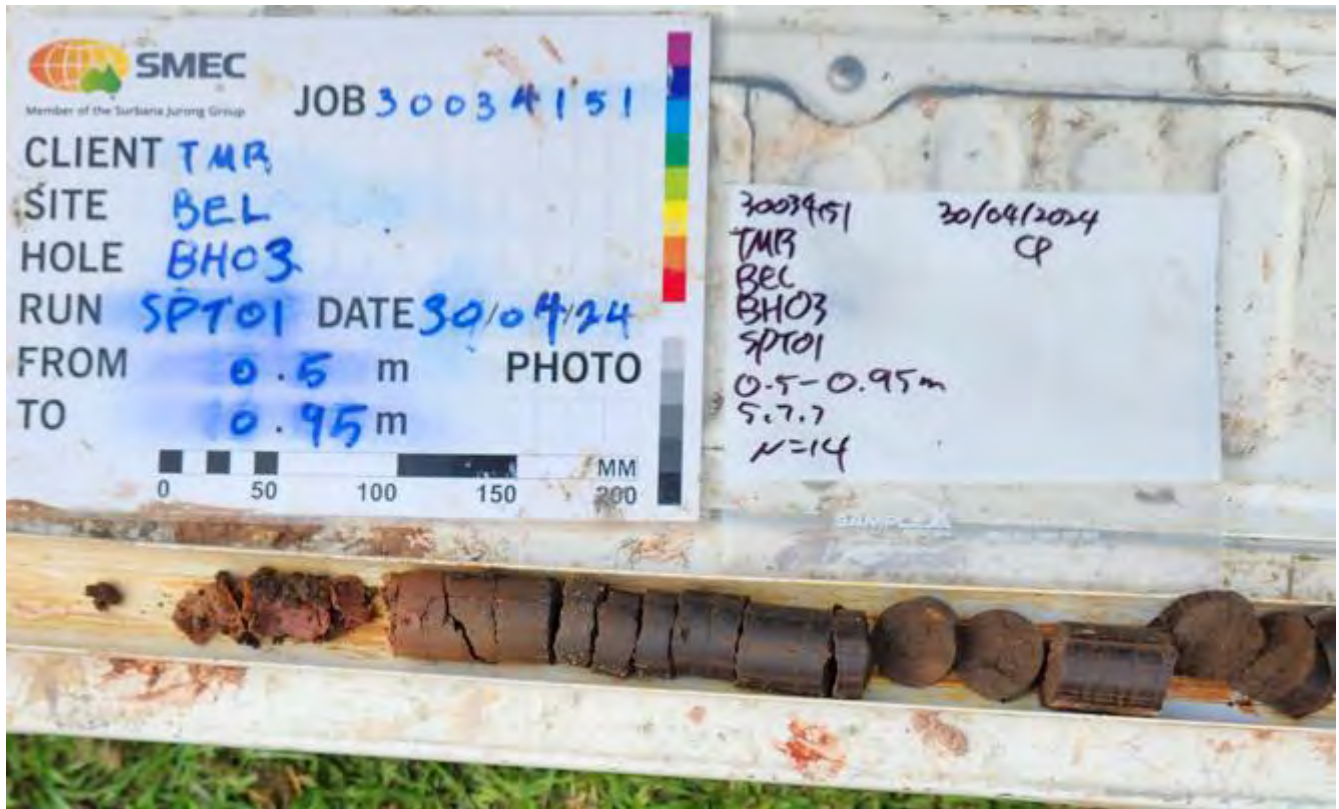
Photo 36: BH03 SPT01

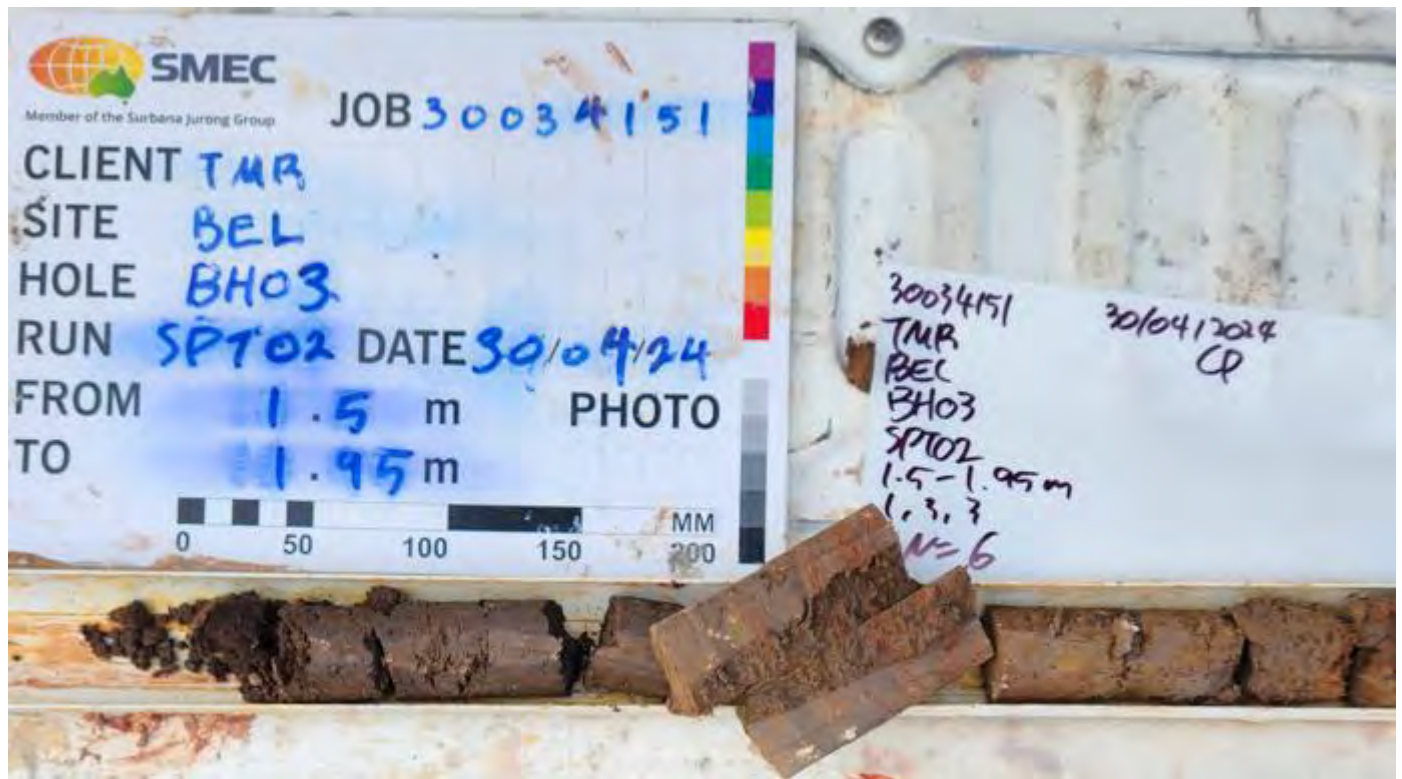
Photo 37: BH03 SPT02

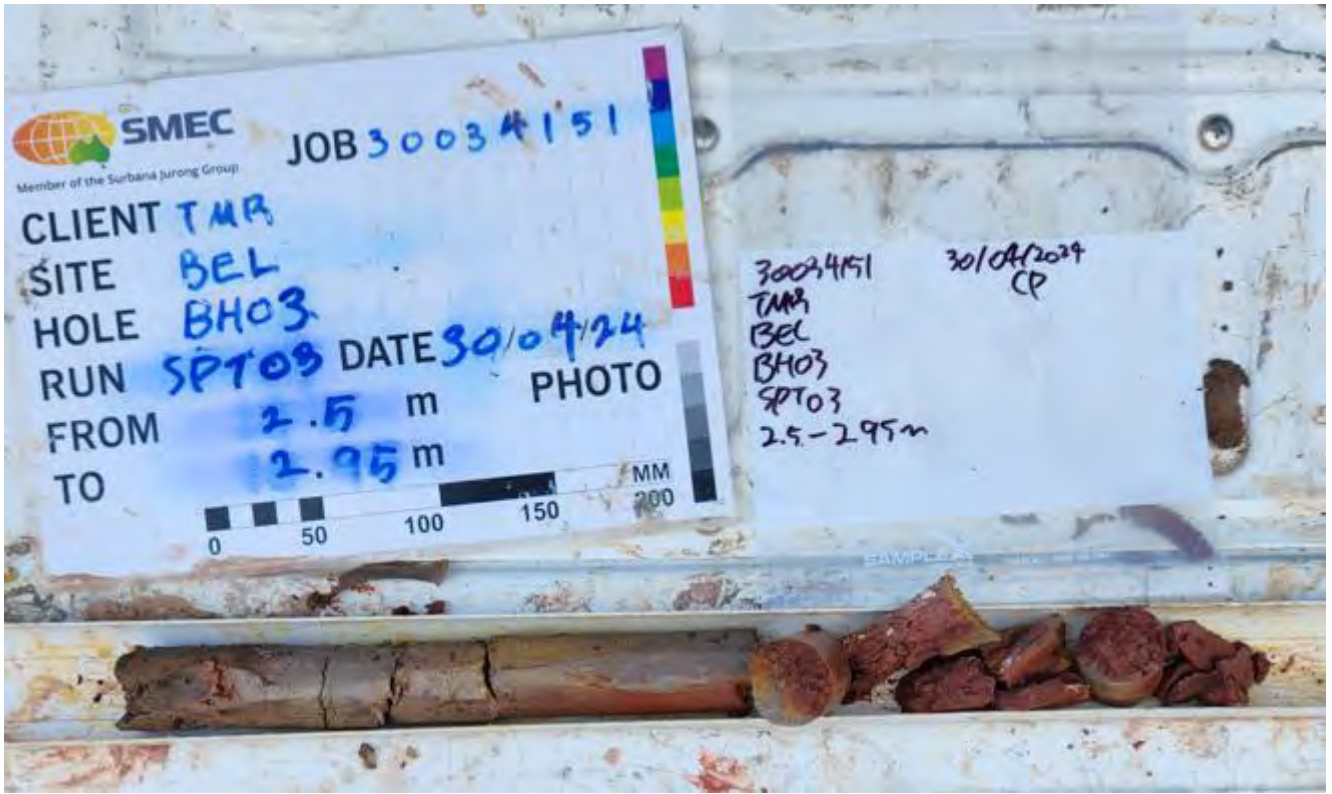
Photo 38: BH03 SPT03

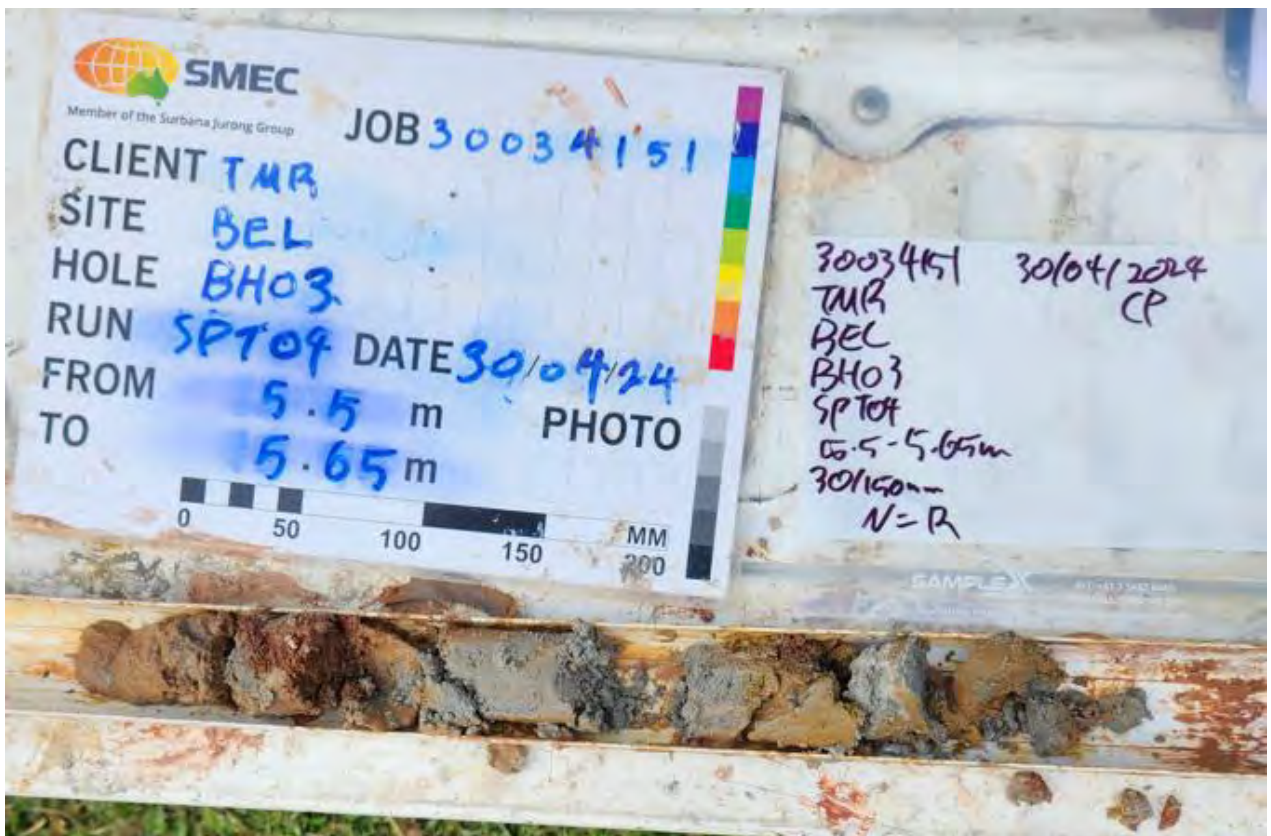
Photo 39: BH03 SPT04

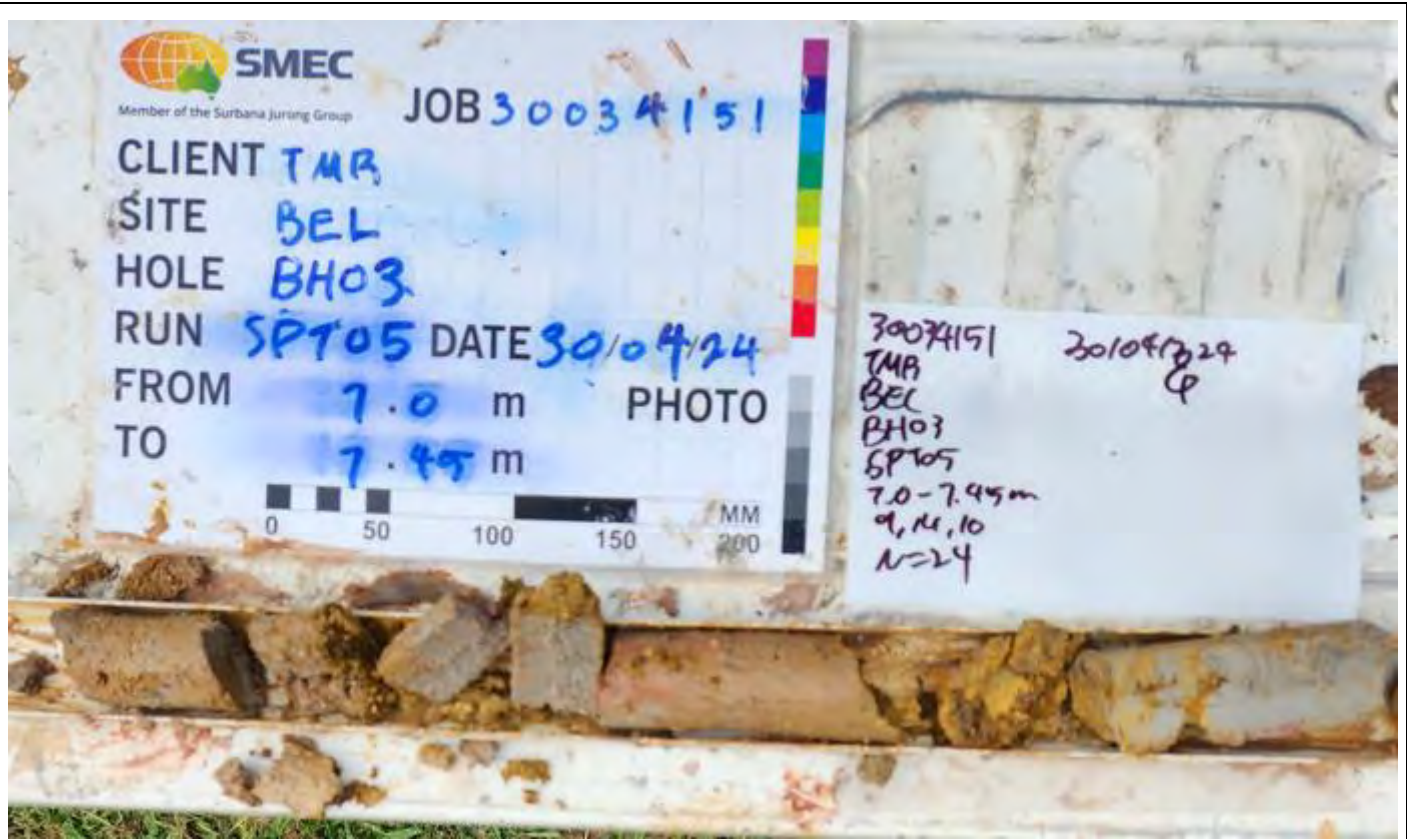
Photo 40: BH03 SPT05

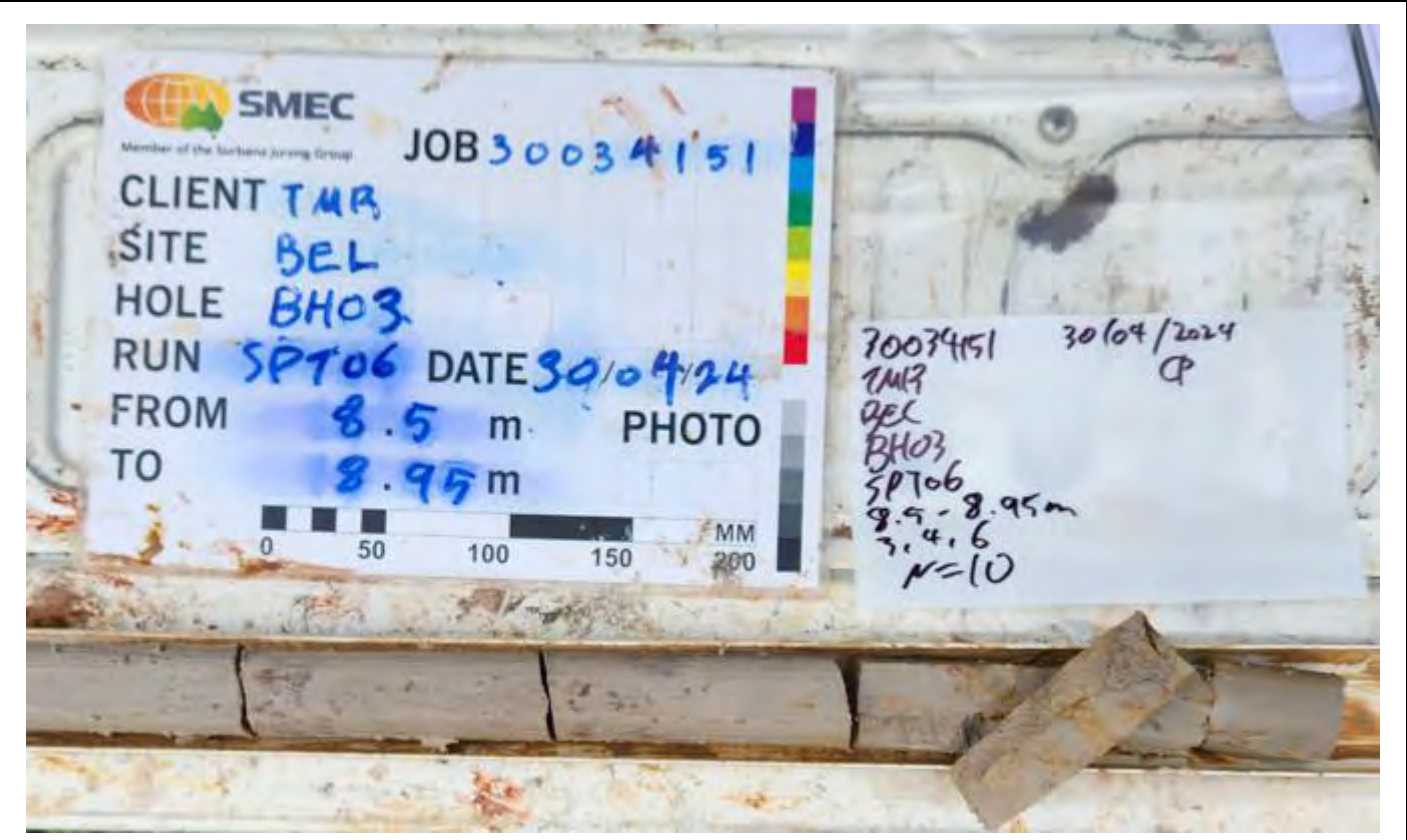
Photo 41: BH03 SPT06

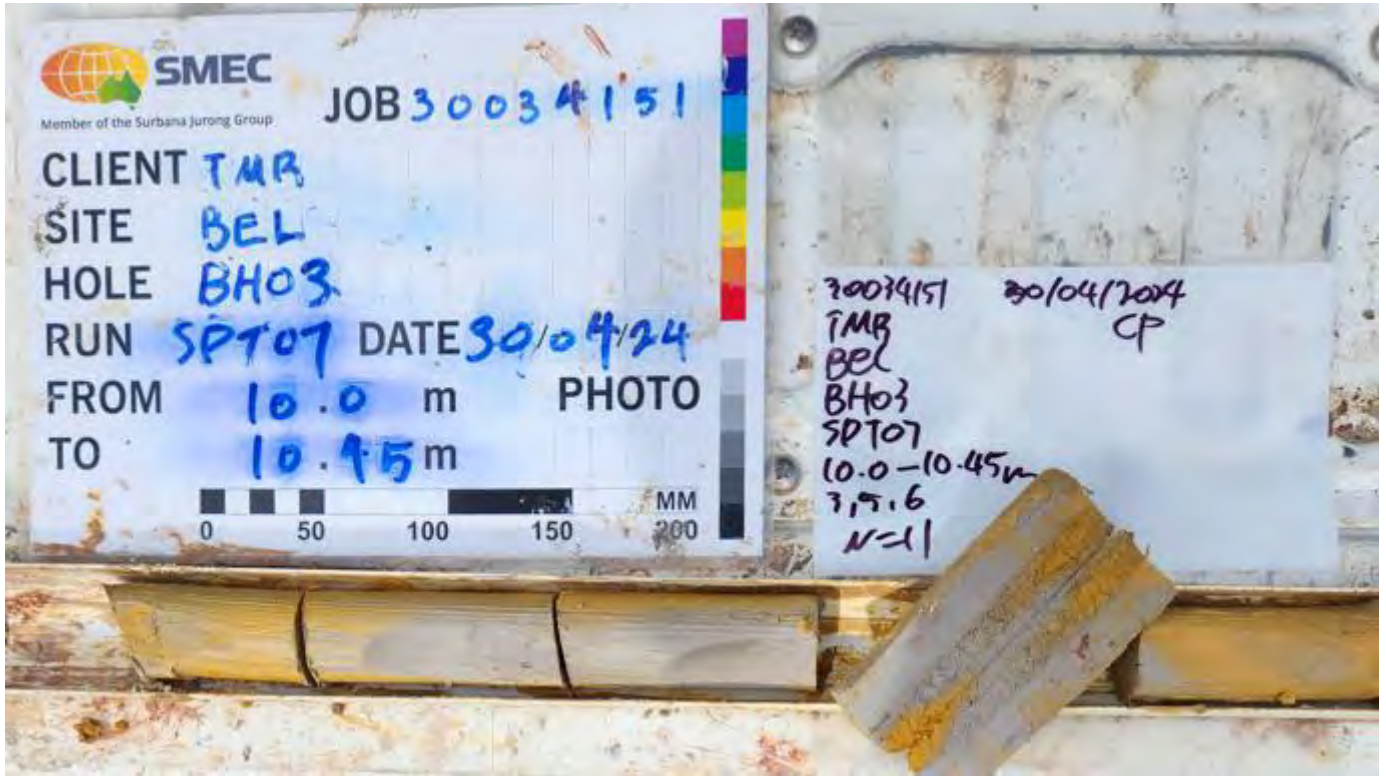
Photo 42: BH03 SPT07

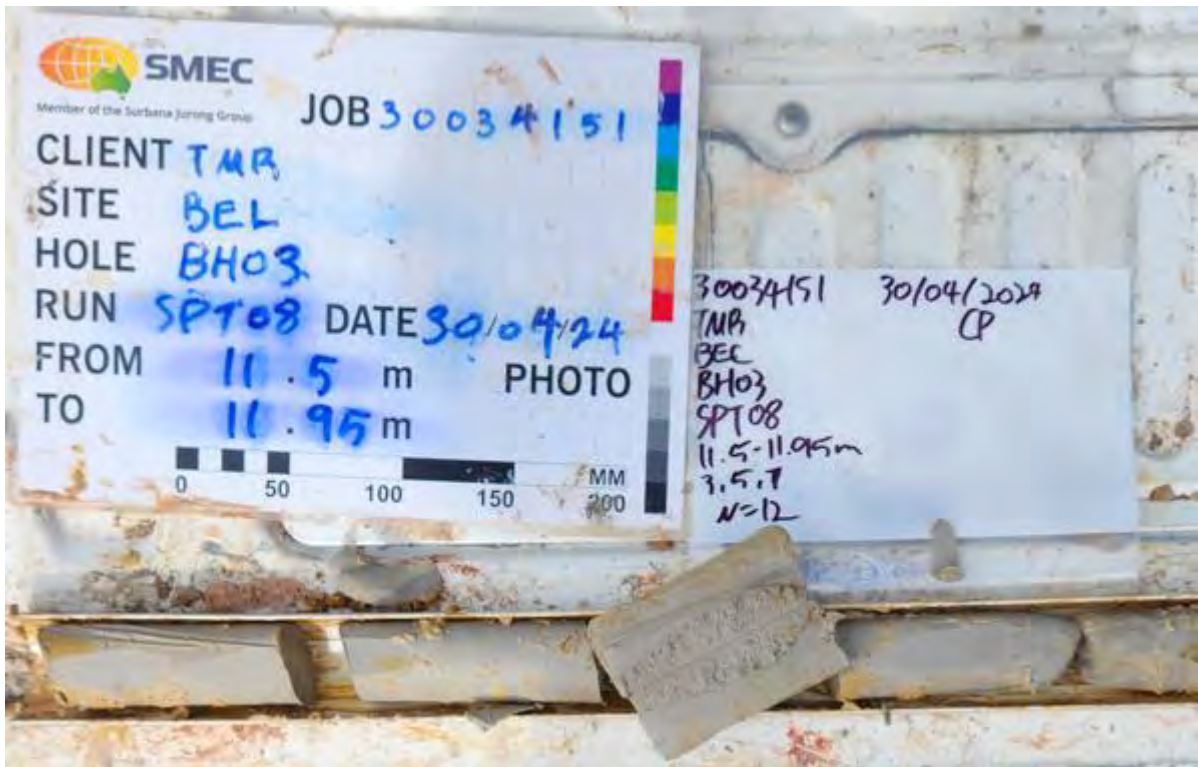
Photo 43: BH03 SPT08

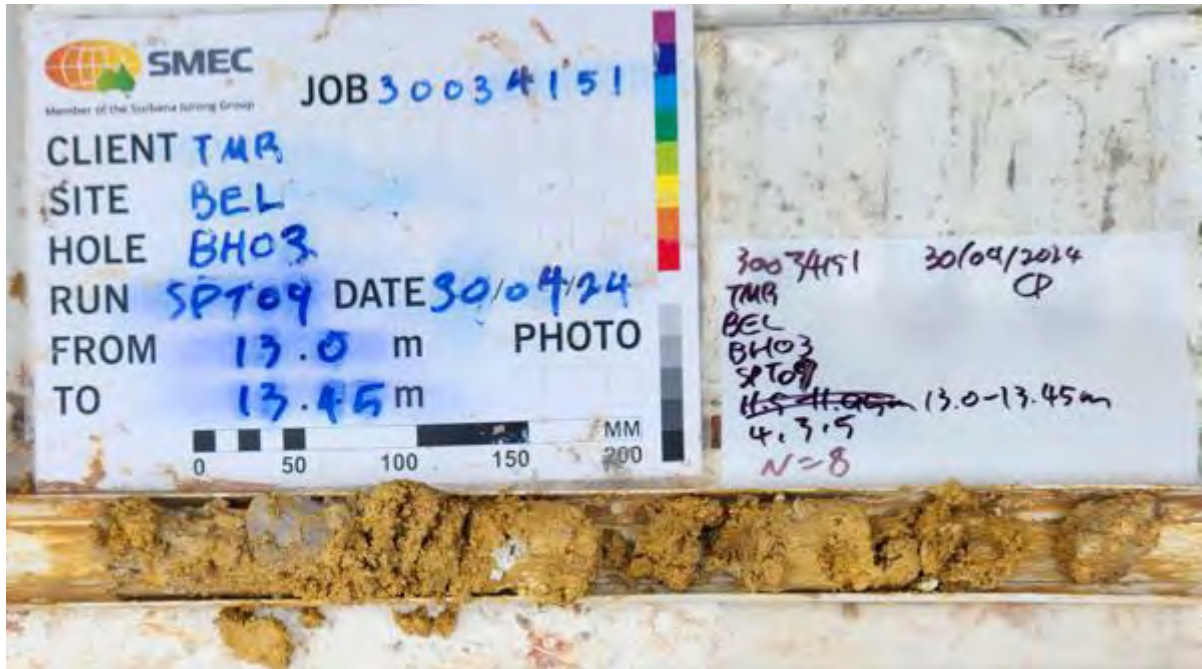
Photo 44: BH03 SPT09
