Geotechnical Factual Report

Bundaberg East Levee

Reference No. 30034151-RPT-3.7-001

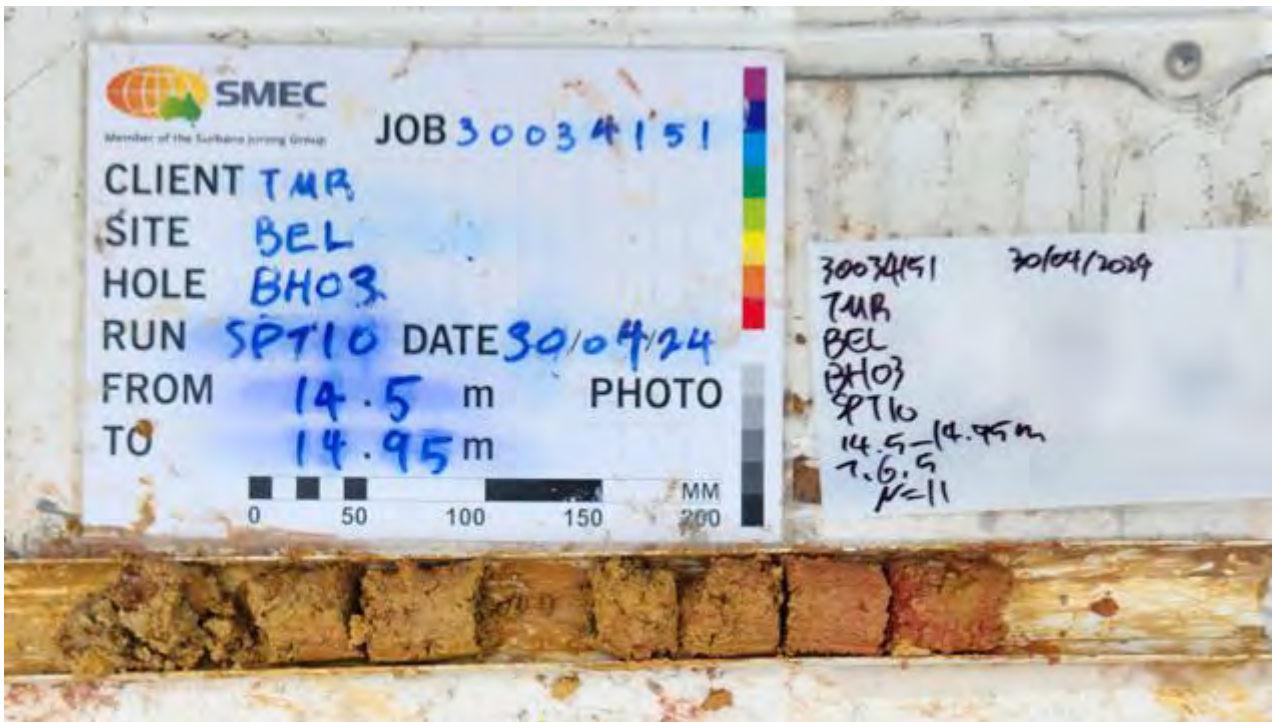
Photo 45: BH03 SPT10

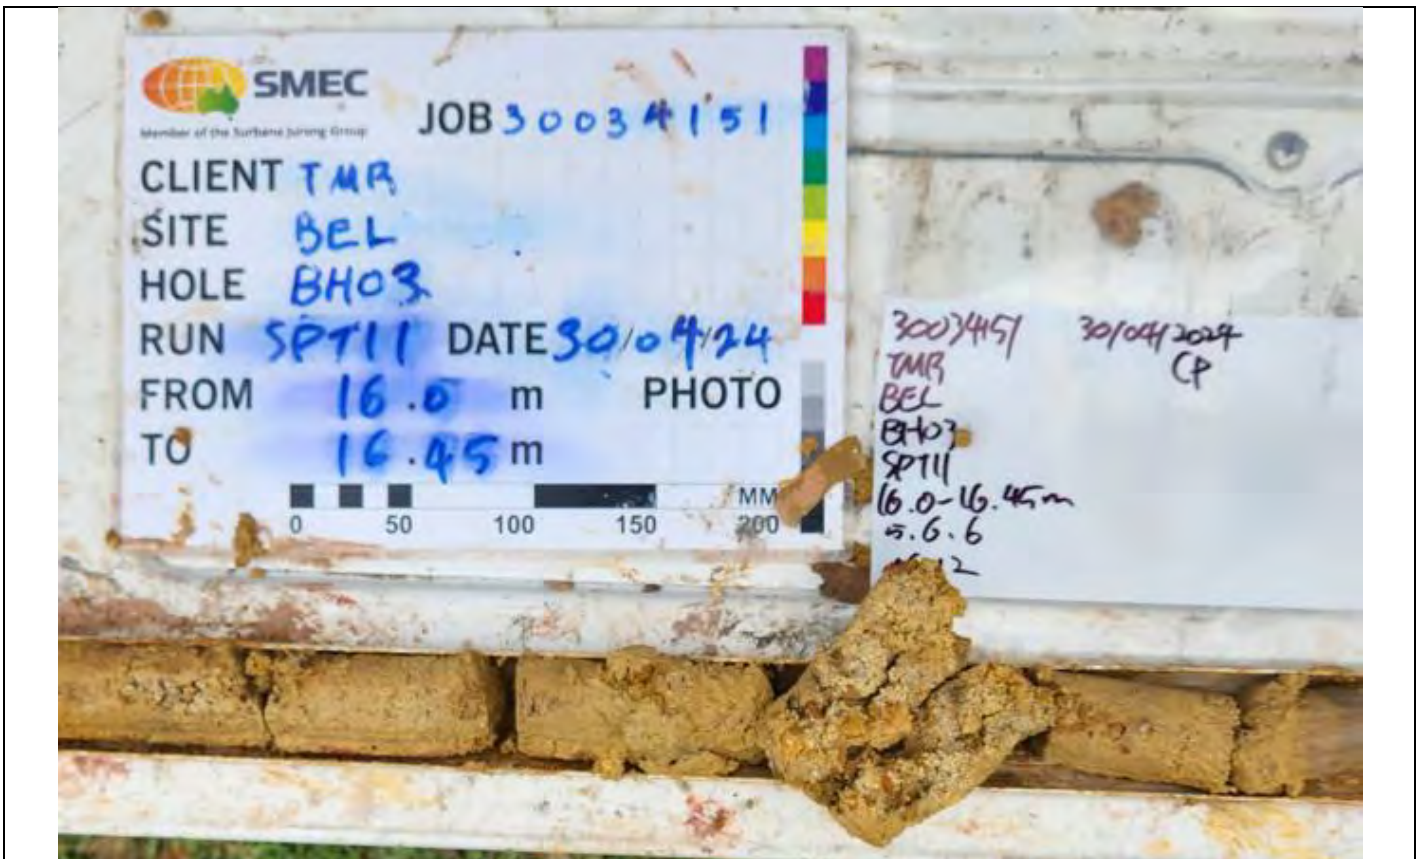
Photo 46: BH03 SPT11

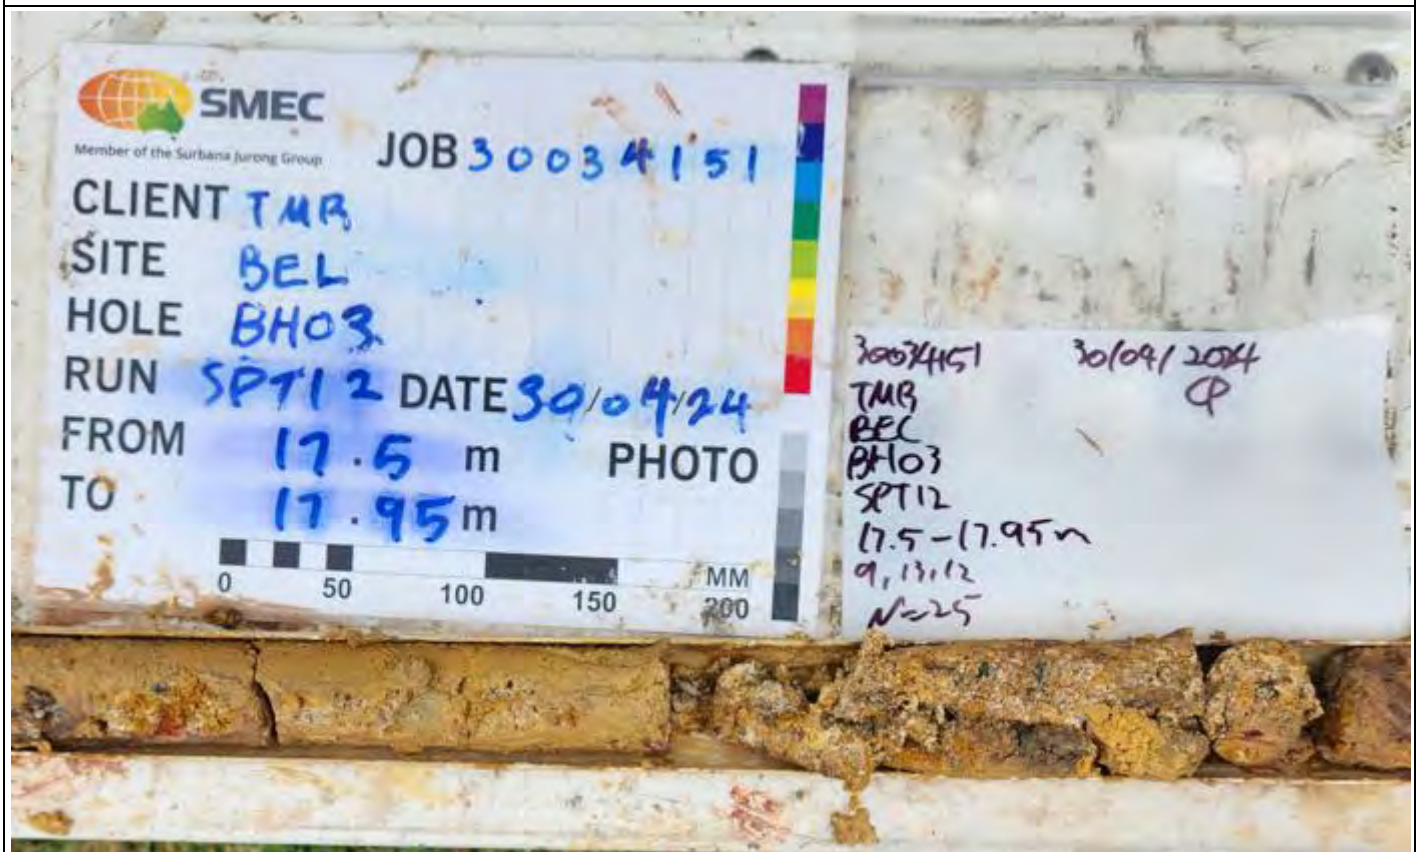
Photo 47: B BH03 SPT12

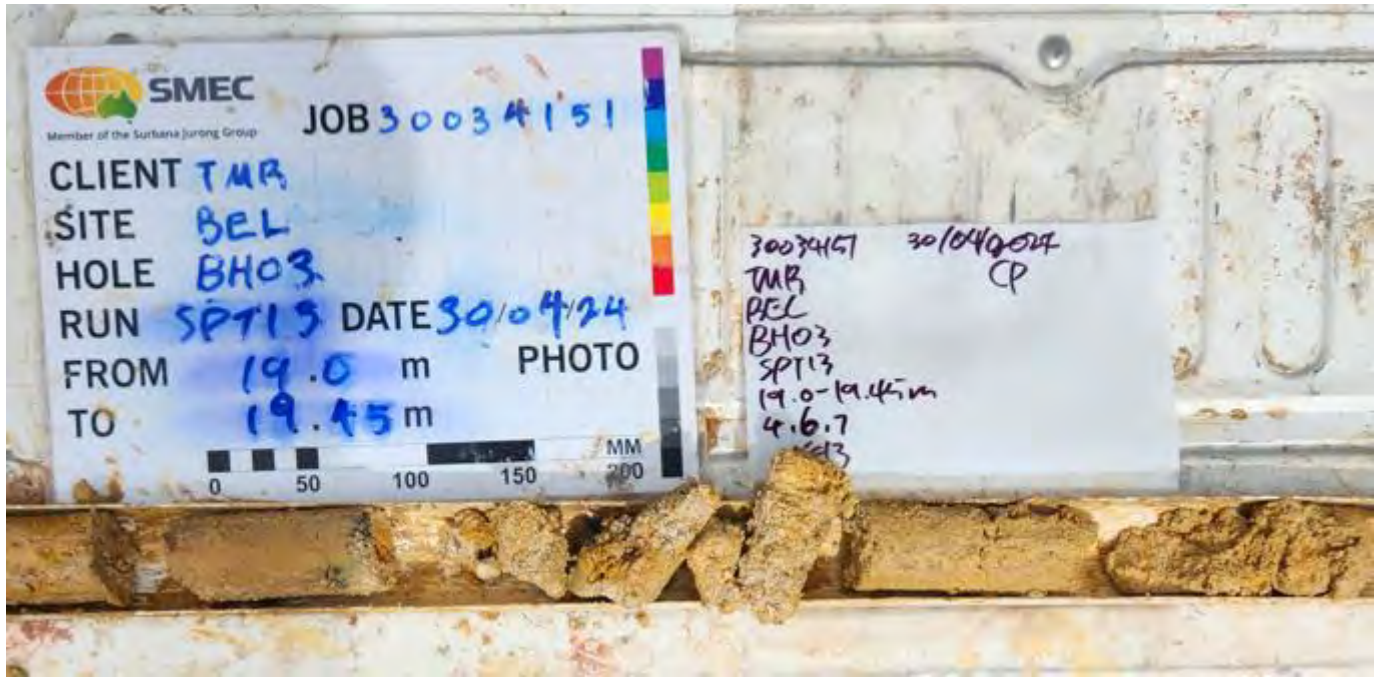
Photo 48: BH03 SPT13

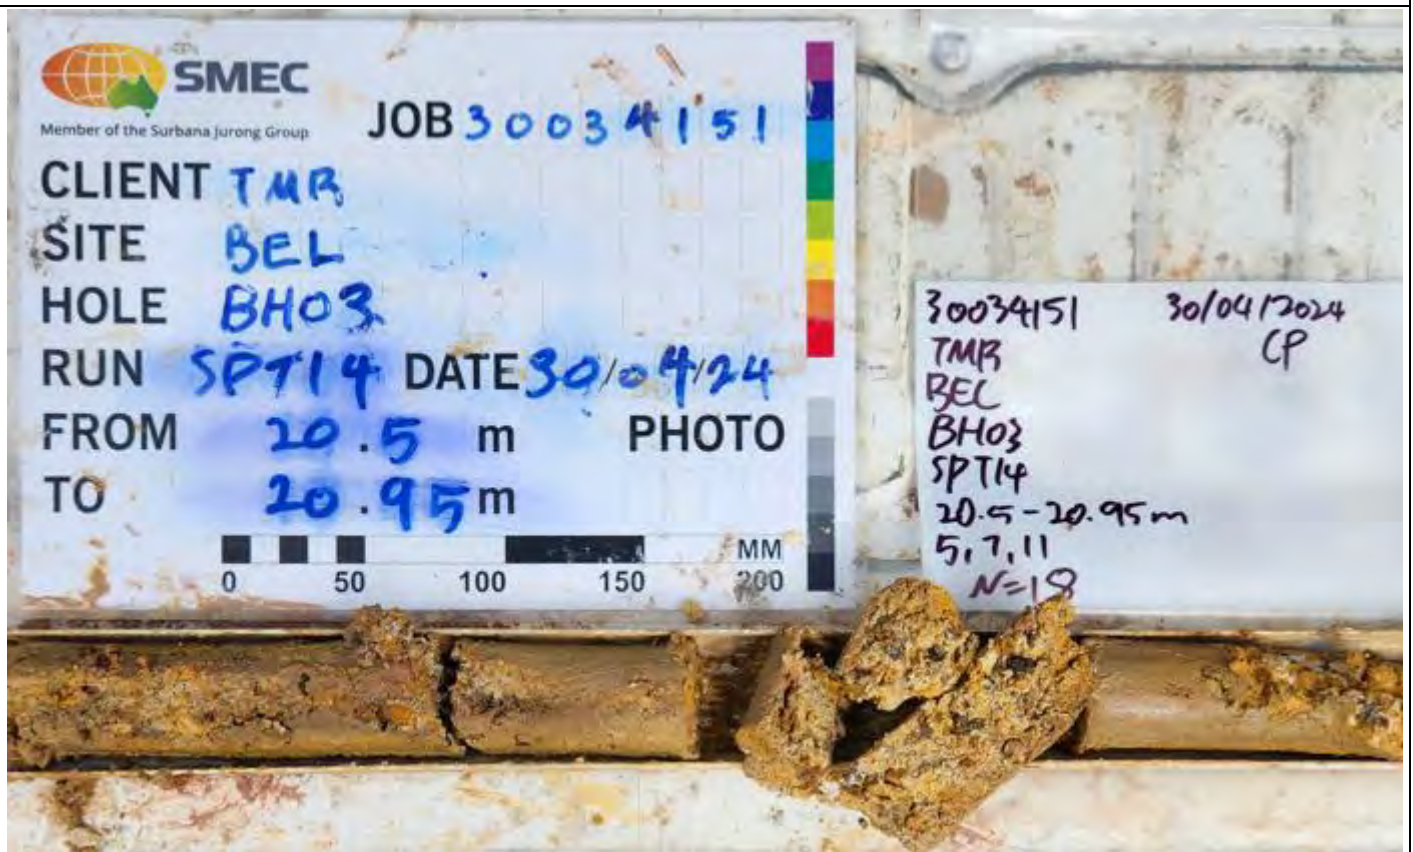
Photo 49: BH03 SPT14

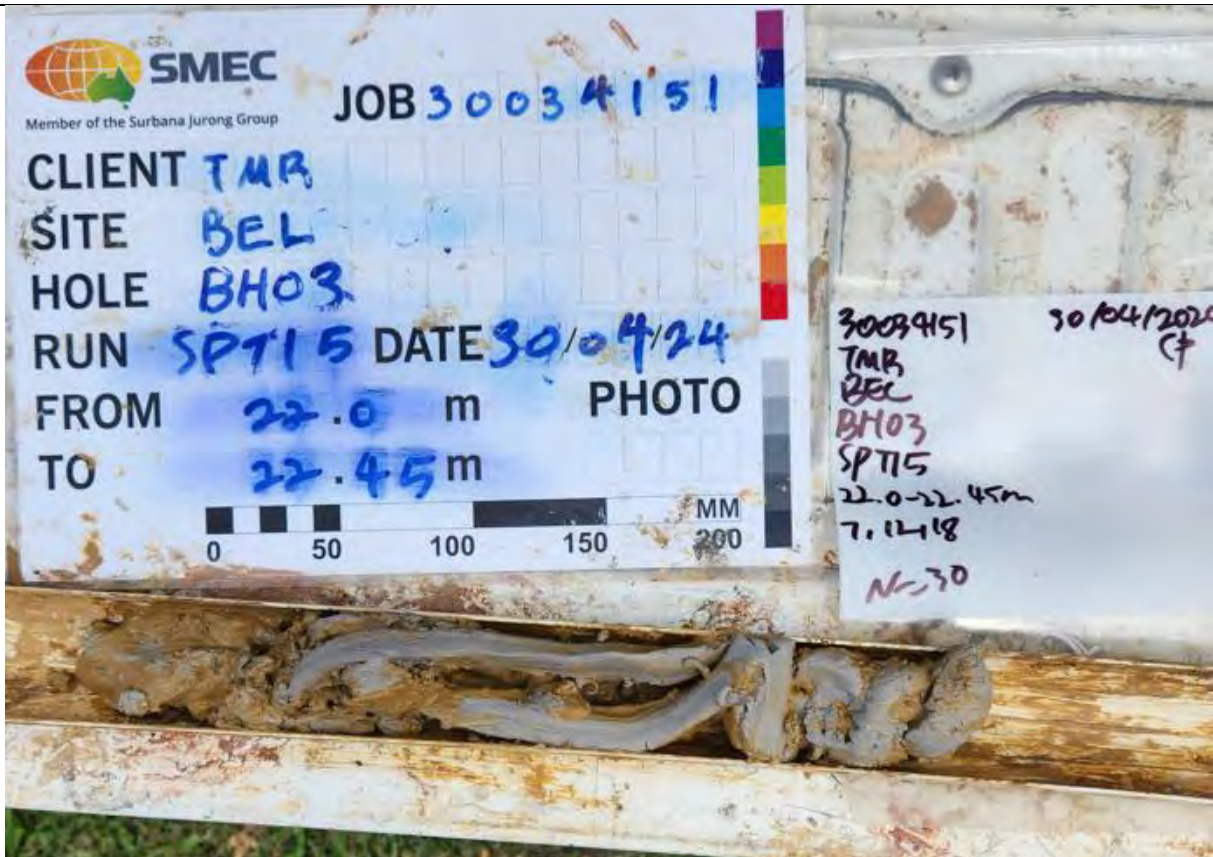
Photo 50: BH03 SPT15

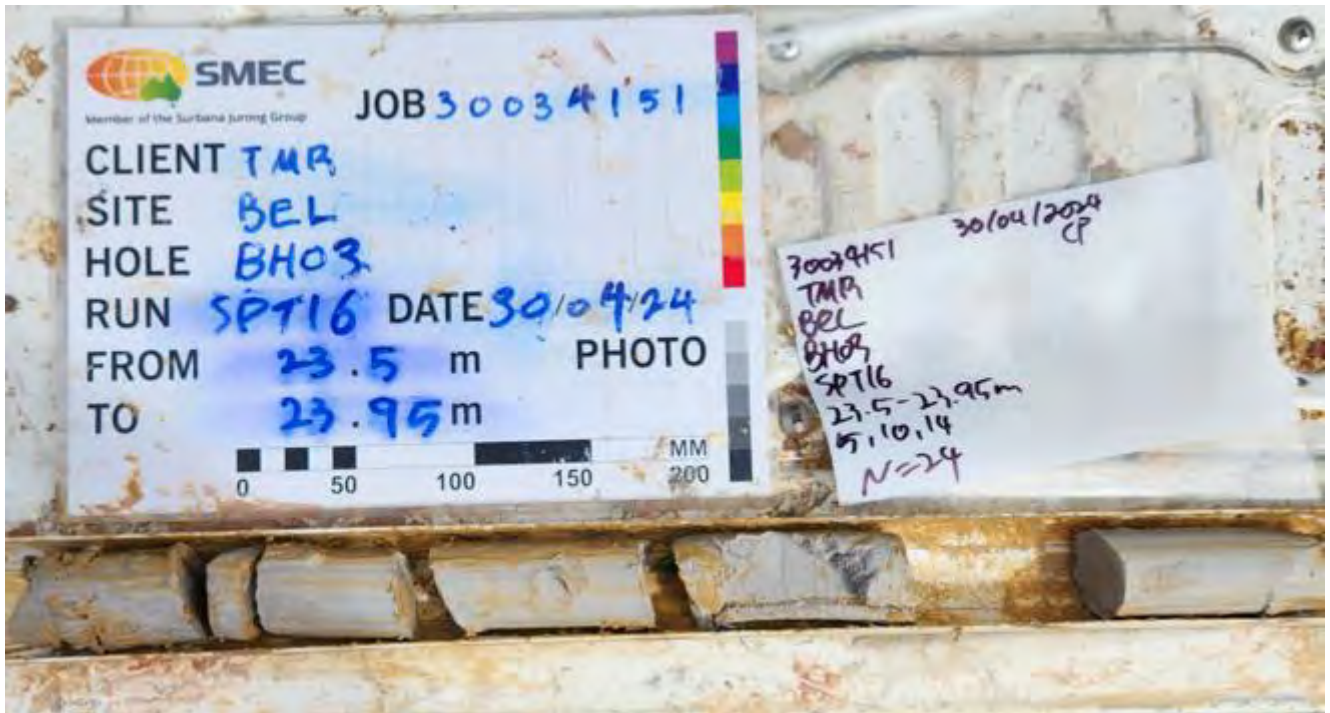
Photo 51: BH03 SPT16

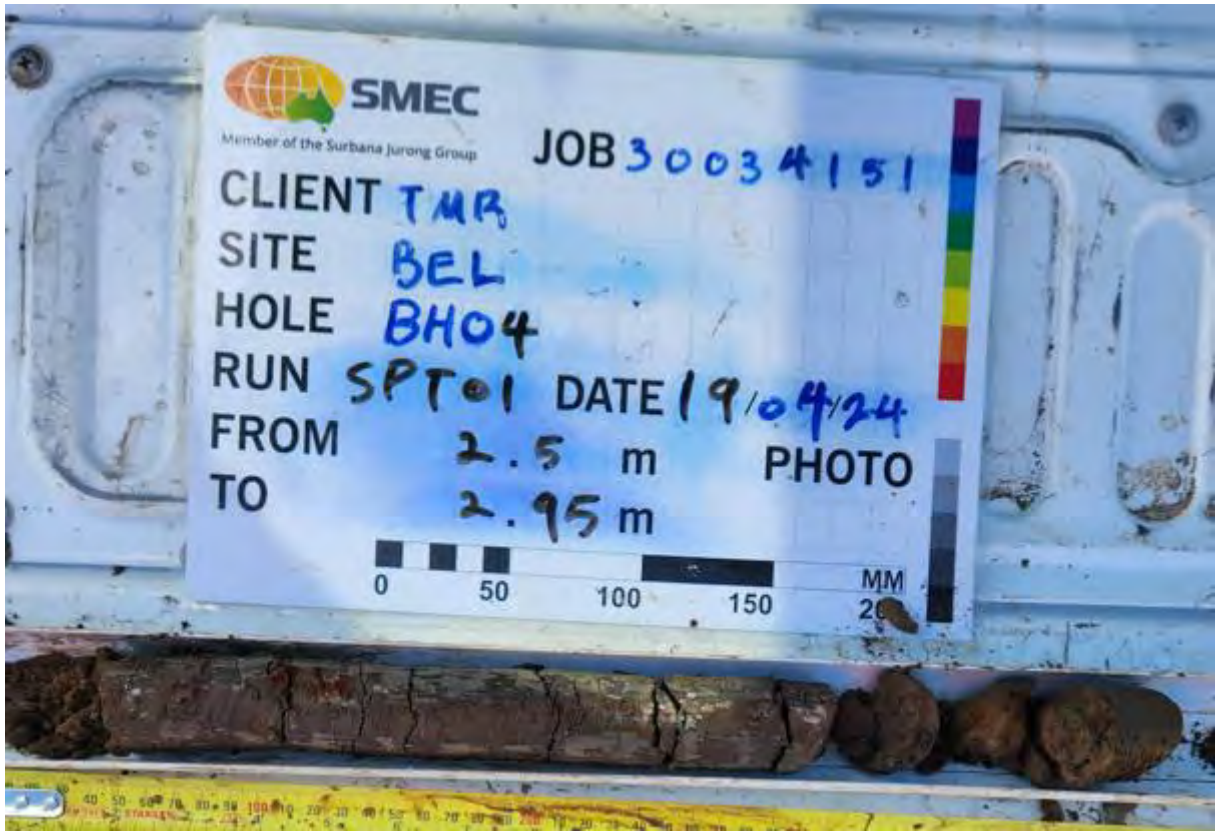
Photo 52: BH04 SPT01

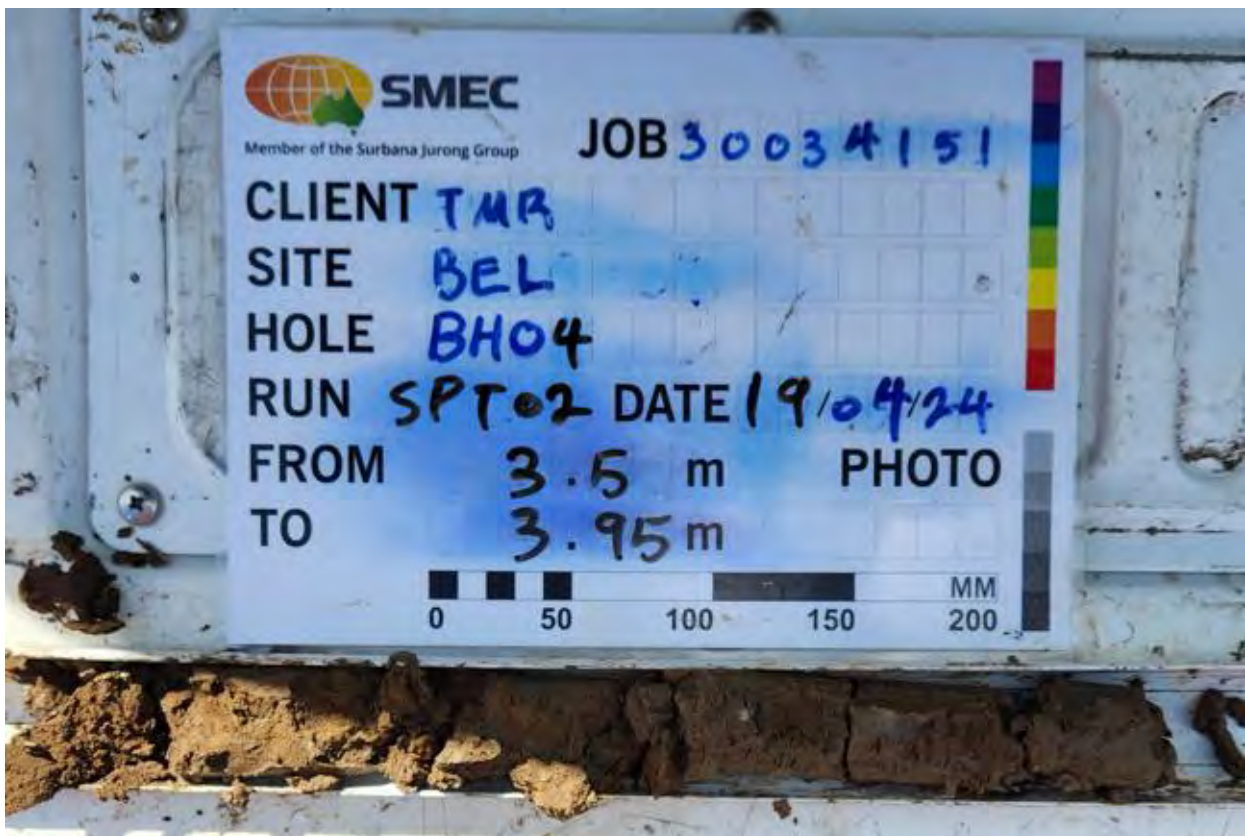
Photo 53: BH04 SPT02

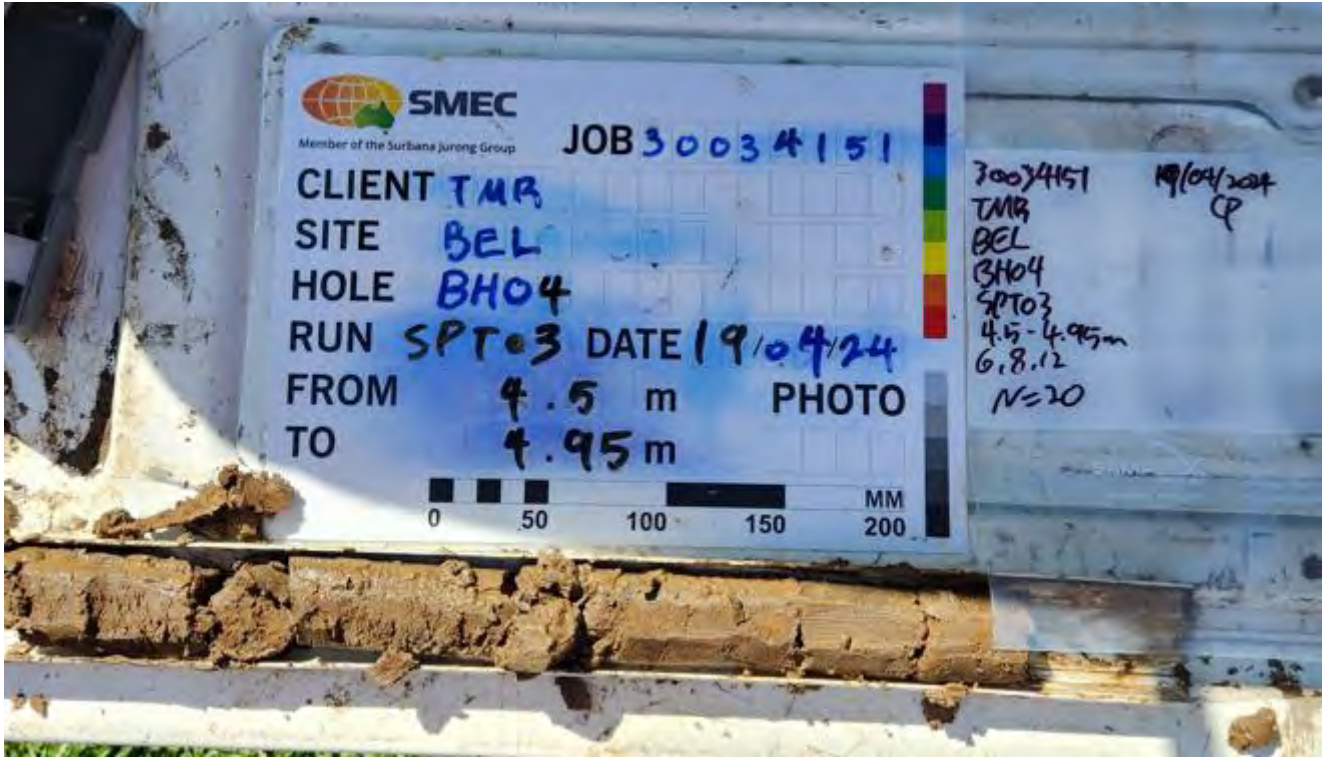
Photo 54: BH04 SPT03

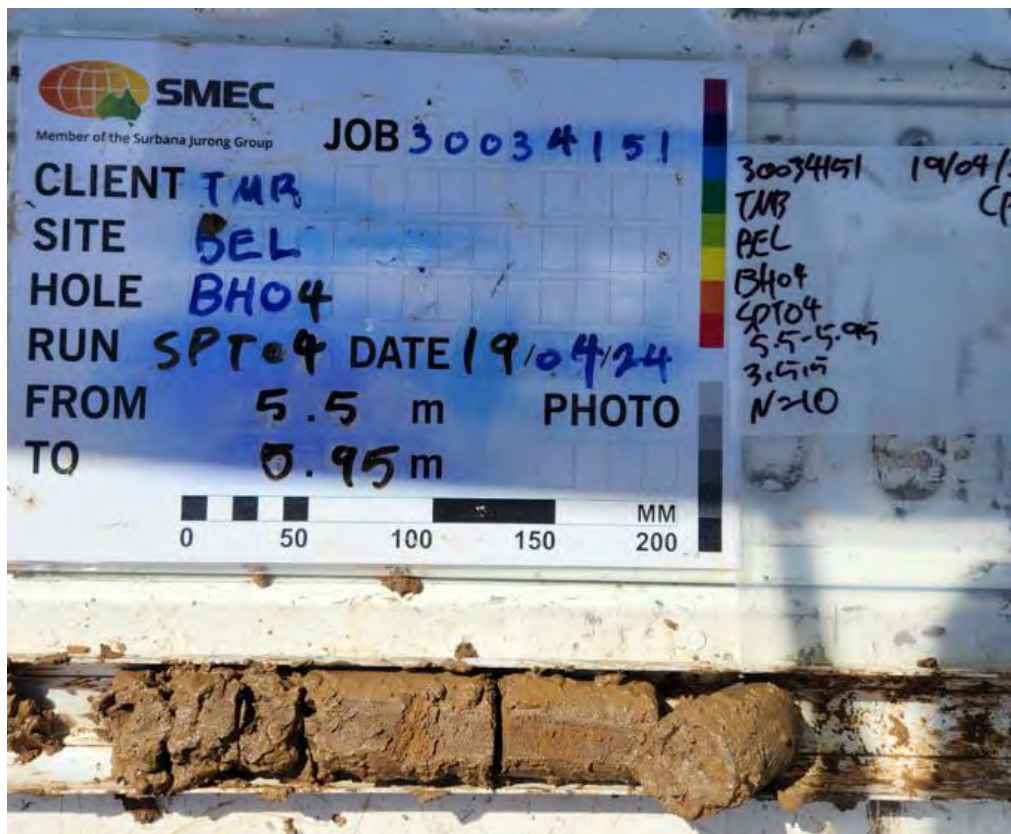
Photo 55: BH04 SPT04

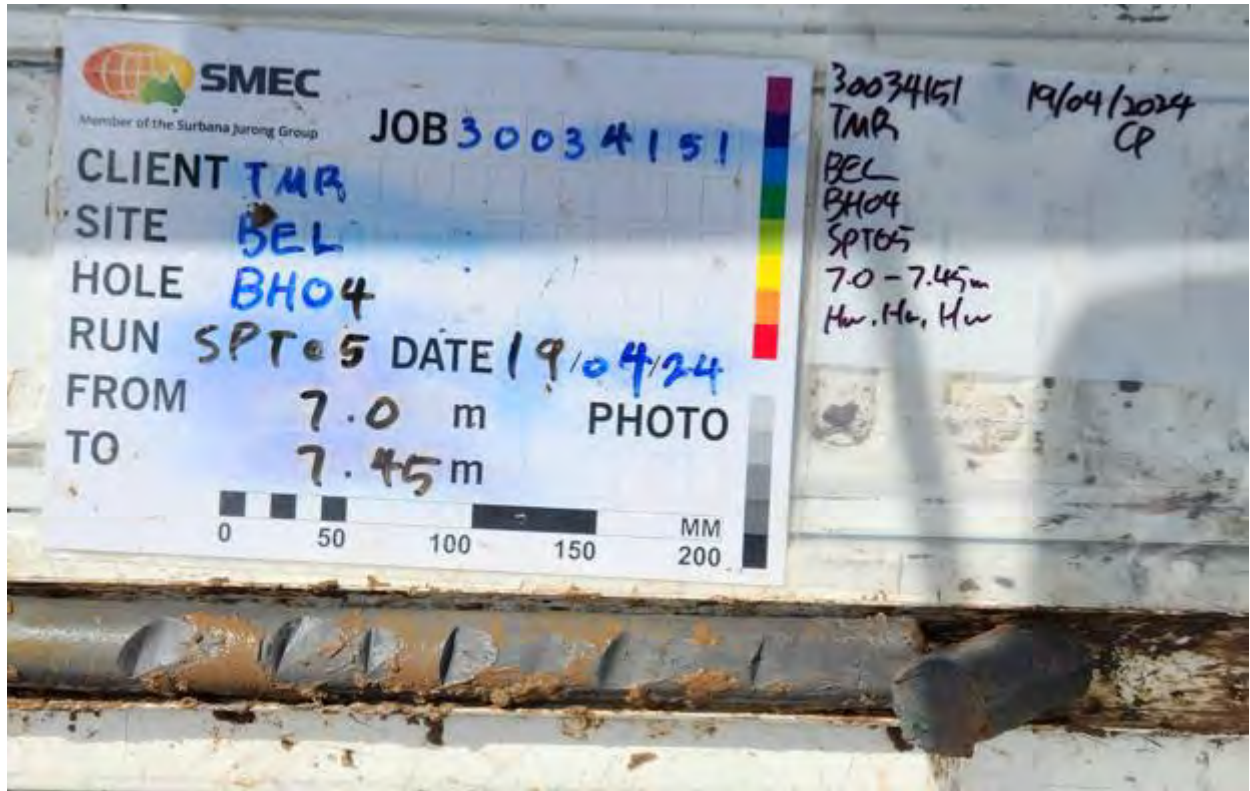
Photo 56: BH04 SPT05

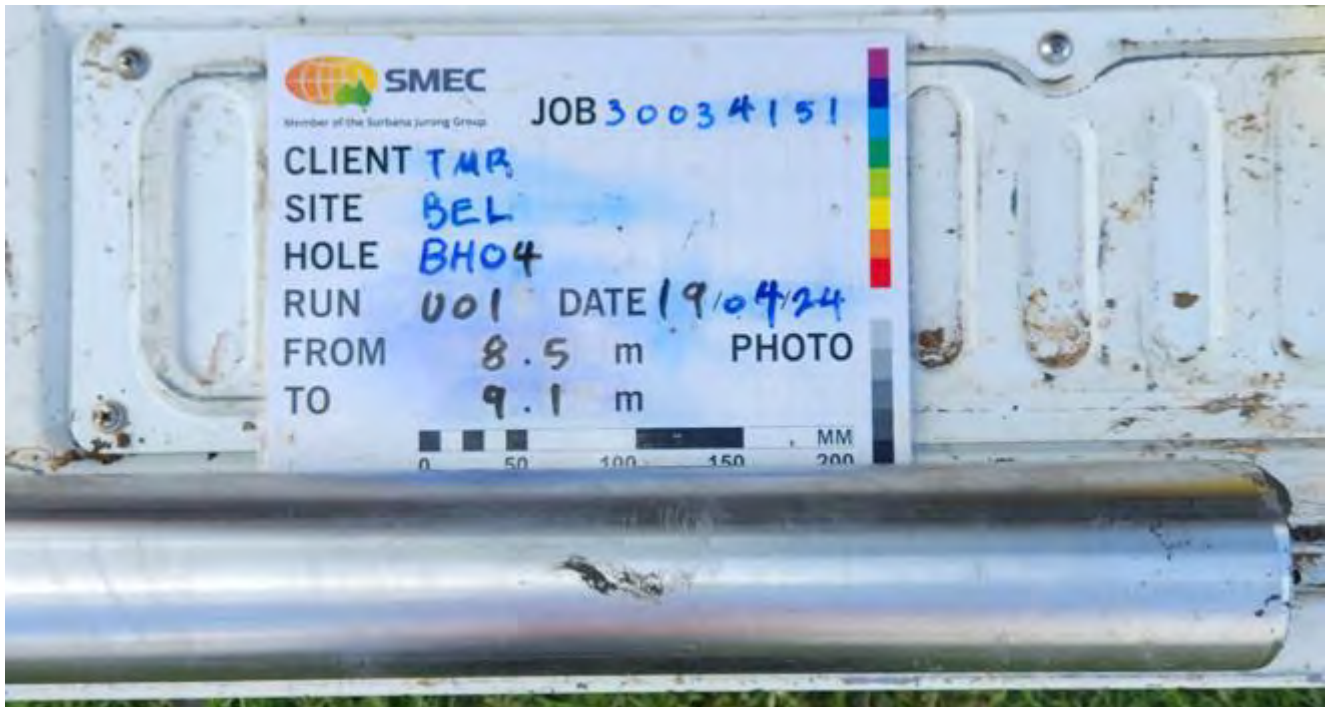
Photo 57: BH04 U01

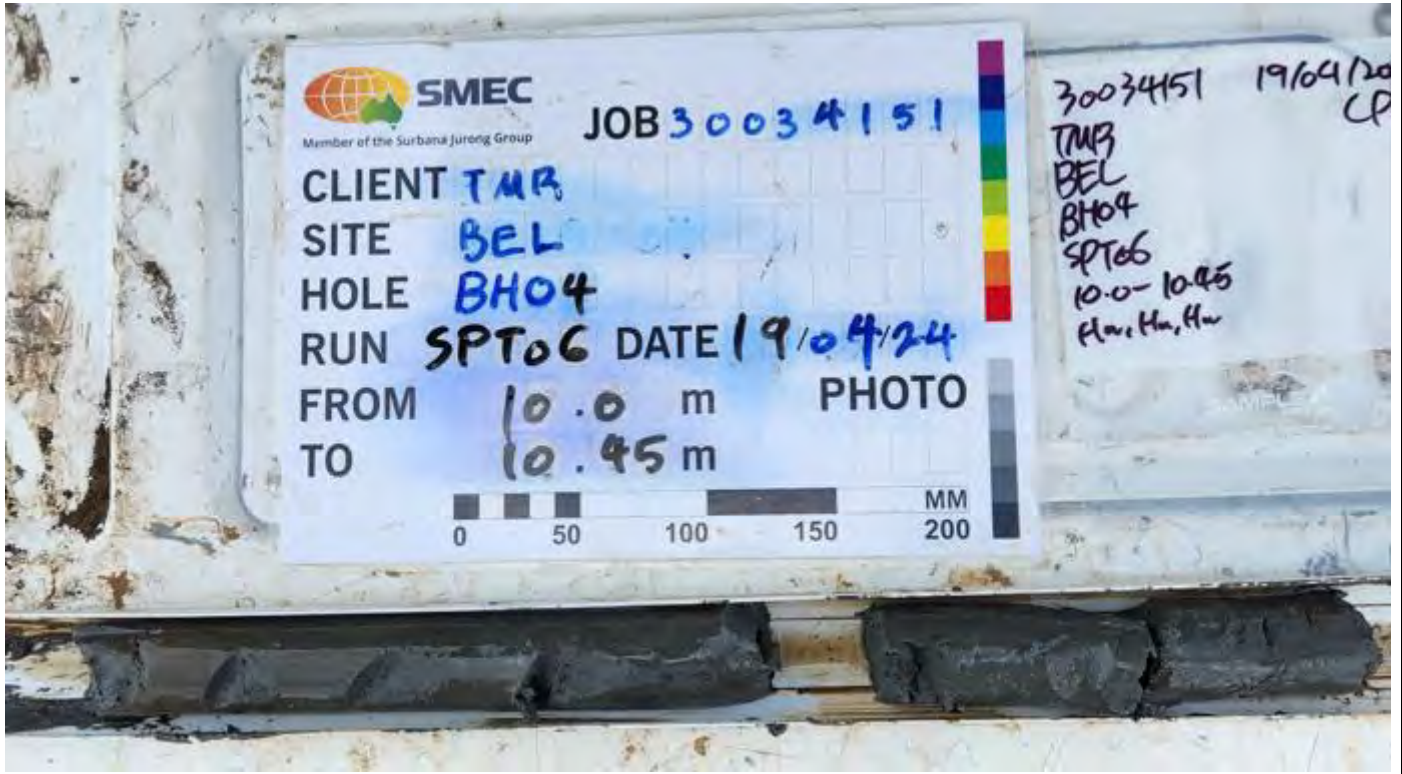
Photo 58: BH04 SPT06

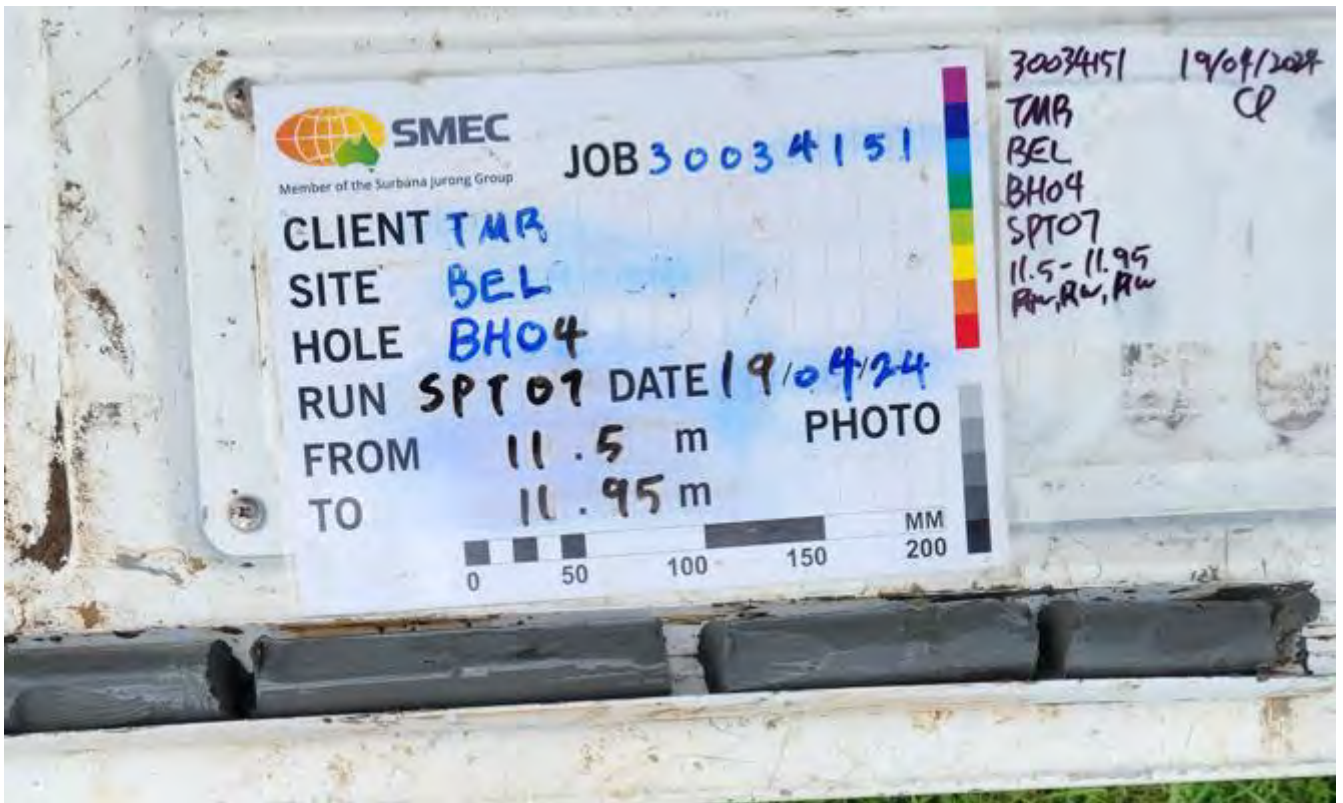
Photo 59: BH04 SPT07

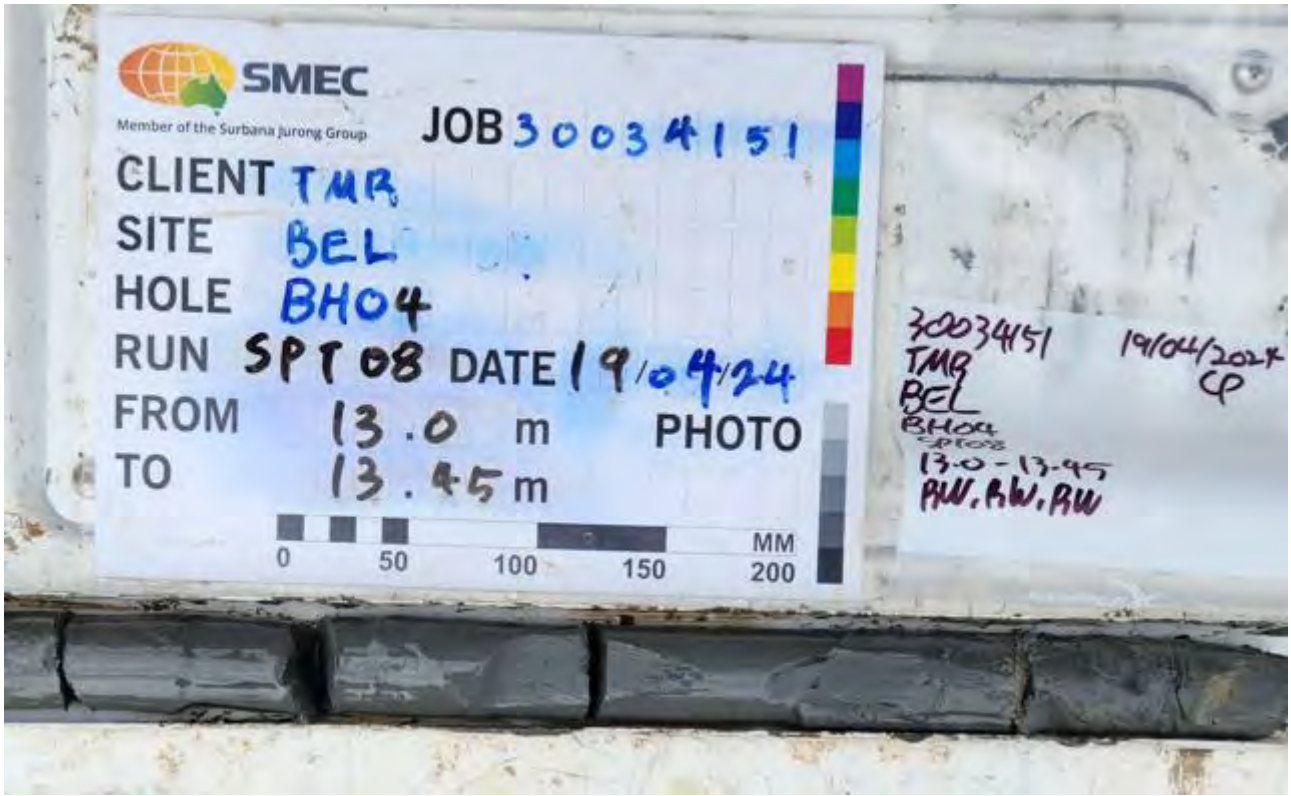
Photo 60: BH04 SPT08

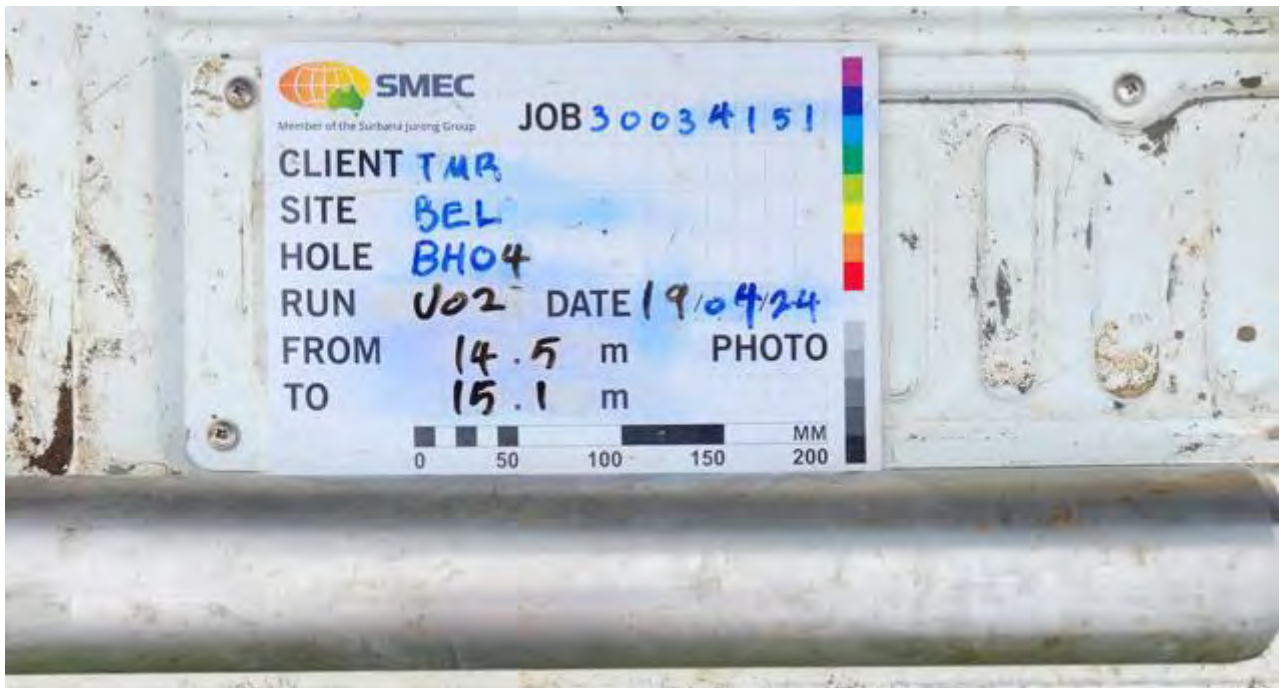
Photo 61: BH04 U02

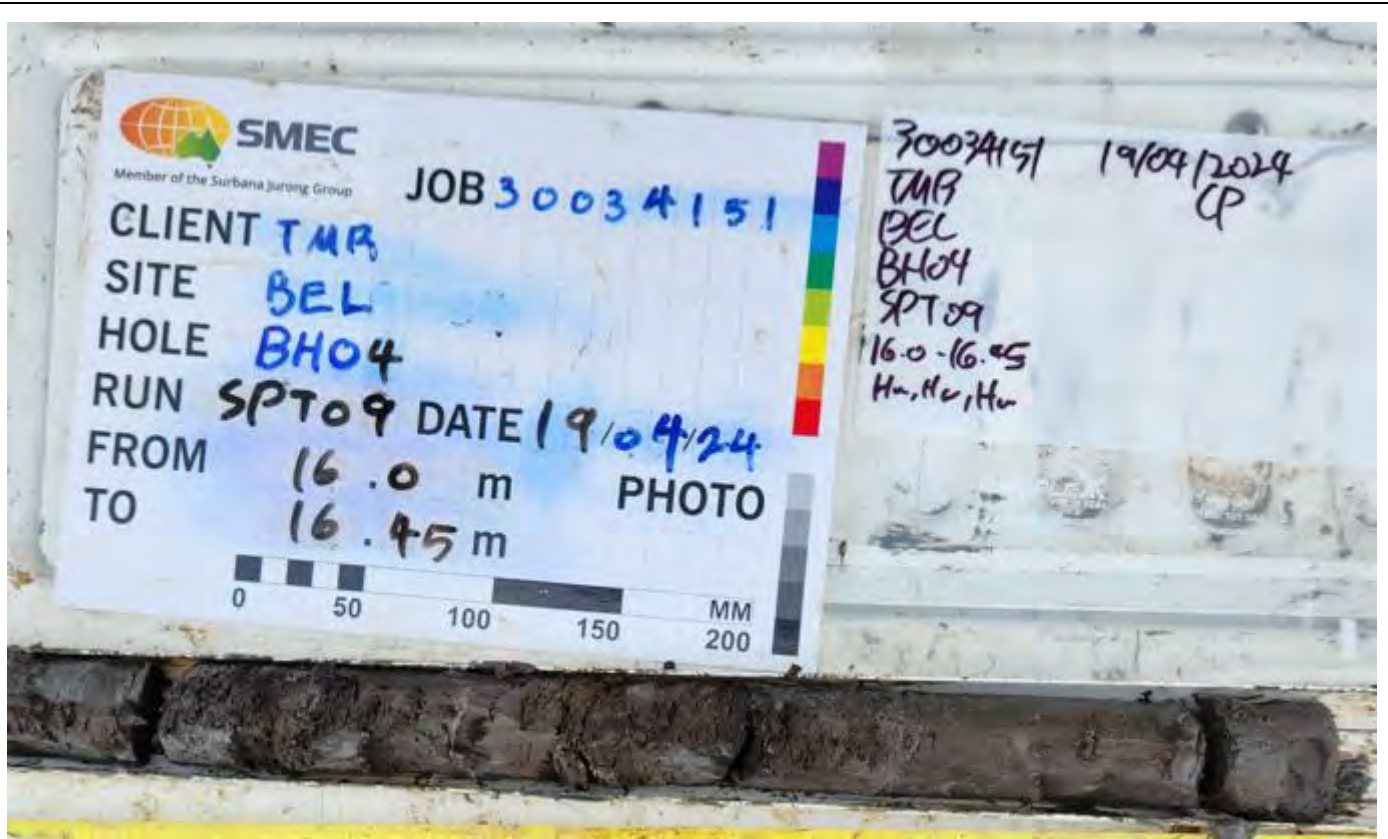
Photo 62: BH04 SPT09

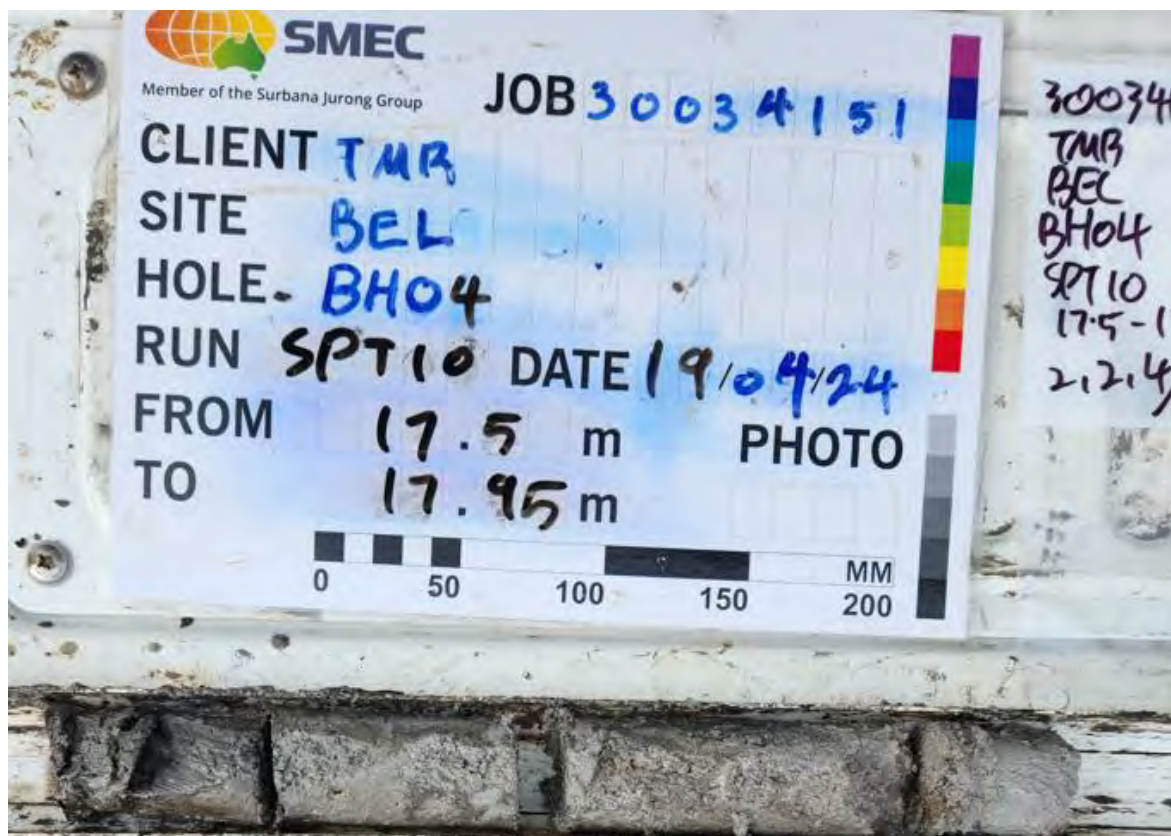
Photo 63: BH04 SPT10

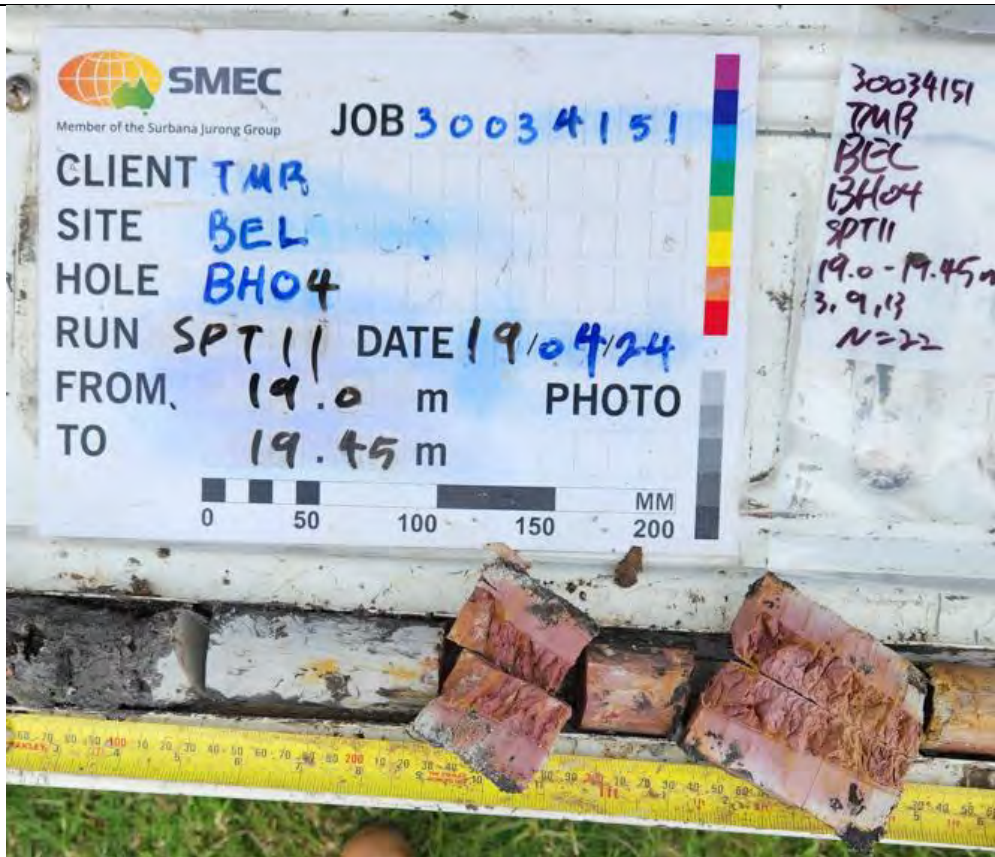
Photo 64: BH04 SPT11

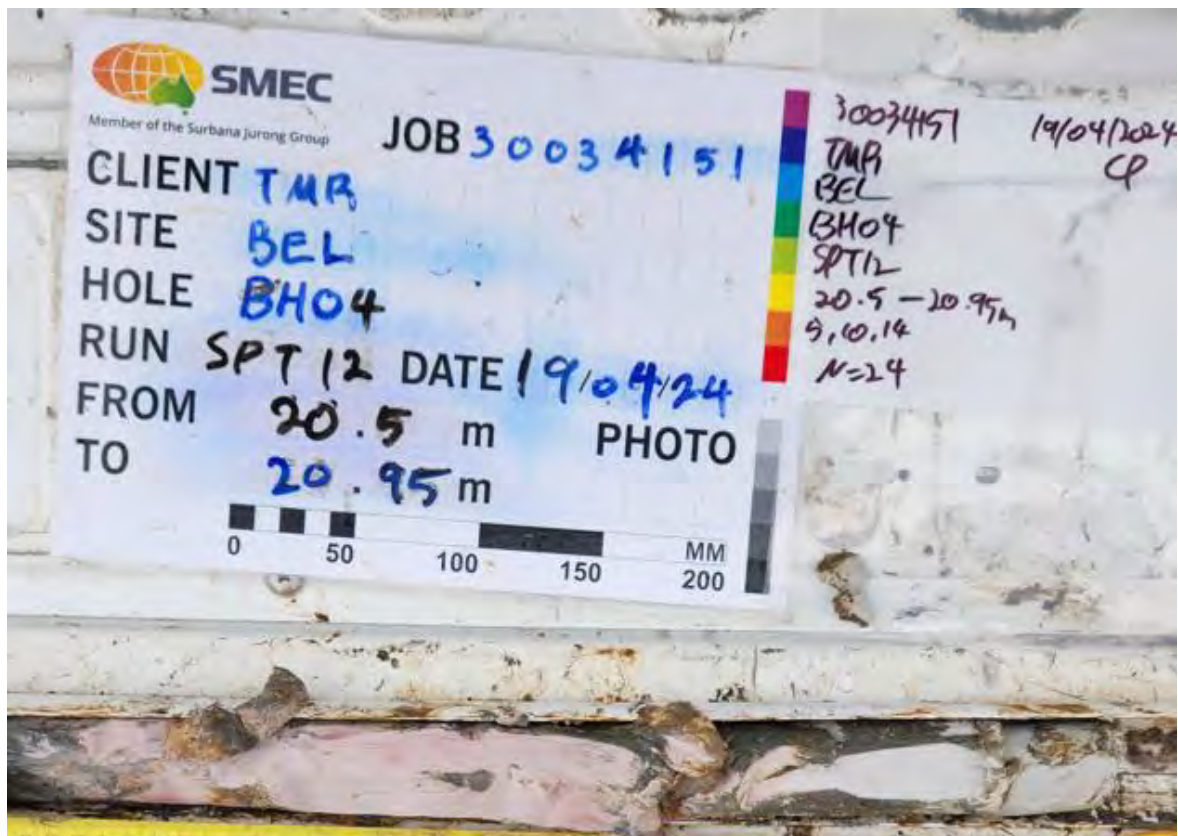
Photo 65: BH04 SPT12

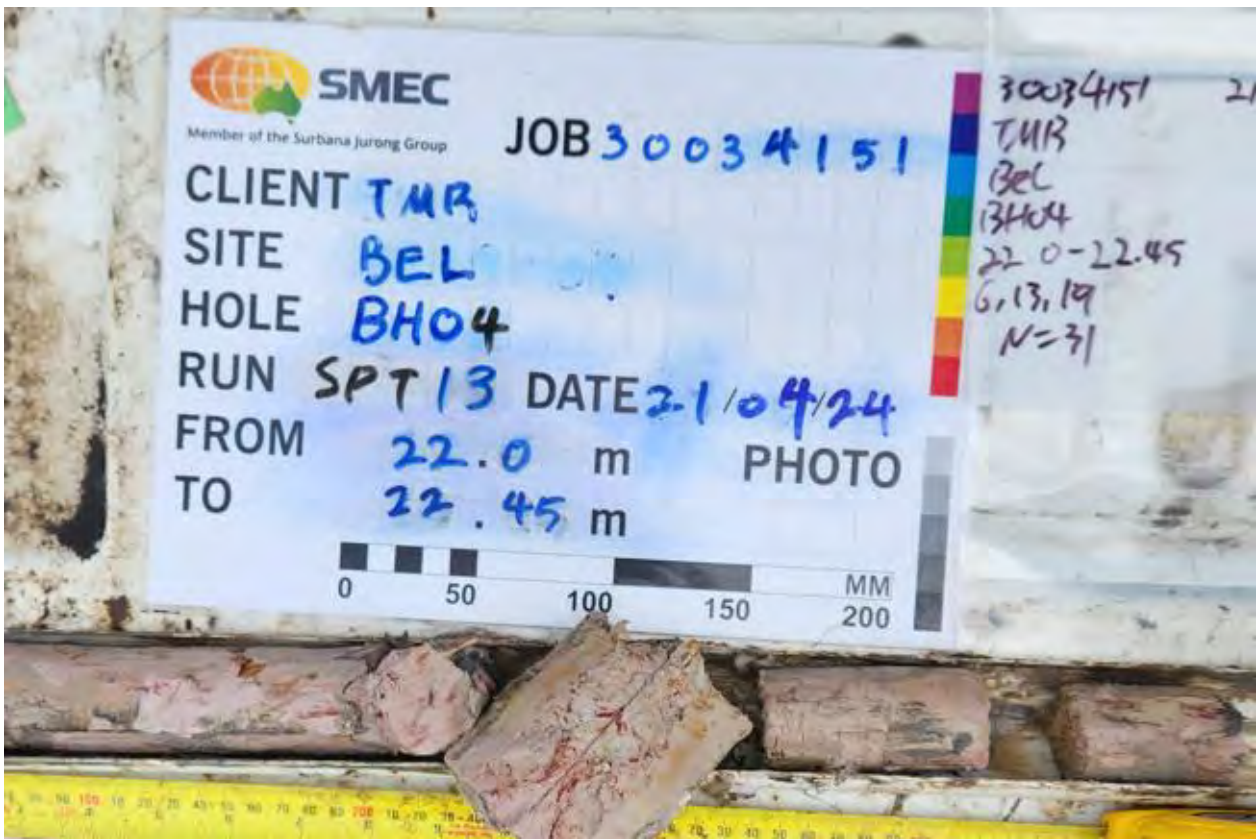
Photo 66: BH04 SPT13
