Geotechnical Factual Report

Bundaberg East Levee

Reference No. 30034151-RPT-3.7-001

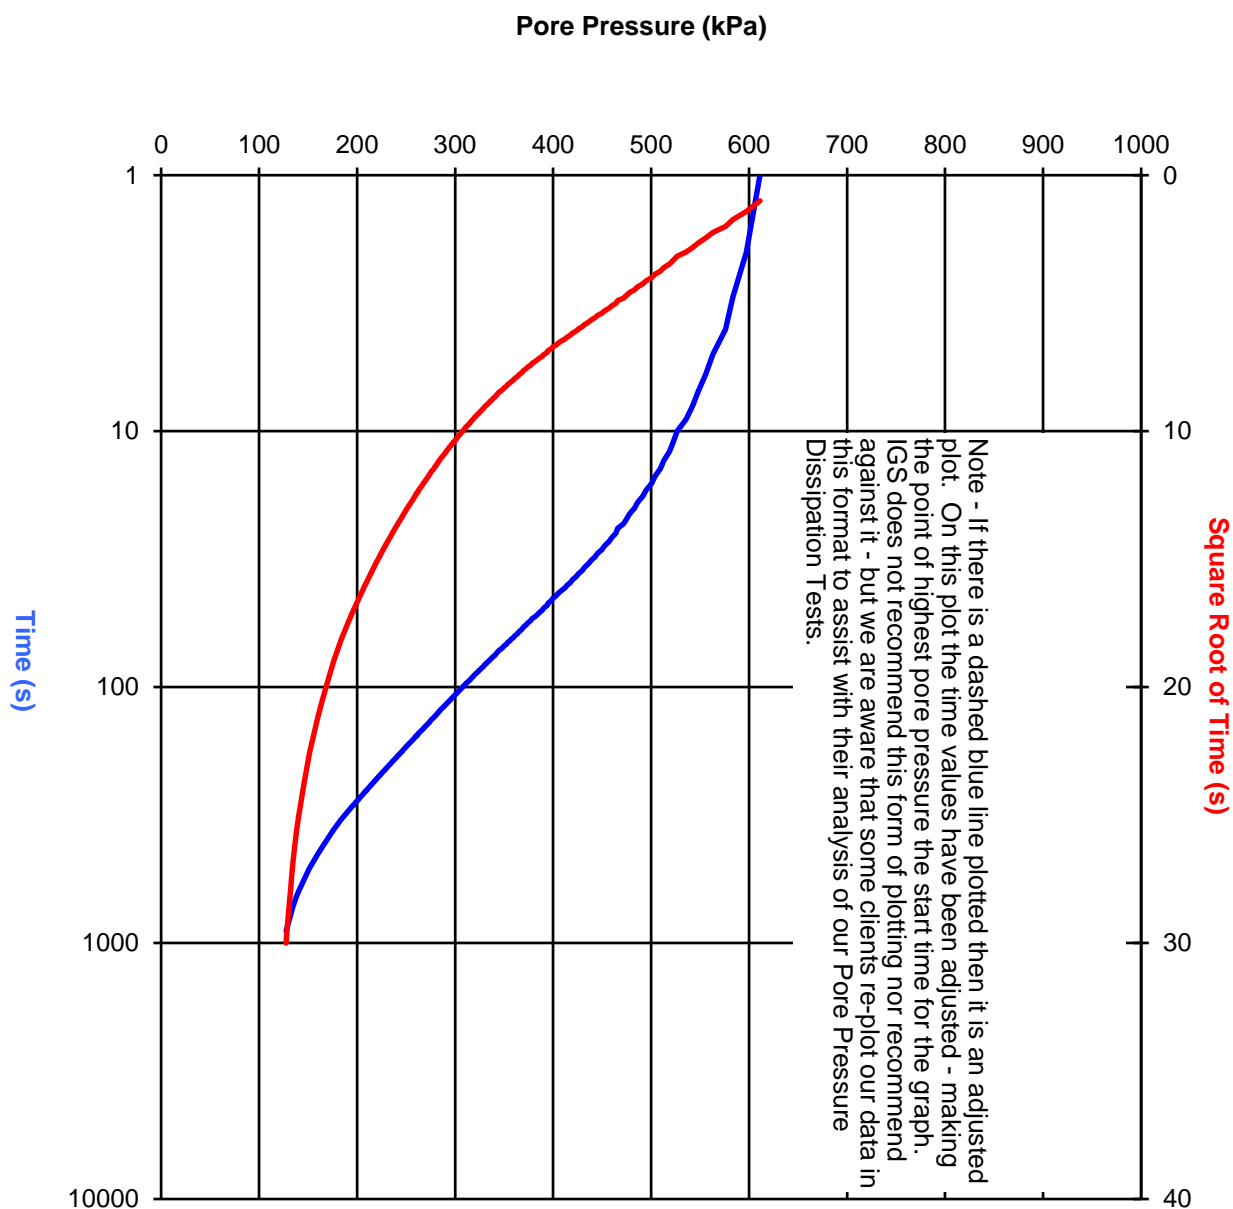
CPT-03
 Depth: 17.49m

Tested By: Sean Gibson
 Test Duration: 0 Hours, 15 Minutes
 Test Date: 20/04/2024
 Job No: G24-03-09
 Cone: S15CFIIP.S19568

Termination Reason: Client Direction
 Special Notes: Nil
