# BUNDABERG LEVEE

EPW00390 – Heritage Impact Assessment – Saltwater Creek Rail Bridge  
(30034151-RPT-13.0-001) – Revision 0

May 2024

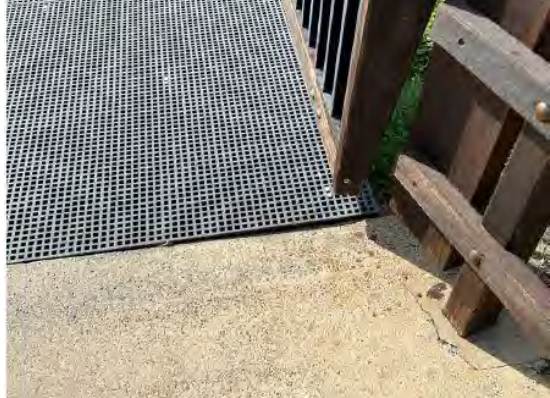
ELEMENT	CONDITION DESCRIPTION AND ILLUSTRATION	
Approach	The concrete approach level is not flush with the bridge decking level and potentially could create a trip hazard.
